**COLORADO DIVISION OF RECLAMATION, MINING AND SAFETY
COAL PROGRAM INSPECTION REPORT**

| Permit Number: C-2009-087 Mine Name: Peabody Sage Creek Mine Operator: Peabody Sage Creek Mining, LLC Operator Address: Mr B. Scott Cowman P.O. Box 250 36600 Routt County Road 27 Hayden, CO 81639 | County: Routt Operation Type: Underground Permit Status: Active Ownership: Federal |

| Inspection Start Date: September 18, 2013 Inspection Start Time: 09:00 Inspection End Date: September 18, 2013 Inspection End Time: 12:30 | | Inspection Type: Coal Partial Inspection Inspection Reason: Surety Release Requested Weather: Raining | |

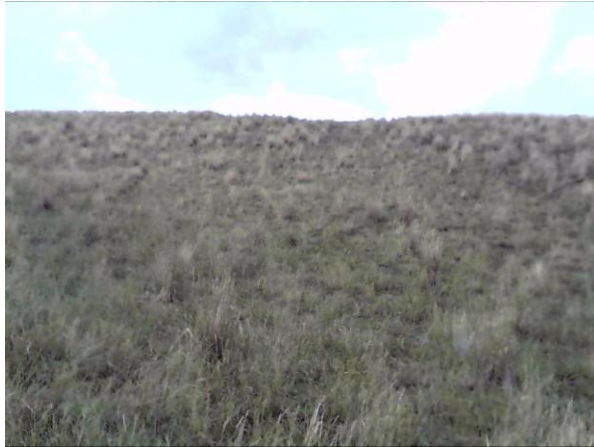
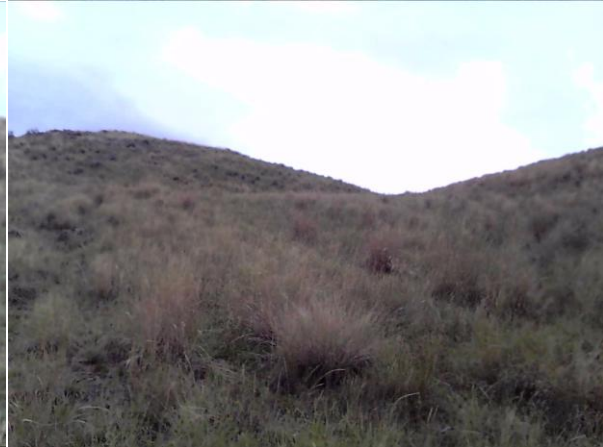
NORTH FACING SLOPES

Based on the absence of topsoil storage and redistribution requirements, no topsoil placement was included in the bond release area. Although no topsoil was verified, good vegetation growth was observed throughout the north and northeast facing slopes, with sparse vegetation along the south and southwest facing slopes.

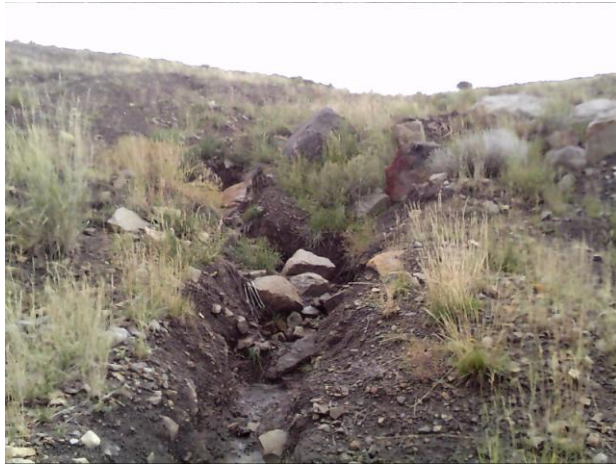
Based on the applicable Rules for Pre-Law Bond Release, the backfilling and grading of the area was successful as the bond release area corresponds favorably with the surrounding terrain. Minor rills and gullies were noticeable with no heavy erosion noted, with the exception of the large drainage from the eastern portion of the area to the stock pond located in the low portion of the area. Although this area displayed heavy down cutting, the feature was established as large shrubs have developed within the erosion. No off site impacts were observed as the area of erosion has been contained within the bond release area. A determination will be made during the review process concerning the extent of erosion and the potential for any off site impacts concerning the features identified during the inspection.

EROSION FEATURE

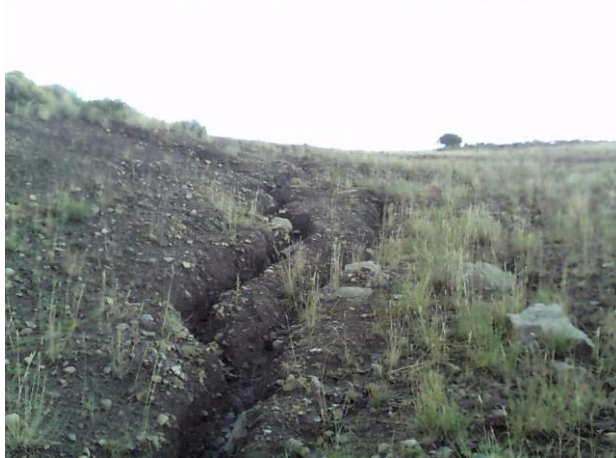
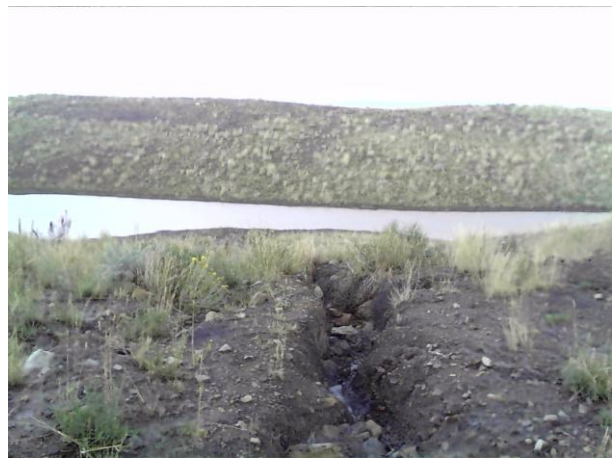
EROSION ABOVE STOCK POND
