**COLORADO DIVISION OF RECLAMATION, MINING AND SAFETY
COAL PROGRAM INSPECTION REPORT**

| Permit Number: C-1994-082 Mine Name: Yoast Mine Operator: Seneca Coal Company, LLC Operator Address: Mr. Roy Karo 37796 Routt County Road 53 P.O. Box 670 Hayden, CO 81639 | County: Routt Operation Type: Surface Permit Status: Permanent Cessation Ownership: Federal |

| Inspection Start Date: September 25, 2013 Inspection Start Time: 10:09 Inspection End Date: September 25, 2013 Inspection End Time: 10:10 | Inspection Type: Aerial Inspection Inspection Reason: Normal I&E Program Weather: Clear |

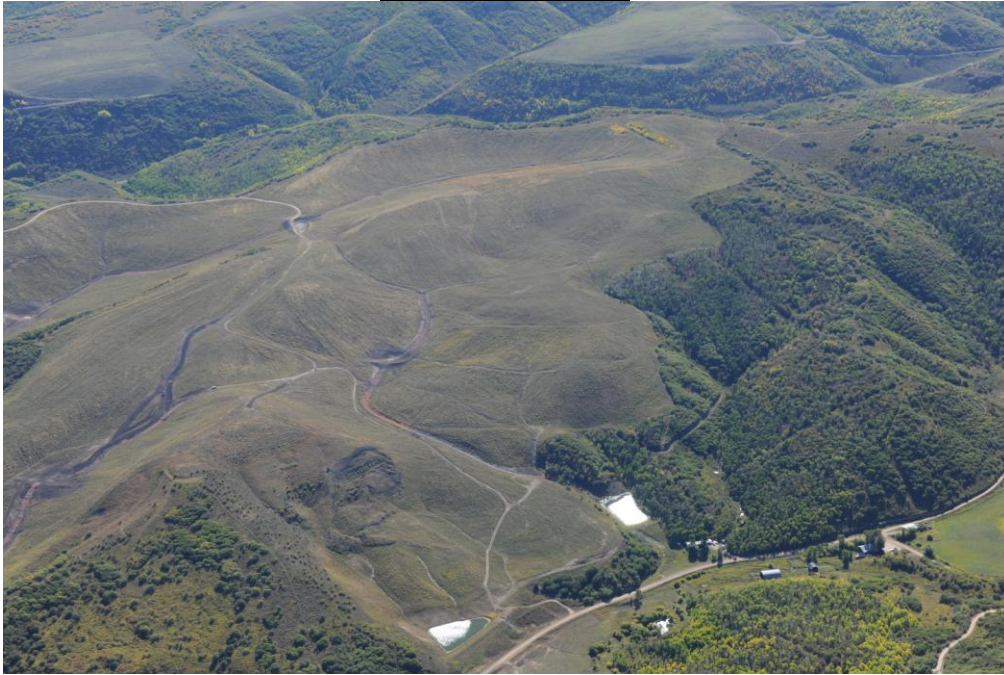
South portion of the mine. Ponds 013 and 014 at the bottom of the photo.

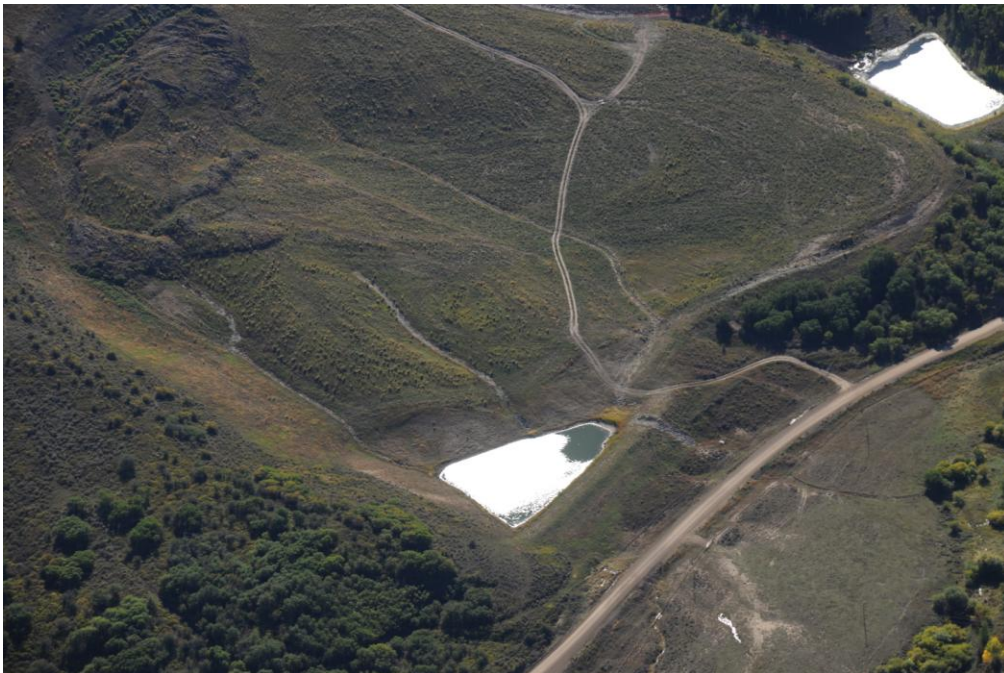
The Pond 013 slide does not appear to have moved since the last inspection.

Ponds 013 and 014. The Pond 013 slide in the top left portion of the picture.

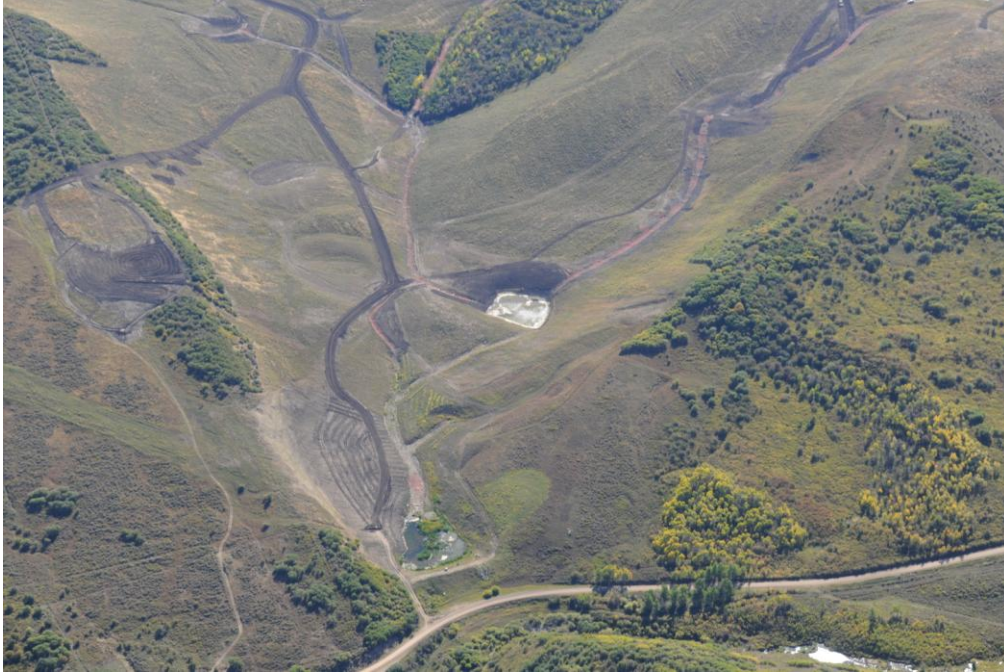
SCC has been conducting repairs on numerous drainages within the affected area. Drainages YPM-6-2, 6-1, 6-3, 7, 5-1, 3-2/3-2a appear to have recently been repaired. These channels have been rip-rapped and check dams have been installed at various locations along the channels.

Ponds 012 and 012a, Channel YPM-5-1 on the top right and YPM-6-3, 6-2, and portions of YPM-7 and 6-1 visible. Topsoil stockpile L on the top left portion of the picture.

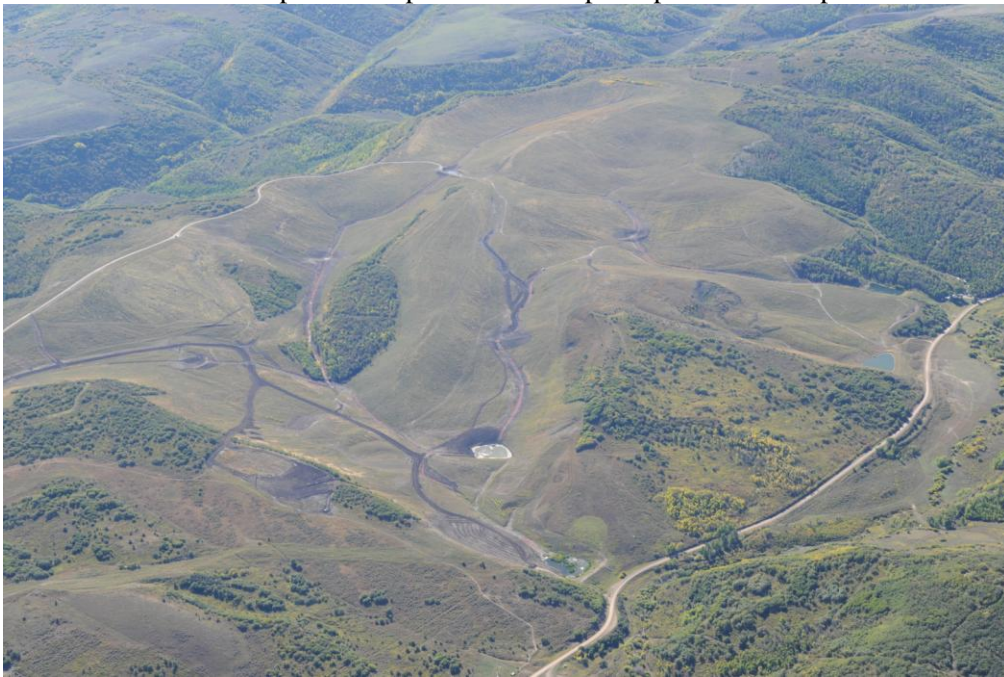
South portion of the mine.

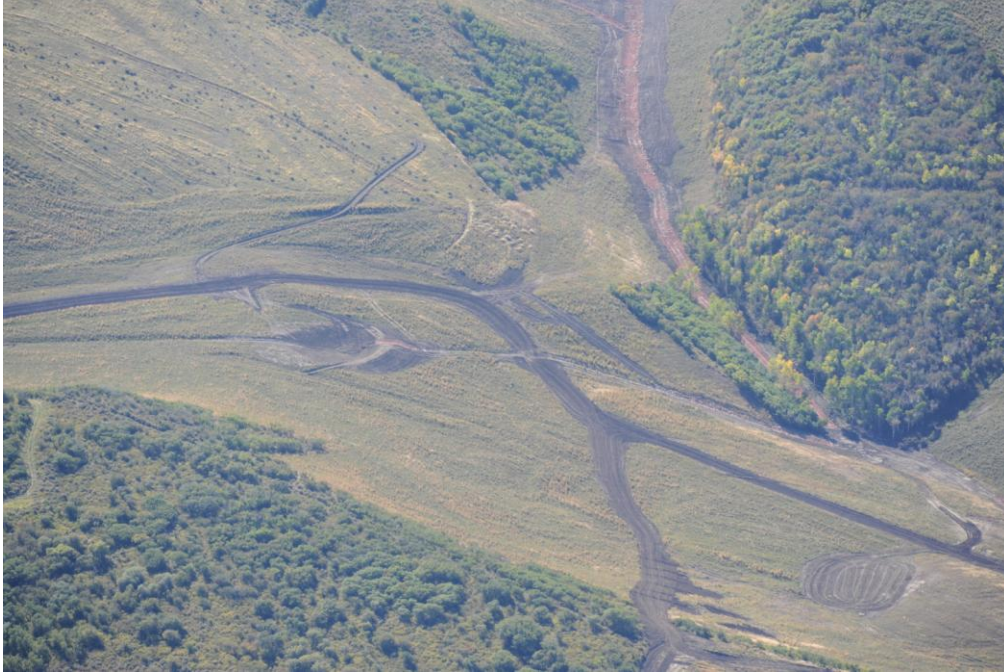
The access road built from the LU3B road along the YPM-7 and YPM-6-2 drainage to conduct drainage repairs appears to have been topsoiled and reclaimed. It appears topsoil from stockpile L was utilized for reclamation.

YPM-7, 6-1 and the drainage repair access road visible.

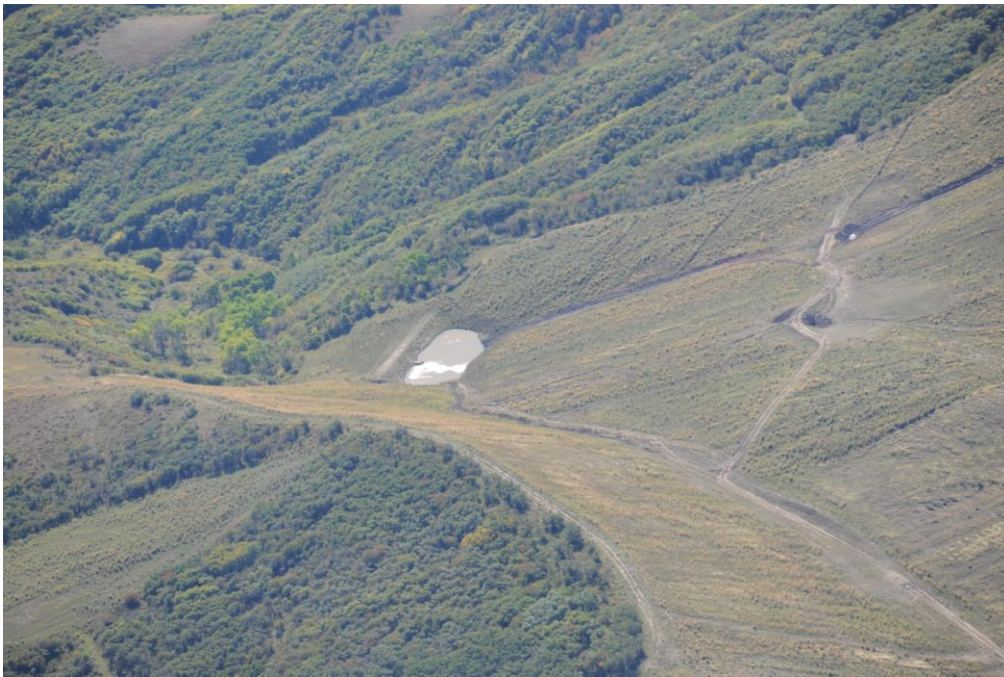
Several surge tanks along the YPM-13 have been in need of repair based on previous inspections. The Division conducted a ground inspection on Monday September 23rd and Mr. Roy Karo with SCC indicated the surge tanks have been repaired. Based on the photographs it appears the spillways of these structures have been re-shaped and stabilized with rip-rap. The YPM-13 channel appears to have a large rill developing in and possibly adjacent to the channel. This rill will need to be monitored and possibly repaired.

Pond 011a and the YPM-9 and 13 drainages visible.

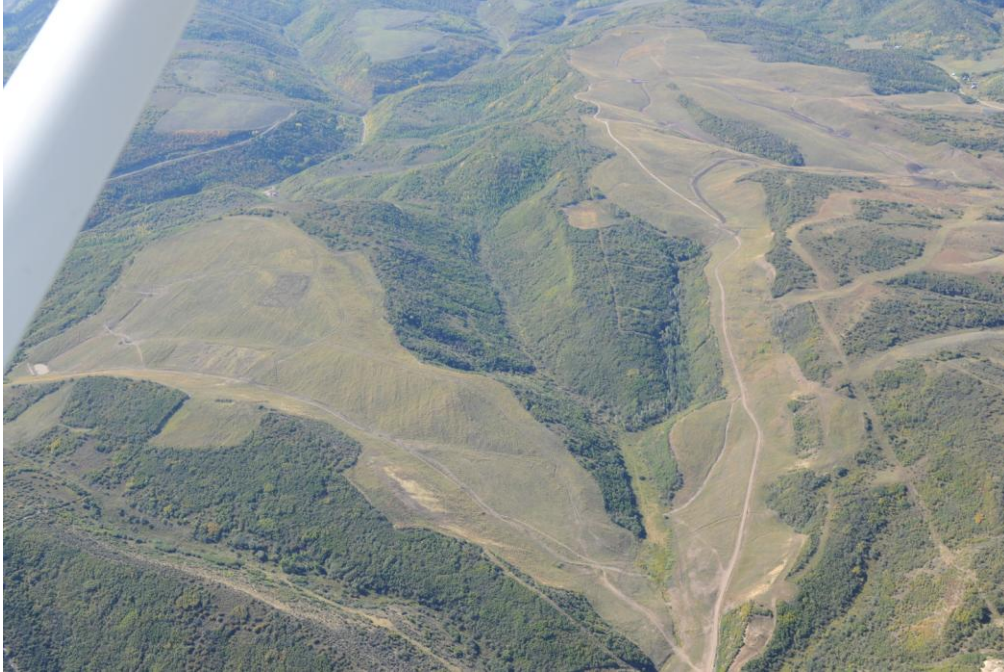
View of the majority of the affected area from the north end looking south. Neck pit appears stable.
