**COLORADO DIVISION OF RECLAMATION, MINING AND SAFETY  
COAL PROGRAM INSPECTION REPORT**

<b>Permit Number:</b> C-1994-082 <b>Mine Name:</b> Yoast Mine <b>Operator:</b> Seneca Coal Company, LLC <b>Operator Address:</b> Mr. Roy Karo 37796 Routt County Road 53 P.O. Box 670 Hayden, CO 81639	<b>County:</b> Routt <b>Operation Type:</b> Surface <b>Permit Status:</b> Permanent Cessation <b>Ownership:</b> Federal
	<b>Operator Representative Present:</b>  Roy Karo
<b>Operator Representative Signature: (Field Issuance Only)</b>

<b>Inspection Start Date:</b> September 23, 2013 <b>Inspection Start Time:</b> 14:00 <b>Inspection End Date:</b> September 23, 2013 <b>Inspection End Time:</b> 17:00		<b>Inspection Type:</b> Coal Partial Inspection <b>Inspection Reason:</b> Normal I&E Program <b>Weather:</b> Clear	
<b>Joint Inspection Agency:</b>  None		<b>Joint Inspection Contacts:</b>	
<b>Post Inspection Agency:</b>  None		<b>Post Inspection Contacts:</b>	
<b>Inspector(s):</b>  Jared L. Ebert	<b>Inspector's Signature:</b>

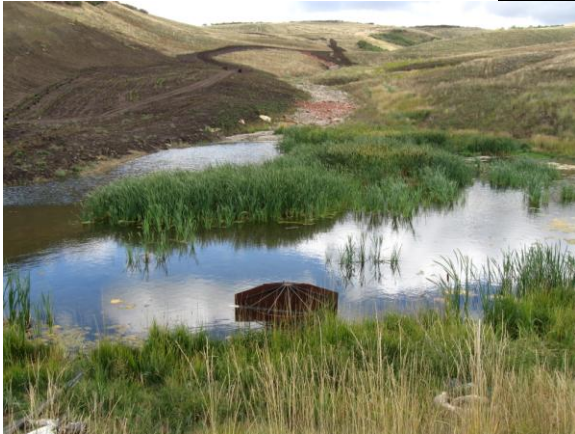
Pond 012 was holding water and not discharging. The embankment was stable and vegetated. The sediment level appears to be high and the pond may need to be cleaned. The primary and emergency spillways were clear and functional.

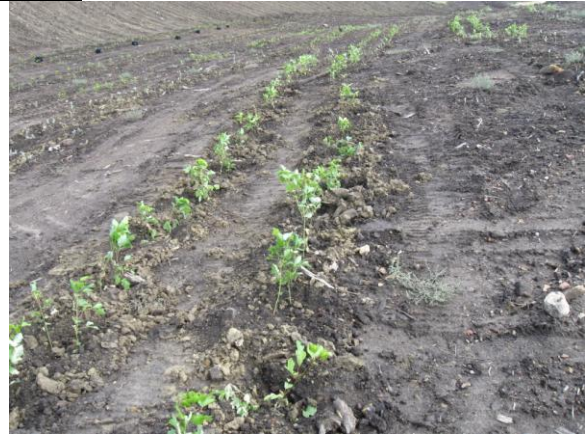
Several rows of trees and shrubs were planted in the recently topsoiled area near the Pond 012 slide. The primary species planted appears to be Box Elder, Narrowleaf Cottonwood, Willow and Birch.

Tree and shrub planting area in the Pond 012 slide area.

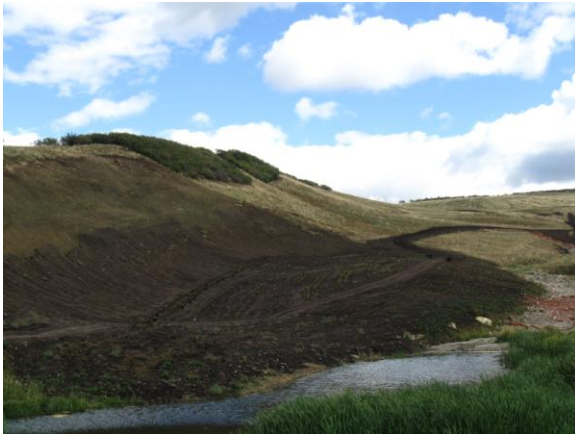
Topsoil was applied to the Pond 012 slide area. Several rows of trees and shrubs were planted in the recently topsoiled area.

Pond 012 slide area, recently topsoiled and trees planted.

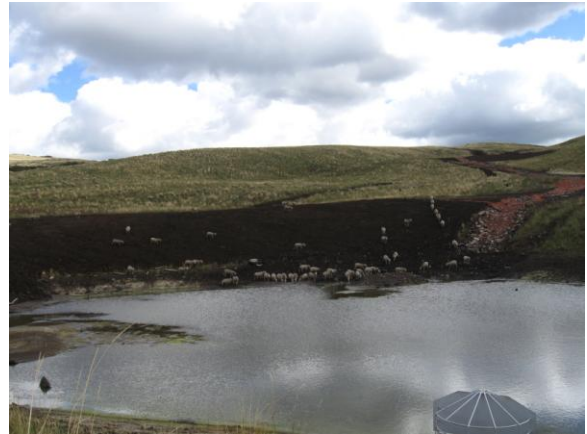
Pond 012a was holding water but was not discharging. The primary and emergency spillways were clear and functional. The embankment was stable and vegetated.

The northeast slope of Pond 12a appears to have been recently graded and topsoiled.

Pond 012a, sheep grazing in the area.

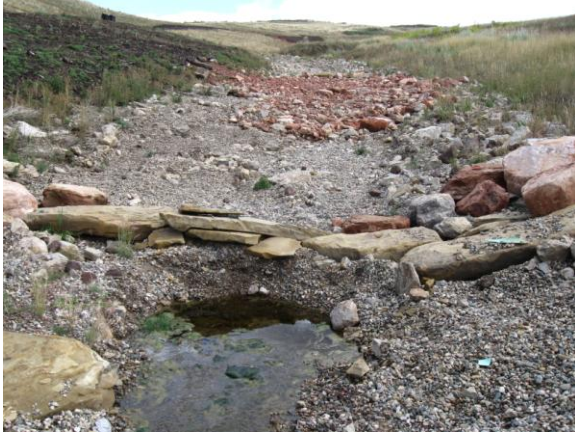
YPM 6-3 drainage inlet to pond 012.

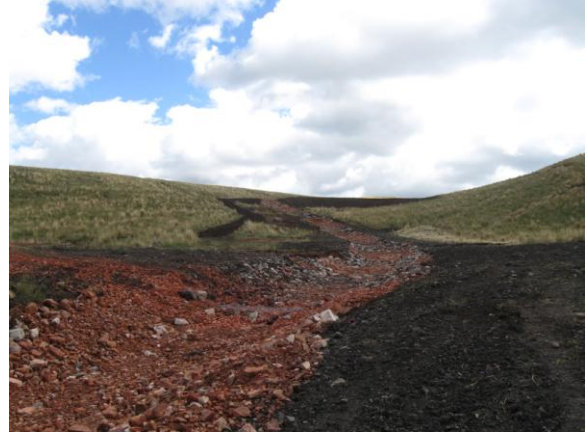
YPM-5-1 drainage

A new surge tank was installed in the YPM-5-1 drainage.

Repairs to drainage channels YPM-6-2, 6-1, 7, 5-1 appear to be complete. The Operator has re-built these channels and lined them with rip-rap and installed gabion check dams at various locations along the drainage.

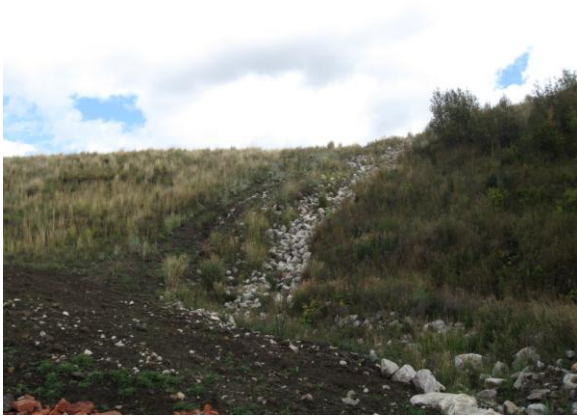
YPM-14 drainage.

A very steep section of YPM-14 discharges into Pond 014. This channel is lined with rip-rap and appears stable.

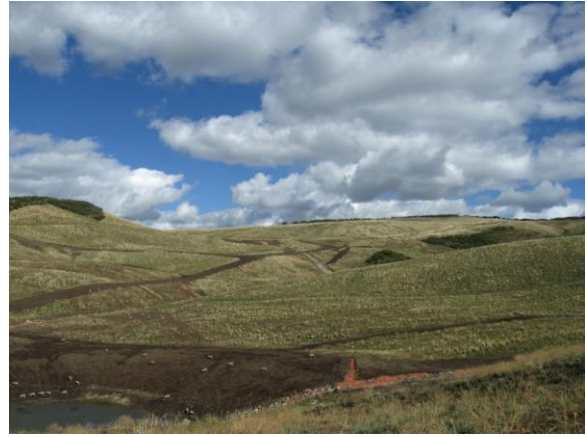
Sheep grazing was occurring in the YPM 6-2/7 and YPM-5-1 drainage basins.

YPM-6-2 and 7 drainage basin.

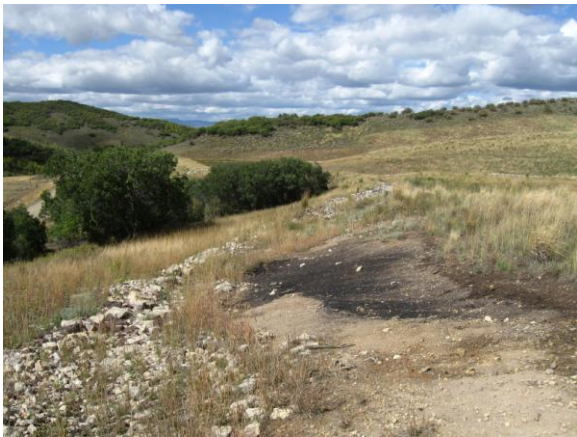
Diversion 13a

Diversion 13A was observed. The lower berm is in place. Sediment has collected in portions of the diversion but overall it appears functional.
