**COLORADO DIVISION OF RECLAMATION, MINING AND SAFETY
COAL PROGRAM INSPECTION REPORT**

Permit Number: C-1981-020 Mine Name: Munger Canyon Mine Operator: CAM Mining, LLC Operator Address: Mr. Corey Heaps P.O. Box 98 Loma, CO 81524	County: Garfield, Mesa Operation Type: Underground Permit Status: Permanent Cessation Ownership: Federal
	Operator Representative Present: None
Operator Representative Signature: (Field Issuance Only)

Inspection Start Date: September 20, 2013 Inspection Start Time: 12:30 Inspection End Date: September 20, 2013 Inspection End Time: 13:40		Inspection Type: Coal Partial Inspection Inspection Reason: Normal I&E Program Weather: Clear	
Joint Inspection Agency: None		Joint Inspection Contacts: 	
Post Inspection Agency: None		Post Inspection Contacts: 	
Inspector(s): Michael P. Boulay	Inspector's Signature: <i>Michael P. Boulay</i>		Signature Date: 10/2/13

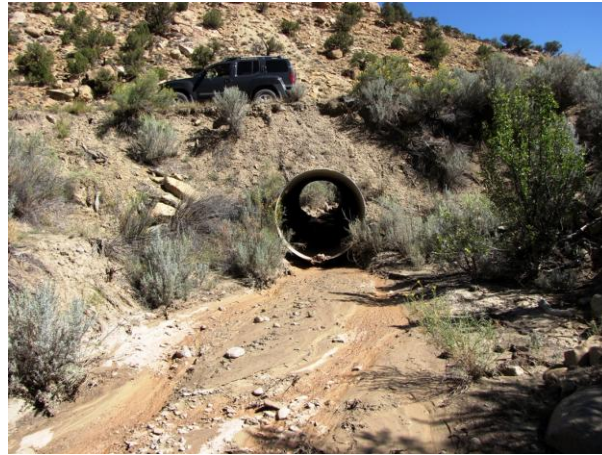
East Salt Creek had a small amount of flow. This area had received substantial precipitation over a several day period during the week prior to this inspection. Munger Creek was mostly dry but showed evidence of recent significant flow in the creek bottom. The Munger Creek crossing is shown in Photograph No. 1. The six foot diameter culvert at the creek crossing is in good condition with no significant accumulation of sediment or other debris. Ditches and culverts associated with the reclaimed waste disposal site, cover soil stockpile site, and the topsoil stockpile locations were in good condition and well maintained. The waste disposal area sediment pond was not retaining any water. The inlet and discharge structures were stable and no problems were identified.

Photo No. 1 - Culvert at Munger Creek crossing.

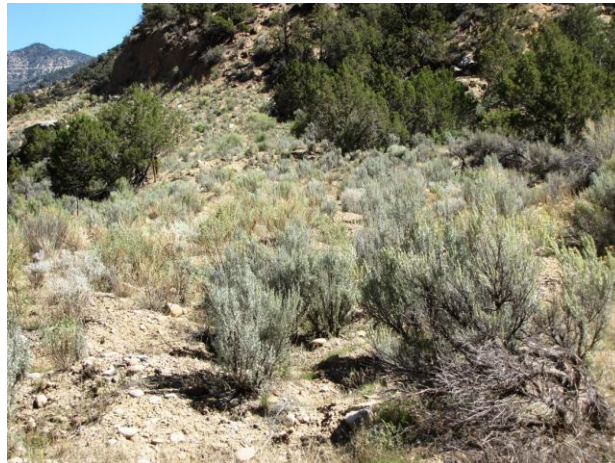
The bottom portion of the reclaimed portal access road was inspected. The upper segment and portal bench area were not inspected. As seen in the attached Photograph No. 2 the vegetation is well established and the reclaimed portal access road is stable. No signs of significant erosion or instability were noted at any of the mine site locations during this inspection.

Photo No. 2 - Reclaimed portal access road.

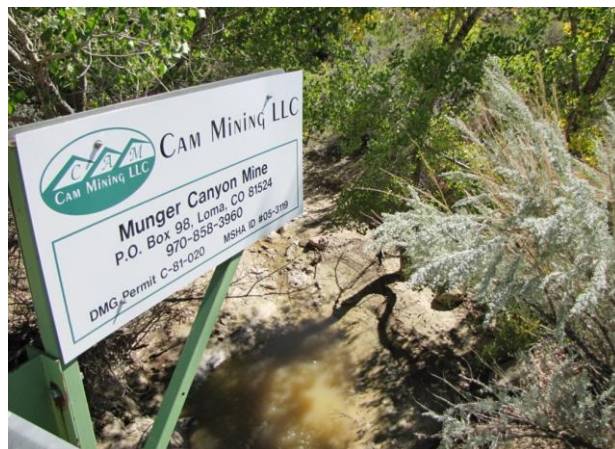
The Mine and Permit identification sign was properly displayed and maintained at the entrance to the permit area from Highway 139. The mine identification sign at the East Salt Creek crossing is shown in Photograph No. 3.

Photo No. 3 - Mine identification sign at East Salt Creek bridge crossing.
