**COLORADO DIVISION OF RECLAMATION, MINING AND SAFETY
COAL PROGRAM INSPECTION REPORT**

Permit Number: C-1981-015 Mine Name: Fruita No 1 & 2 Operator: Dorchester Coal Company Operator Address: NA	County: Mesa Operation Type: Underground Permit Status: Revoked Ownership: Private
	Operator Representative Present: None
Operator Representative Signature: (Field Issuance Only)

Inspection Start Date: September 20, 2013 Inspection Start Time: 08:00 Inspection End Date: September 20, 2013 Inspection End Time: 09:45	Inspection Type: Coal Complete Inspection Inspection Reason: Normal I&E Program Weather: Clear
Joint Inspection Agency: None	Joint Inspection Contacts:
Post Inspection Agency: None	Post Inspection Contacts:
Inspector(s): Michael P. Boulay	Inspector's Signature: <i>Michael P. Boulay</i> Signature Date: October 2, 2013

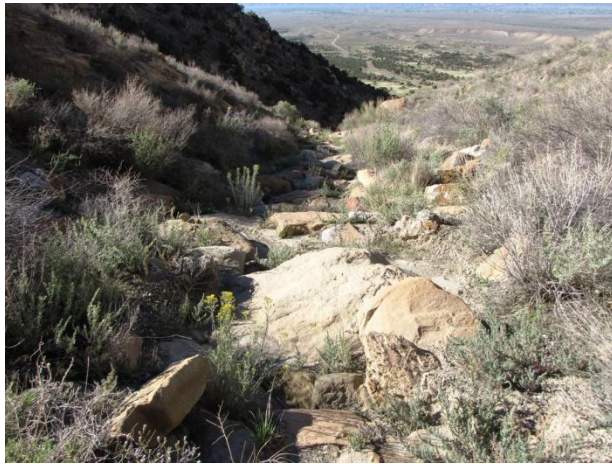
Photo No. 1 – View from Portal Bench

Backfill slopes appear stable, with no evidence of slumping, caving or excessive erosion. There are no slumps or cracks present at the #1 portal backfill. The site remains stable with no significant erosion or instability problems. A view looking south from a location just below the portal backfill is shown in Photograph No. 1.

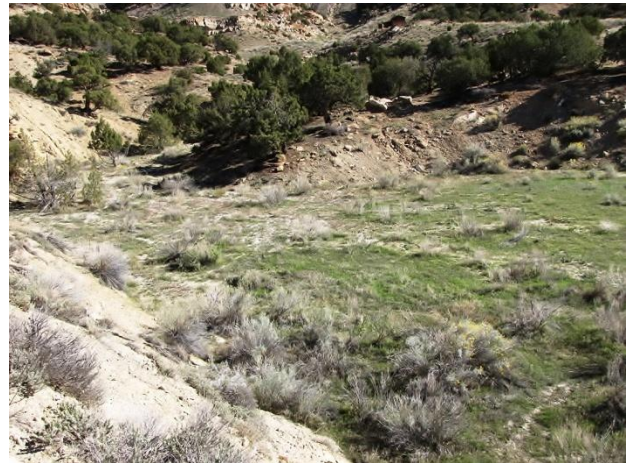
Photo No. 2 – Sediment Pond

The mine site was dry at the time of the inspection. The riprap permanent channel on the steep Mine 1 bench fill outslope is well constructed and no problems were noted during this inspection. The channel remains stable and in good condition. The sediment pond was completely dry. The pond embankment and spillway are stable. There appears to have been some recent inflow to the pond as evidence by some siltation at the inlet. The sediment pond inlet is shown in Photograph No. 2.

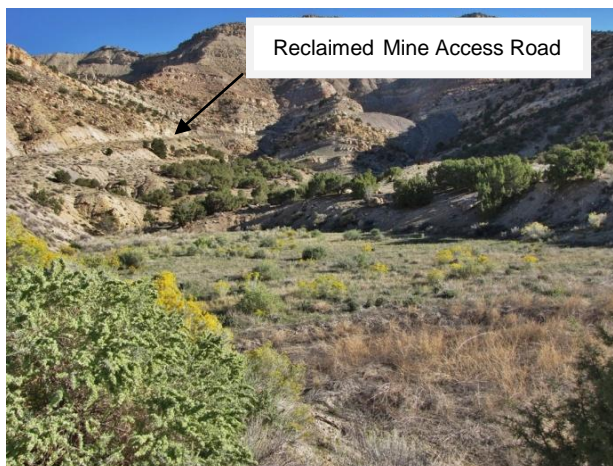
Photo No. 3 – Site Overview

The reclaimed mine access road was inspected along its entire length up to the upper bench area (see Photograph No. 3). The rock check structures at the lower end of the reclaimed roads remain in place and are functional. There is some evidence of recent runoff from the lower end of the road due to the significant precipitation in this area during the week prior to this inspection, but no significant erosion or instability problems were noted. The minor rilling in the vicinity of the checks dams has not changed considerably and is about the same as noted previously (Photograph No. 4). The reclamation remains stable with no problems identified.
