COLORADO DIVISION OF RECLAMATION, MINING AND SAFETY COAL PROGRAM INSPECTION REPORT

Permit Number: C-1982-057 Mine Name: Seneca II-W Mine Operator: Seneca Coal Company, LLC Operator Address: Mr. Roy Karo 37796 Routt County Road 53 P.O. Box 670 Hayden, CO 81639	County: Routt Operation Type: Surface Permit Status: Permanent Cessation Ownership: Federal
	Operator Representative Present: None
Operator Representative Signature: (Field Issuance Only)

Inspection Start Date: September 25, 2013 Inspection Start Time: 10:05 Inspection End Date: September 25, 2013 Inspection End Time: 10:08	Inspection Type: Aerial Inspection Inspection Reason: Normal I&E Program Weather: Clear
Joint Inspection Agency: None	Joint Inspection Contacts:
Post Inspection Agency: None	Post Inspection Contacts:
Inspector(s): Jared L. Ebert Harry B. Ranney	Inspector's Signature:

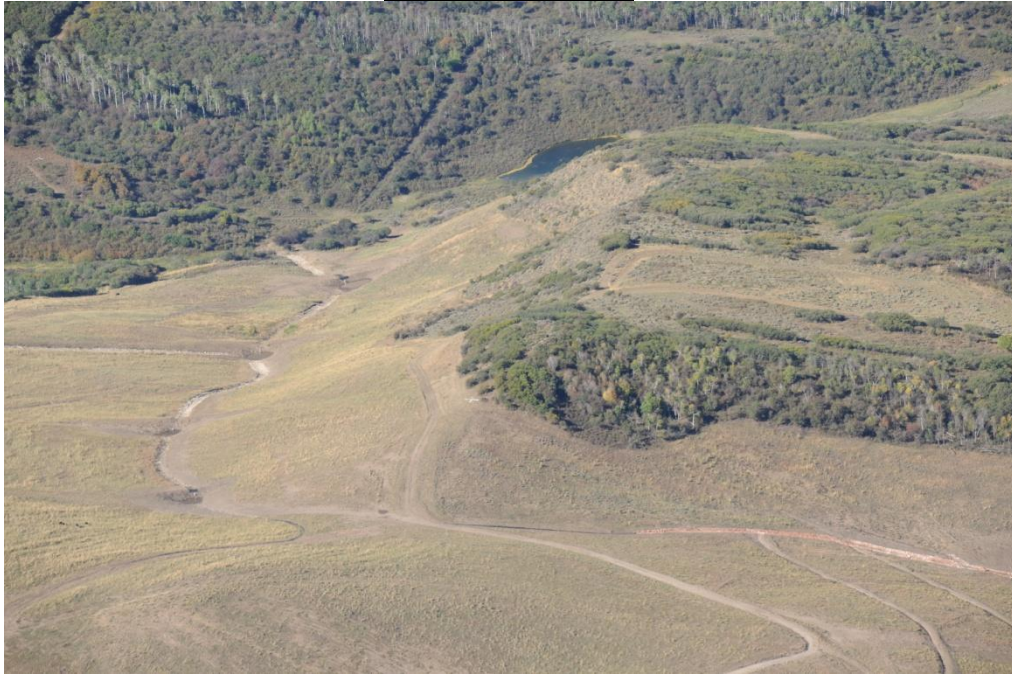
Pond 005, 006, 016, 017 were visible in the photographs. These ponds were holding water and the impoundments appeared stable.

PM-1A drainage looking south west to Pond 017.

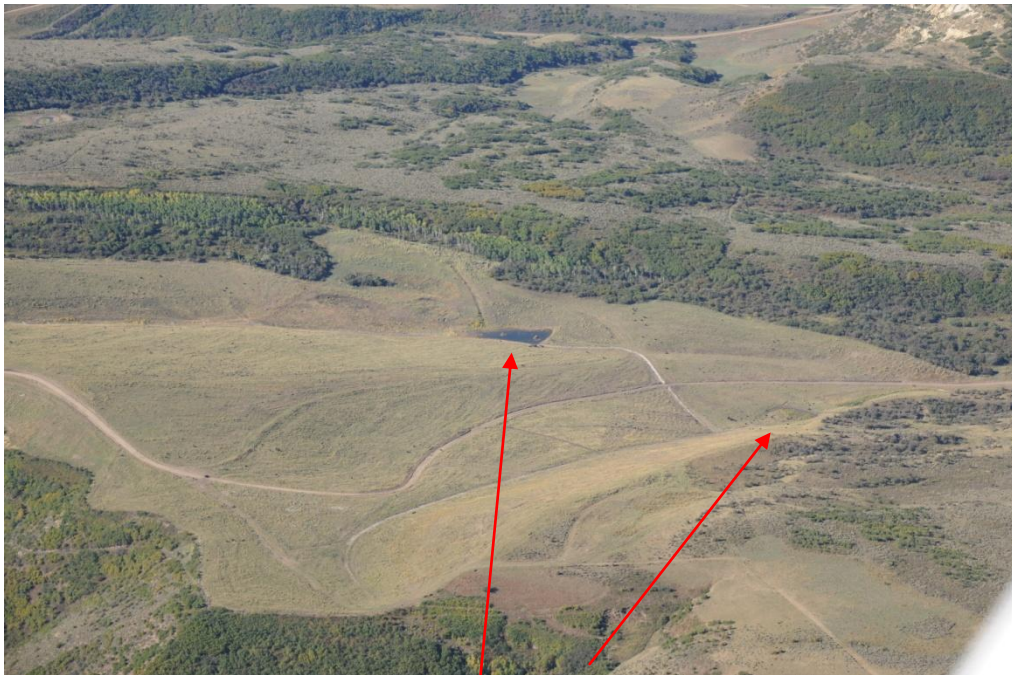
Stock ponds T-20 may have been holding a little bit of water, but overall it appeared marshy. Pond T-18, T-27 and T-26 were visible in the photographs. These ponds were holding water. All the impoundments appeared to be stable and functional.

The G haul road, J haul road, Ridgeline Access Road and portions of the K haul road were visible in the photographs. These roads appeared to be graded and maintained.

Northern portion of the affected area, T-18 and T-20 visible, Ridgeline Access Road

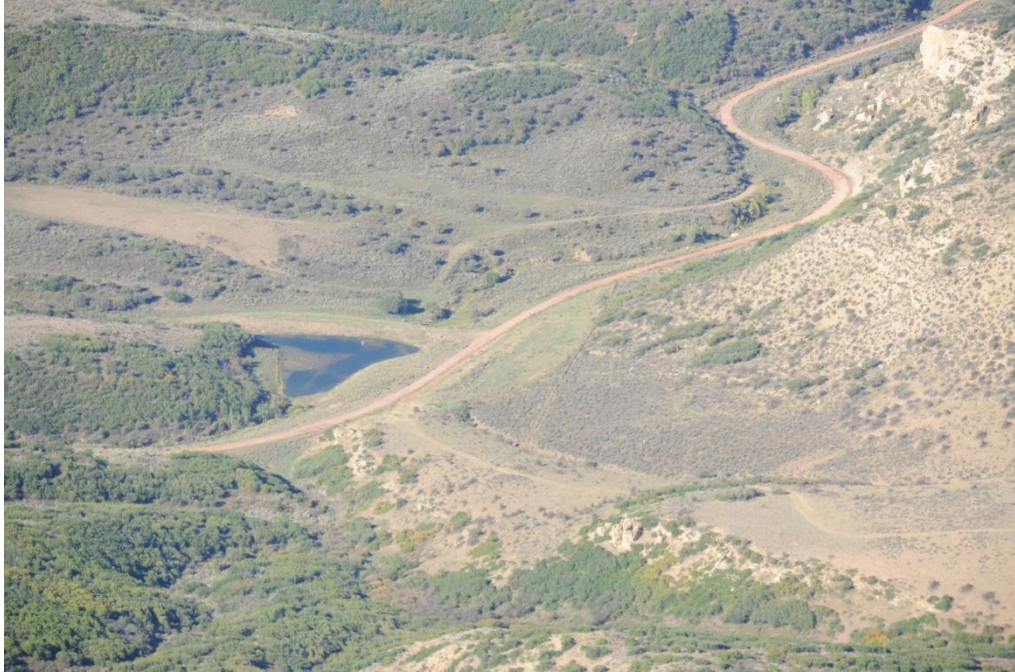
Pond 005 and G haul road

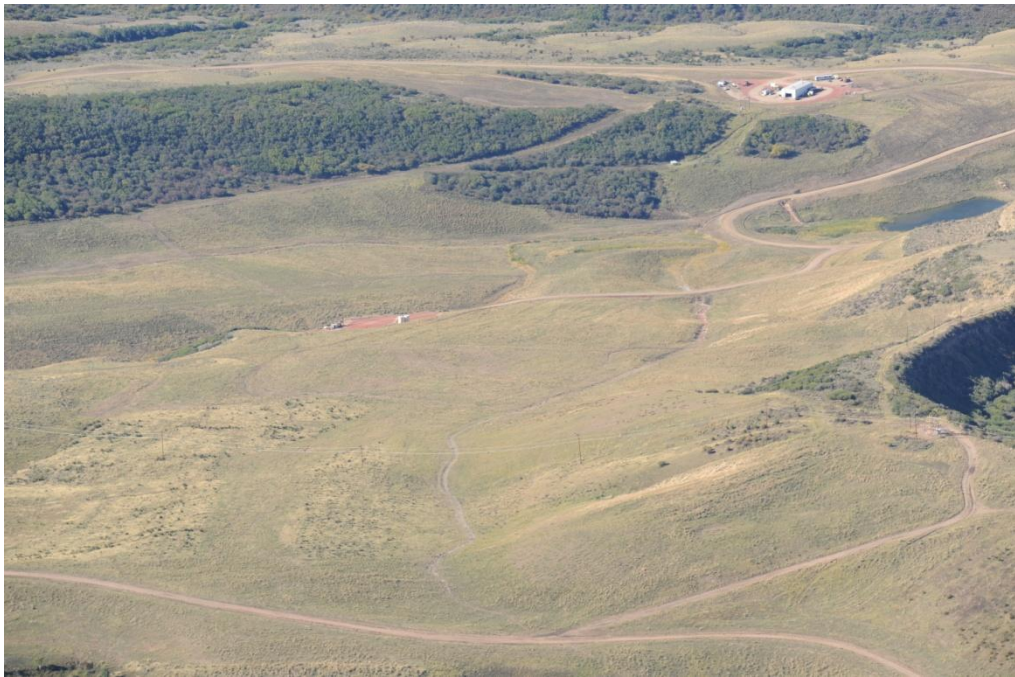
The 006-NE4, 006-NE3 and the PM-3 drainage basins appear well vegetated and stable. Large rills or gullies were not observed in the photographs.

From the northeast end of drainage 006-NE4 looking southwest. Pond 006 and shop in the top right portion of the picture.

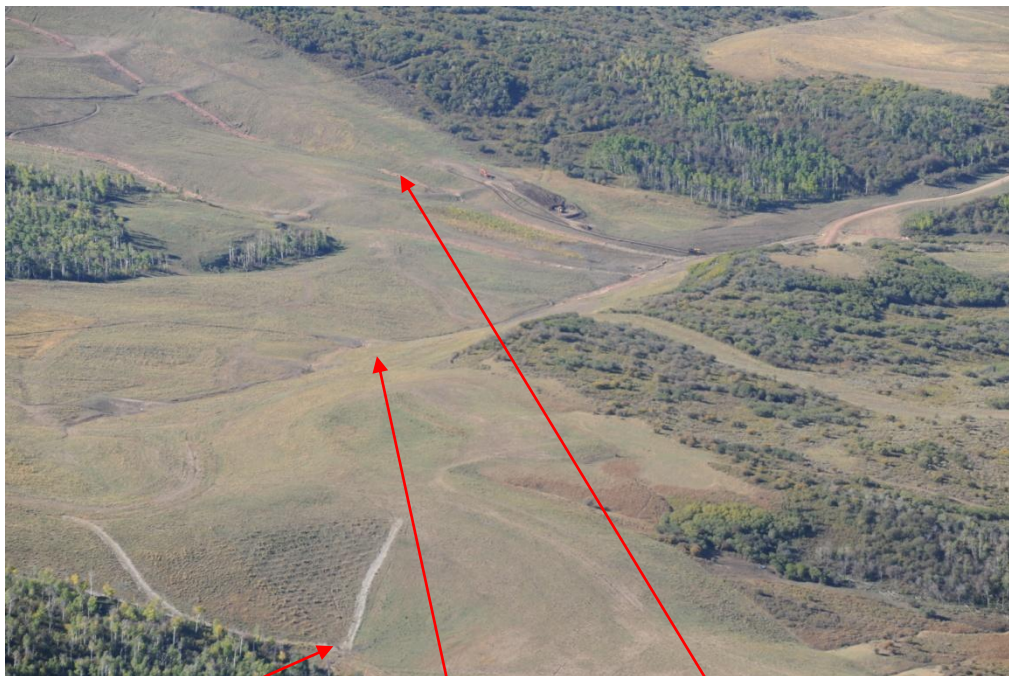
The PM-3, 4, 4B, 4-D, and 2A drainages were observed in the photographs. Overall, these drainages appeared stable. Smaller rills and gullies could not be seen given the size of the photographs; however, large gullies and failures were not observed.

PM-4 and 4-B drainage, PM-3 drainage and PM-2A drainage.

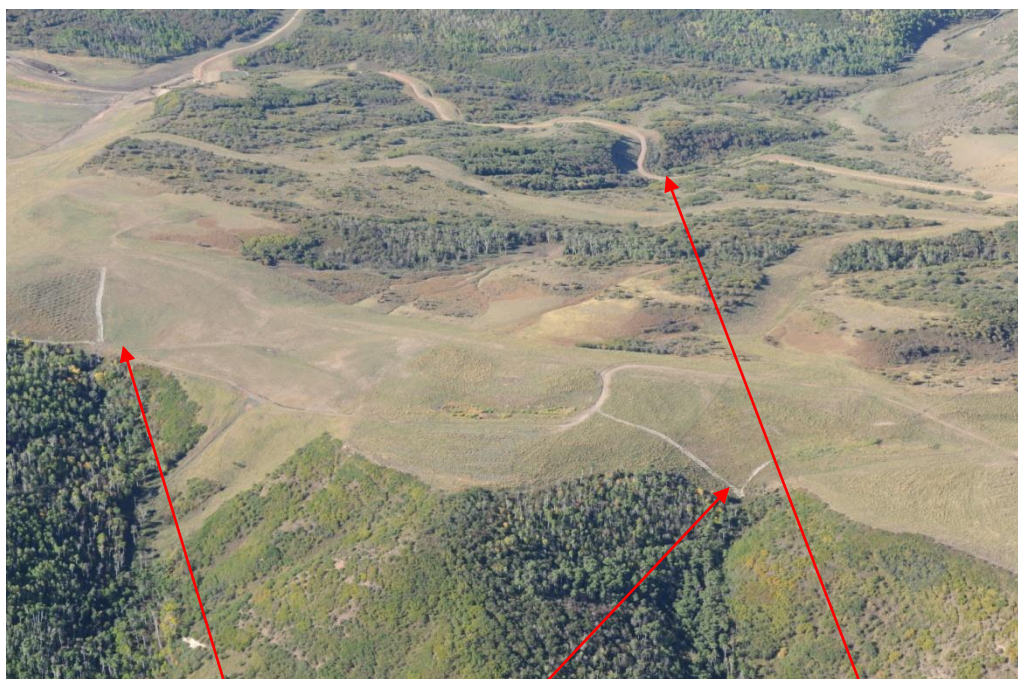
PM-4 and 4-C drainage, PM-5A and 5B drainage, J haul road.

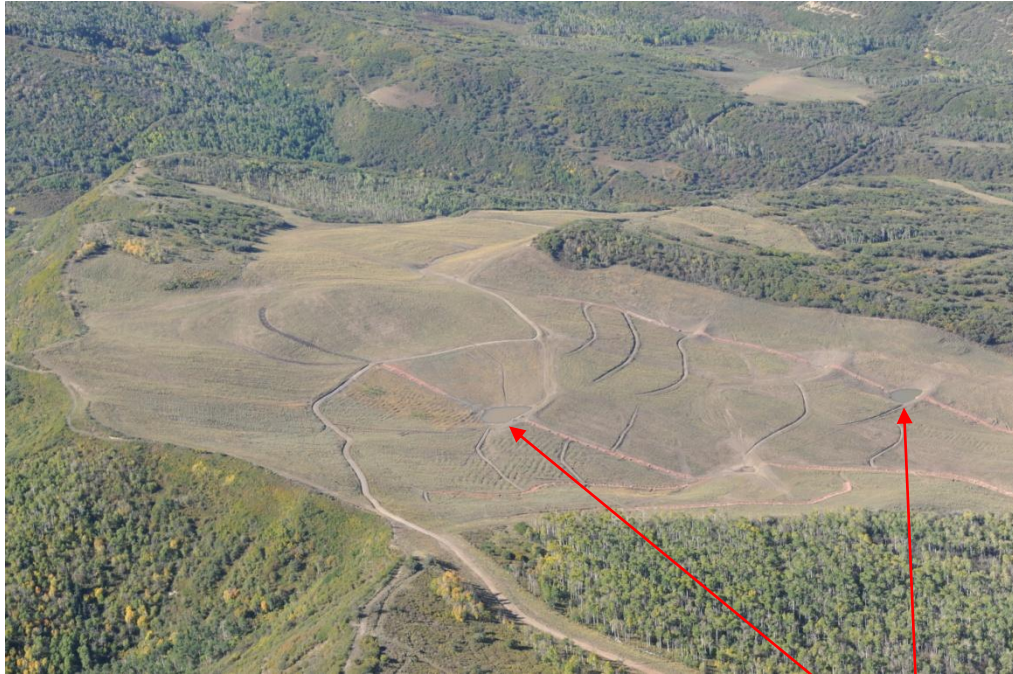
South expansion area, drainages PM-2B and 2A, stock tanks T-26 and T-27

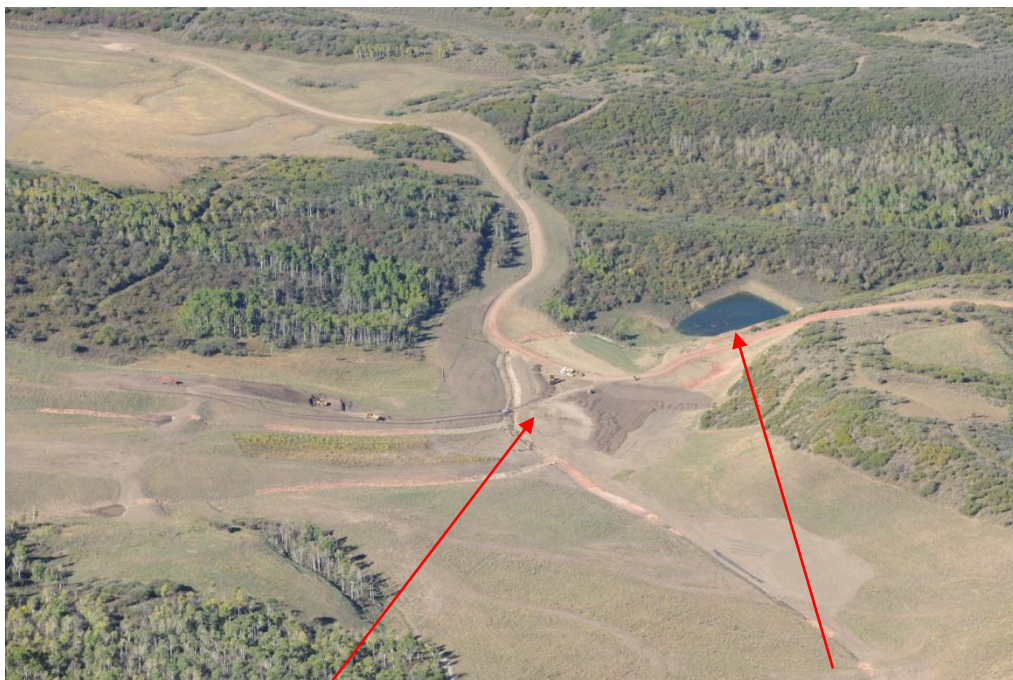
The Operator appears to be continuing reclamation in the former Pond 016a area. Topsoil is being excavated from a stockpile (possibly stockpile ZZ) and transported to the Pond 016a graded area.

Pond 016A reclamation and topsoil application. Pond 016
