**COLORADO DIVISION OF RECLAMATION, MINING AND SAFETY
COAL PROGRAM INSPECTION REPORT**

Permit Number: C-1982-057 Mine Name: Seneca II-W Mine Operator: Seneca Coal Company, LLC Operator Address: Mr. Roy Karo 37796 Routt County Road 53 P.O. Box 670 Hayden, CO 81639	County: Routt Operation Type: Surface Permit Status: Permanent Cessation Ownership: Federal
	Operator Representative Present: Roy Karo
Operator Representative Signature: (Field Issuance Only)

Inspection Start Date: September 26, 2013 Inspection Start Time: 07:00 Inspection End Date: September 26, 2013 Inspection End Time: 13:00	Inspection Type: Coal Partial Inspection Inspection Reason: Normal I&E Program Weather: Clear
Joint Inspection Agency: None	Joint Inspection Contacts:
Post Inspection Agency: None	Post Inspection Contacts:
Inspector(s): Jared L. Ebert	Inspector's Signature:

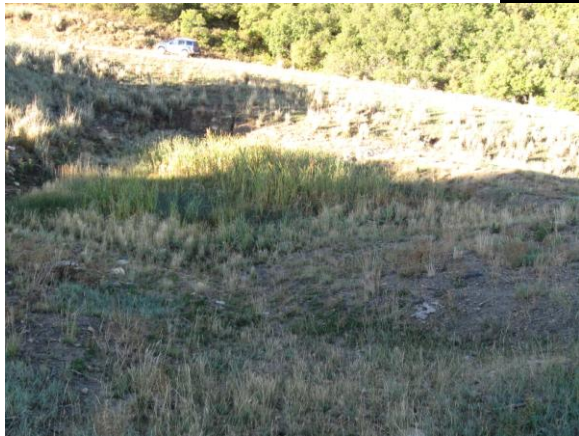
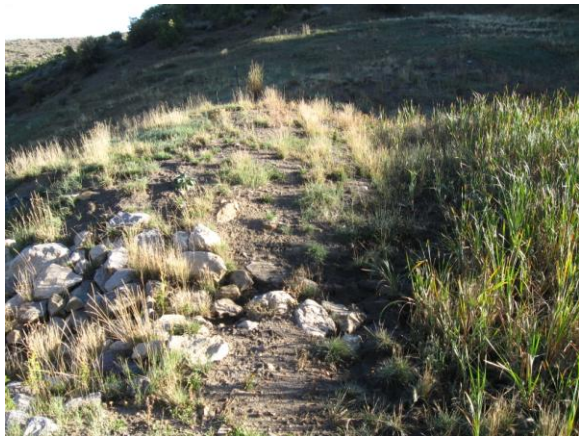
Stock pond T-22 was observed. The impoundment embankment was in place and appeared stable and vegetated. The bottom of the impoundment is boggy with a healthy stand of cattails established.

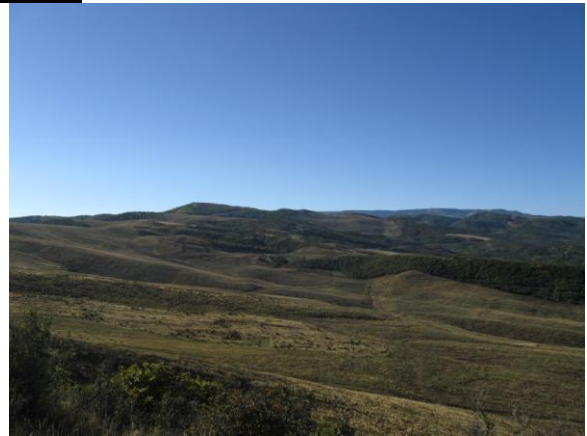
The 006 Gulch basin was observed. Overall the vegetation in the basin is well established and the area appeared stable.

006 Gulch drainage basin from north end looking south.

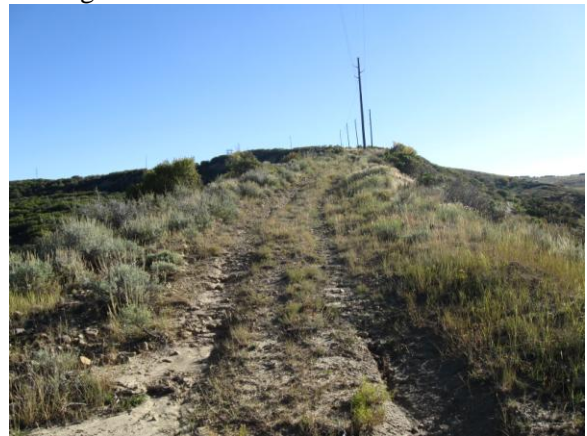
LU-1B road.

The LU1B access road was observed. The powerline is in place along the road. The road itself is a simple two track road that is very overgrown in places with native grasses and shrubs.

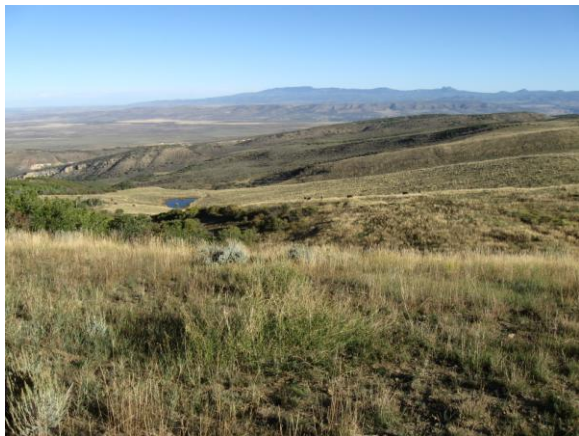
The 005 Gulch basin was observed. Cows were grazing throughout the basin. Overall the vegetation in the basin is well established.

005 Gulch drainage basin, stock pond T-18 visible.

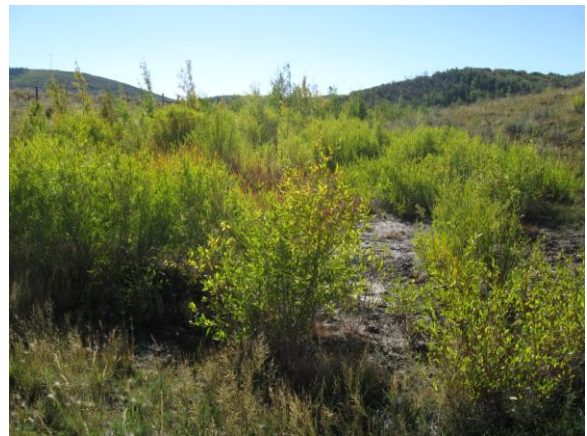
Tree/Shrub enclosure north of PM 4-D.

A shrub enclosure is located north of drainage PM 4-D. The enclosure was inspected. Water appears to collect in a small depression inside the enclosure and a small marshy area has formed. Planted aspen trees and willow have well established. A fence post on the southwest corner of the enclosure is broken and down, it appears animals have been browsing inside the enclosure. If it is still the desire of the Operator/landowner to exclude wildlife from this area, the fence should be repaired.

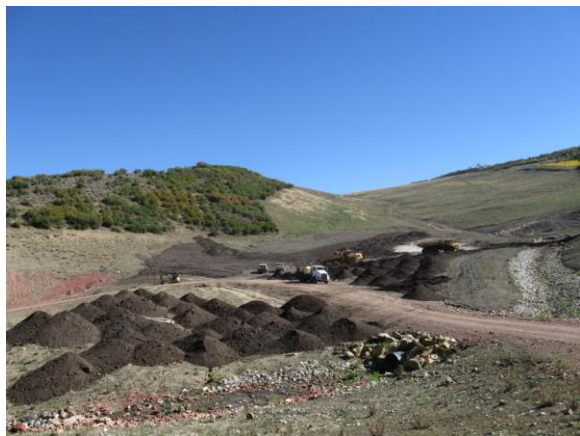
Reclamation activities in the former Pond 016A area have continued. SCC is spreading topsoil from a stockpile adjacent to the PM-2A drainage (possibly the former stockpile ZZ) around the remediation area.

Reclamation at the former Pond 016A site.
Topsoil application.

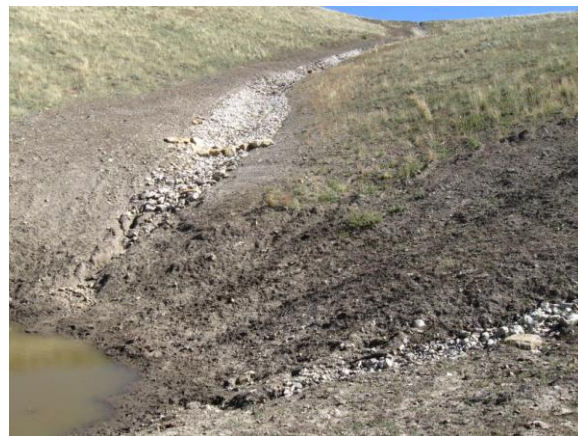
PM-1 drainage

The PM 1, 1-A and 1-B drainages were observed. Stock pond T-25 has become a surge tank and a rill is forming below the shrub enclosure near the surge tank.

Several surge tanks have been constructed along the PM 1 and 1-A channels. Several PVC riser pipes are missing and will need to be replaced.

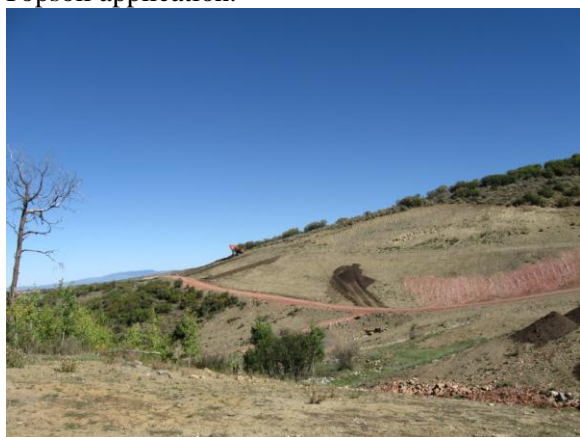
Reclamation at the former Pond 016 slide area.
Topsoil application.

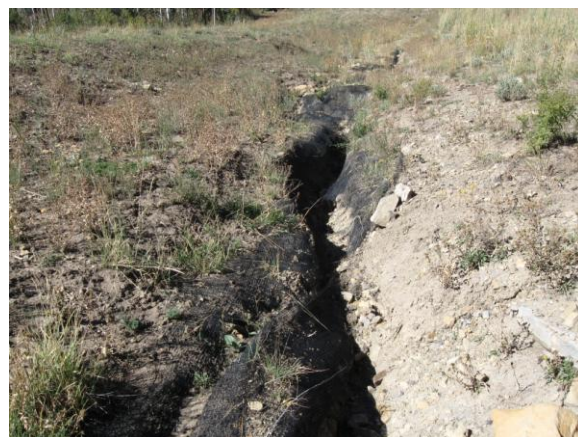
PM-1B drainage channel.

The upper reaches of PM 1-B are lined with turf re-enforced matting. Rills have formed in the middle of this channel and need to be monitored and repaired in places.
