COLORADO DIVISION OF RECLAMATION, MINING AND SAFETY
MINERALS PROGRAM INSPECTION REPORT
PHONE: (303) 866-3567

MINE NAME: Empire Pit	MINE/PROSPECTING ID#: M-1977-534	MINERAL: Sand and gravel	COUNTY: Clear Creek
INSPECTION TYPE: Monitoring	INSPECTOR(S): Tom Kaldenbach	INSP. DATE: June 4, 2013	INSP. TIME: 13:00
OPERATOR: City of Golden	OPERATOR REPRESENTATIVE:	TYPE OF OPERATION: 112c - Construction Regular Operation

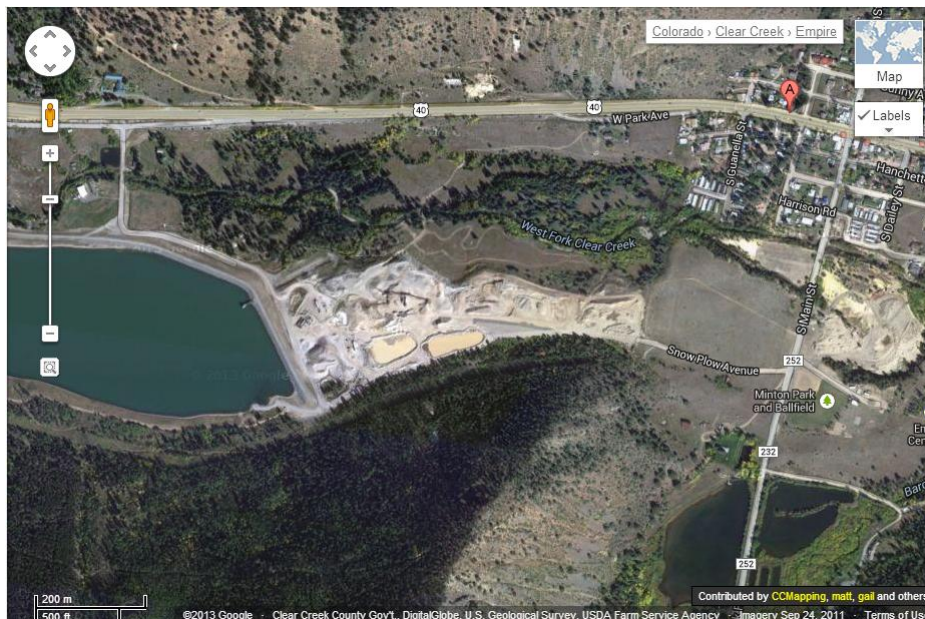
The East Side is located on a terrace above the West Fork of Clear Creek. Asphalt and rock are being stockpiled and processed in the East Side, but mining activities are largely complete. A significant amount of regrading has been done in the East Side since late 2011, as indicated by comparison of the Google Earth image from that time (shown below) and the site conditions observed during this inspection.

Google Earth Image from September 24, 2011. Empire Pit permit area includes the West Side (Guanella Reservoir and dam) on left side of image and East Side (Process Area) in center of image. Town of Empire is on right side of image.

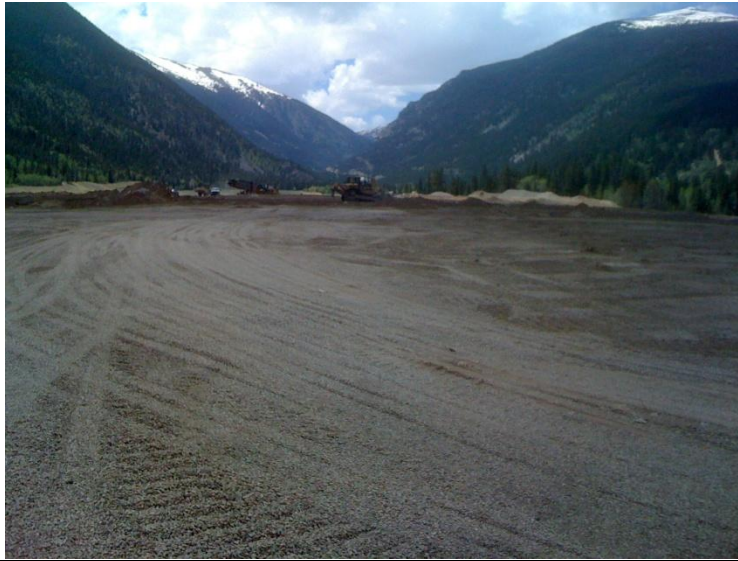
Photo 1 – East Side. Gravelly regraded surface.

Page 11 of Amendment 1 (AM-01) specifies that approximately 6 inches of on-site topsoil are to be replaced in the East Side. Topsoil stockpiles in the East Side appeared to have adequate volume for covering the site. Replacement of topsoil on regraded areas in the East Side was discussed during the inspection. During reclamation the topsoil may be placed directly on a gravelly regraded surface. The approved reclamation plan did not require segregation of soil horizons during mining operations. After topsoil is placed on a gravelly surface, there is potential over time for infiltrating run-off to cause the fine-grained topsoil to migrate downward into the underlying coarse-grained gravel. Loss of topsoil from the surface in this way may hinder development of grass revegetation that is approved for the postmining pasture land use. To hinder the migration of fine-grained topsoil downward into underlying gravelly regraded material, the operator should not spread screened gravel material as a base for topsoil.

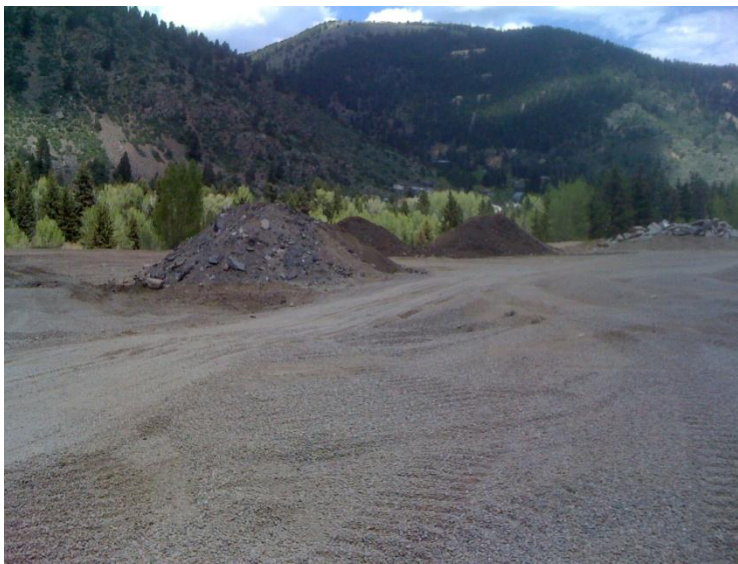
Photo 2 – East Side. Stockpiles of recycled asphalt (on left) and concrete (in distance on right).

All material stockpiles will need to be removed from the site. Debris scattered on the site, including pieces of scrap concrete, must also be removed from the site and not be left in regraded material. While regrading, special attention should be given to creating a stable hydraulic transition area between the gently sloping regraded area in the East Side, and the undisturbed more steeply sloping forested mountainside to the south.

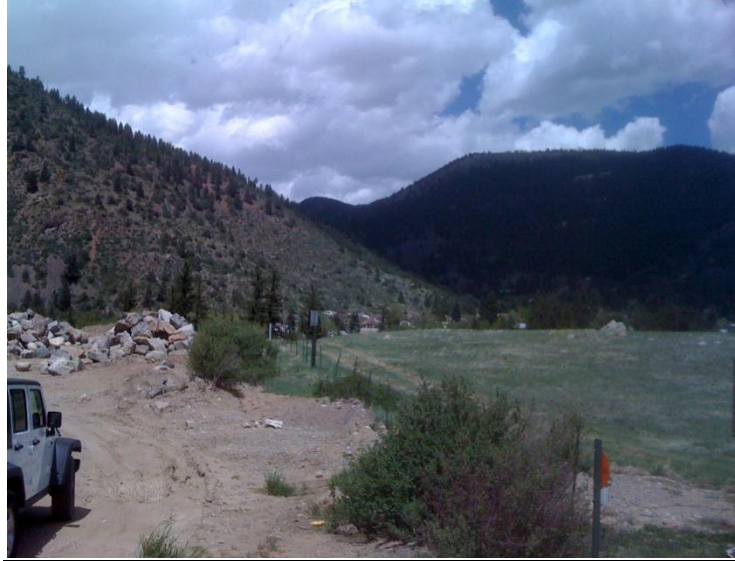
A mine i.d. sign was properly displayed at the mine entrance gate. The affected area boundary was evident from surrounding land uses (road, reservoir, and stream), and in places was marked by a fence or metal posts.

Photo 3 – Permit boundary on south end of East Side marked by fence. Grassed area is outside permit area.

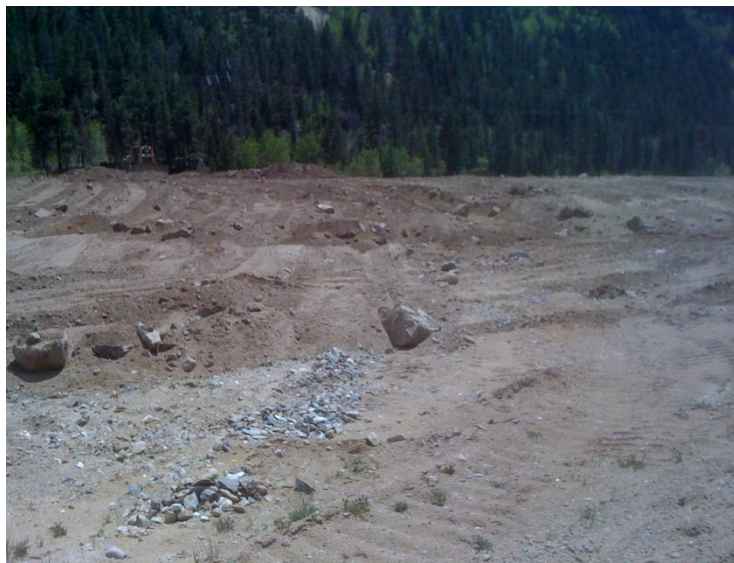
Photo 4 – East Side. Partially re-graded area.

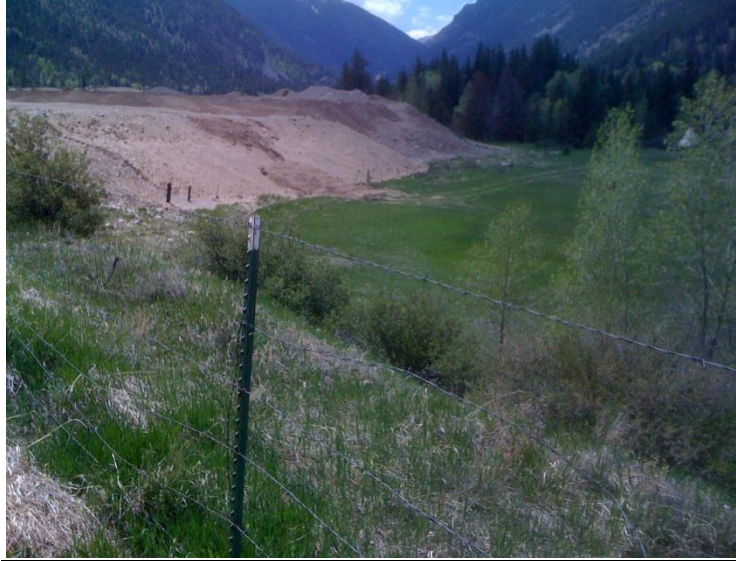
Photo 5 – East Side. Affected area/undisturbed land boundary in upper half of photo.

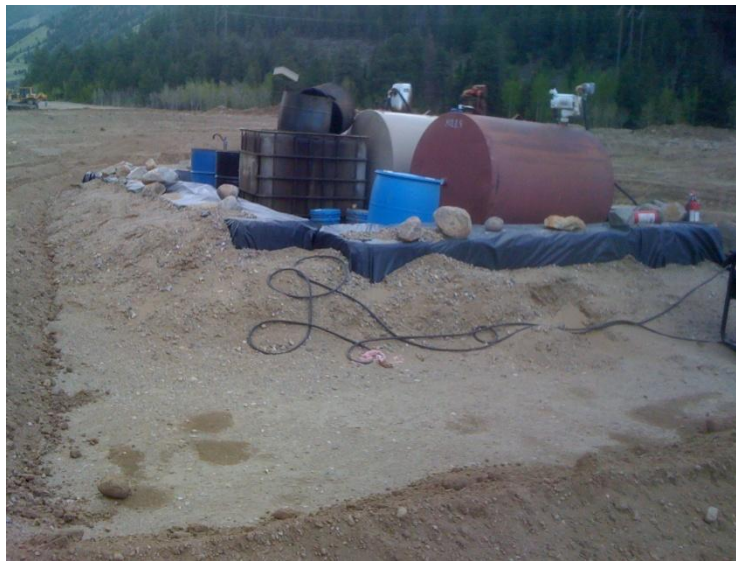
Fuel was properly stored within secondary containment structures.

Photo 6 – East Side. Fuel tanks, with secondary containment.

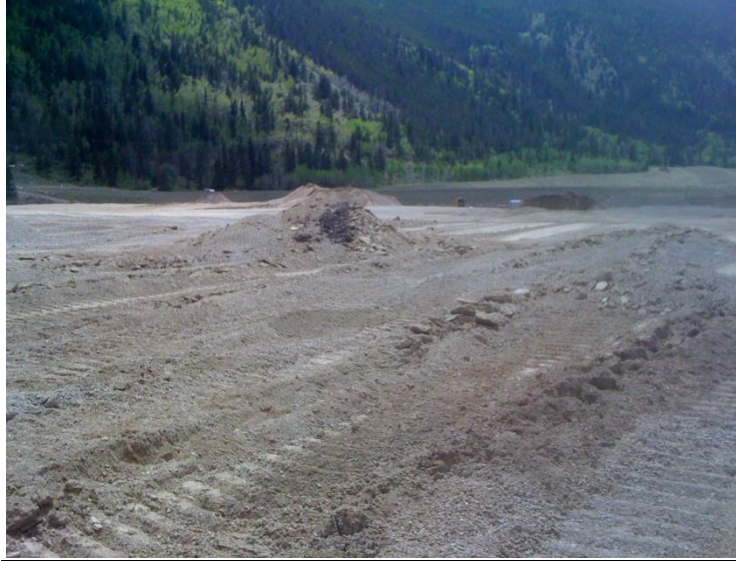
Photo 7 – East Side. Partially regraded gravelly material.

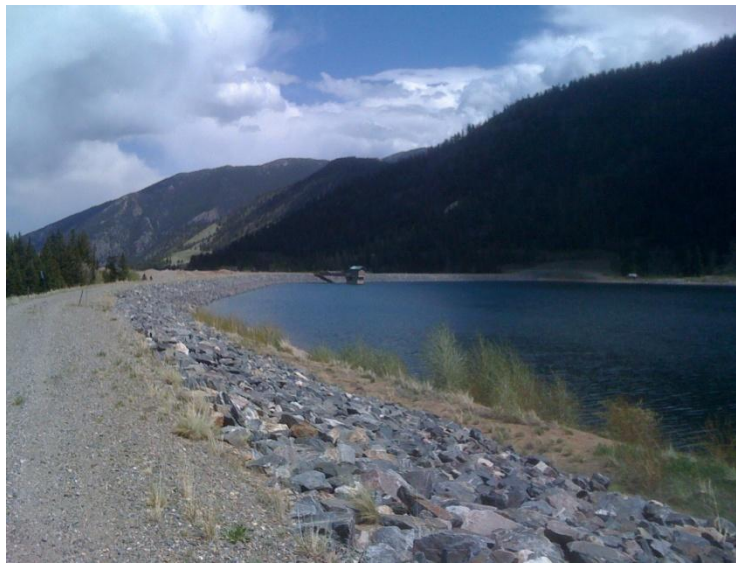
Photo 8 – West Side. Guanella Reservoir

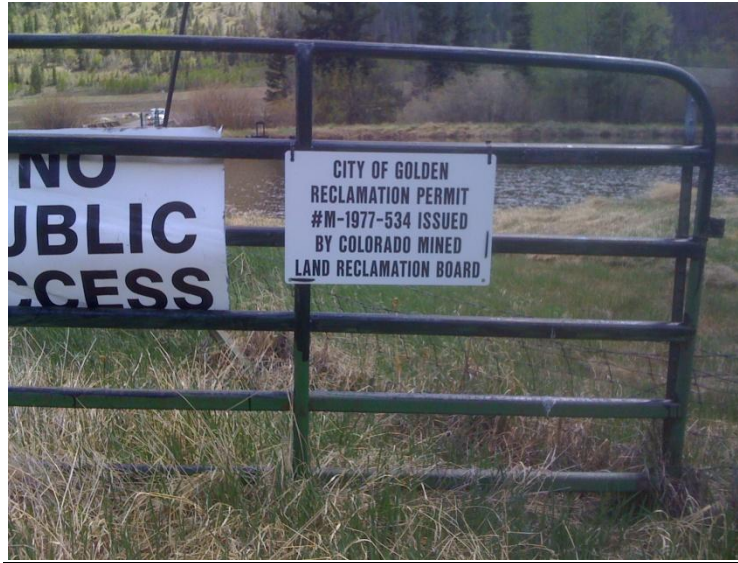
Photo 9 – Sign on entrance gate.
