COLORADO DIVISION OF RECLAMATION, MINING AND SAFETY
MINERALS PROGRAM INSPECTION REPORT
PHONE: (303) 866-3567

| MINE NAME: Leyden Pit | MINE/PROSPECTING ID#: M-1983-139 | MINERAL: Sand and gravel | COUNTY: Jefferson |
| INSPECTION TYPE: Monitoring | INSPECTOR(S): Tom Kaldenbach | INSP. DATE: July 2, 2013 | INSP. TIME: 09:40 |

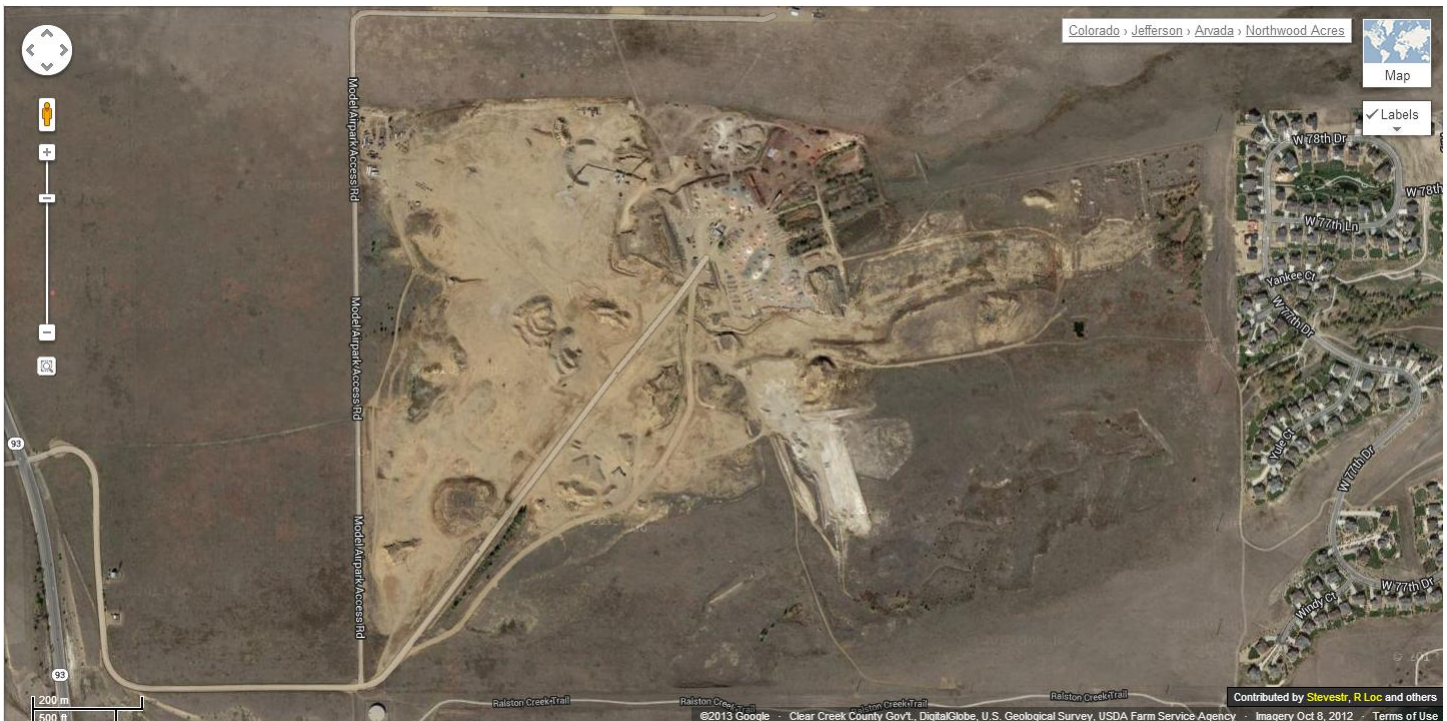
The site appeared during the inspection much as it does in the Google Earth image from October 8, 2012, shown below. There are several material stockpiles on the site, mainly in the central and western portion of the permit area. Product stockpiles for sales are located near the office near the center of the site. City of Arvada plans to use stockpiles on the east side of the site for filling in low areas there for mosquito control. Other stockpiles will be graded out and then the site will be revegetated. During the inspection, the need for a Technical Revision was discussed that will be submitted after the permit is transferred to City of Arvada. The Technical Revision will inventory stockpiles that need regrading.

Regrading was in progress on the embankment of a sediment control pond.

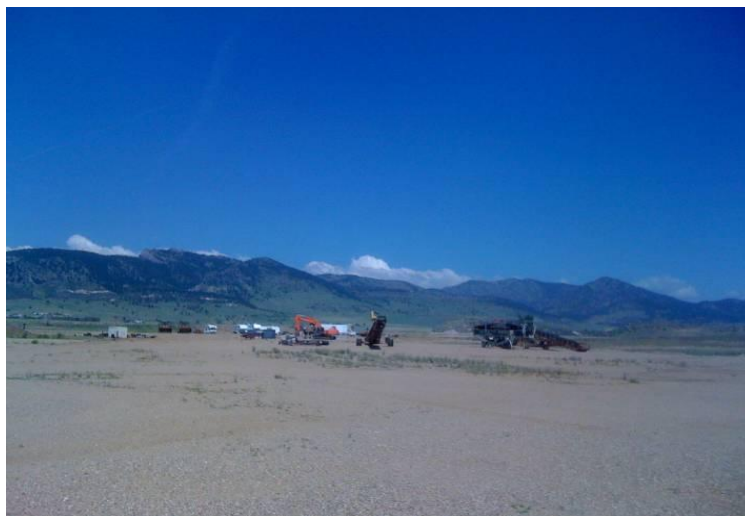
Photo 1 – Equipment on west side of site.

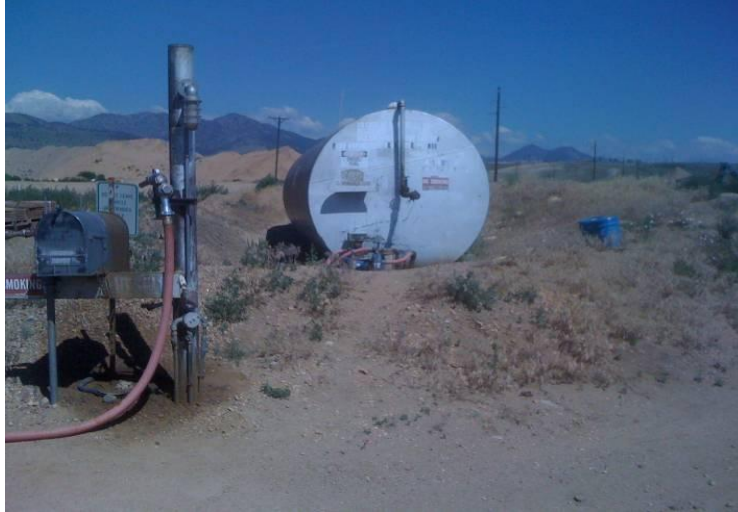
Fuel was stored in secondary containment structures.

Photo 2 – Fuel storage tank inside secondary containment berm.

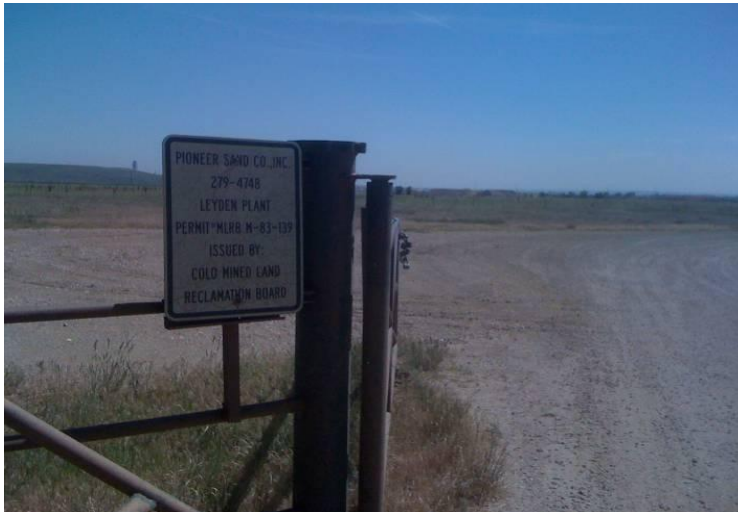
A mine i.d. sign was properly displayed at the mine entrance gate. The affected area was marked by fences.

Photo 3 - Sign at site entrance gate.
