COLORADO DIVISION OF RECLAMATION, MINING AND SAFETY COAL PROGRAM INSPECTION REPORT

Permit Number: C-1996-083 Mine Name: Bowie No. 2 Mine Operator: Bowie Resources, LLC Operator Address: Mr William A Bear P.O. Box 483 Paonia, CO 81428	County: Delta Operation Type: Underground Permit Status: Active Ownership: Federal and Forest
Operator Representative Present: Bill Bear and Gary Harding	
Operator Representative Signature: (Field Issuance Only)

Inspection Start Date: October 2, 2013 Inspection Start Time: 08:00 Inspection End Date: October 3, 2013 Inspection End Time: 09:30	Inspection Type: Coal Complete Inspection Inspection Reason: Normal I&E Program Weather: Clear
Joint Inspection Agency: None	Joint Inspection Contacts:
Post Inspection Agency: None	Post Inspection Contacts:
Inspector(s): Susan L. Burgmaier	Inspector's Signature: <i>Susan Burgmaier</i> Signature Date: 10/07/2013

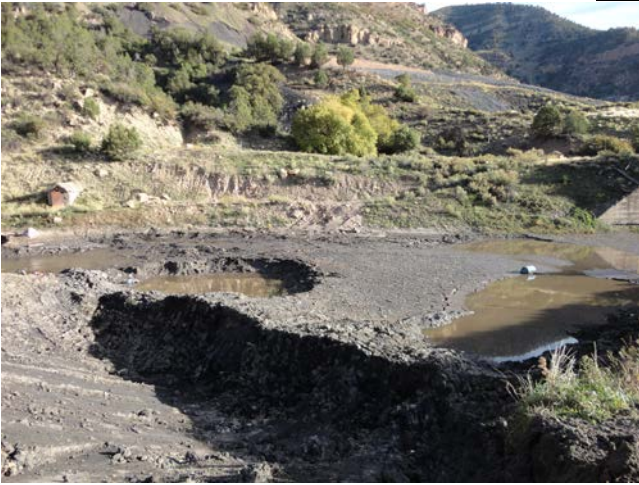
Pond C

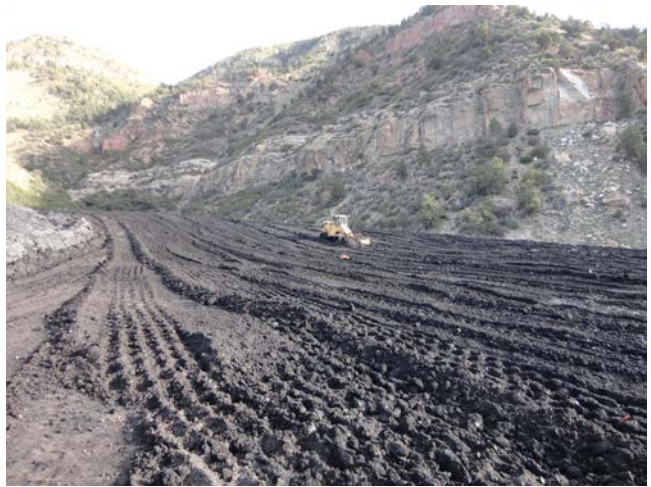
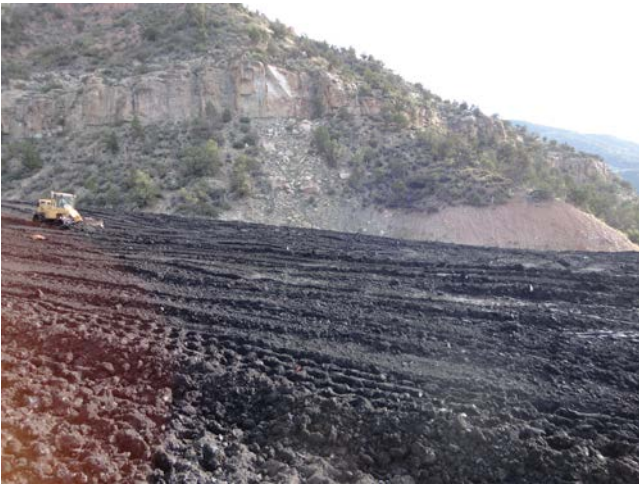
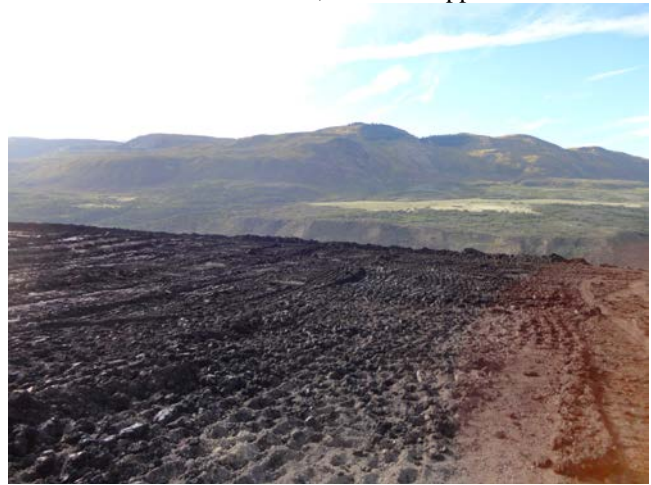
Gob Pile #2: The operator had completed grading and compaction of the end-dumped gob material cited in NOV CV-2013-004. Grading and compacting operations on Gob Pile #2 were current at the time of the inspection; accordingly, NOV CV-2013-004 is abated and terminated as a result of this inspection.

Gob Pile #2, East side upper bench

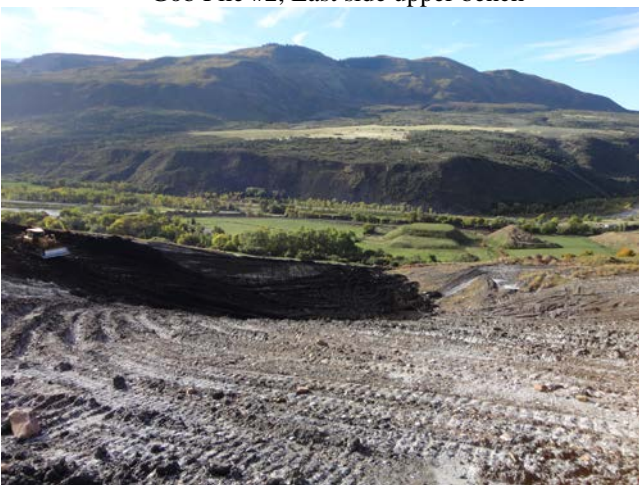
Newly generated gob material had been placed on the upper expansion area, in the center of Gob Piles #2 and #4. Compaction efforts were underway on the lower portion of the expansion area.

Gob Pile #2, lower expansion area compaction

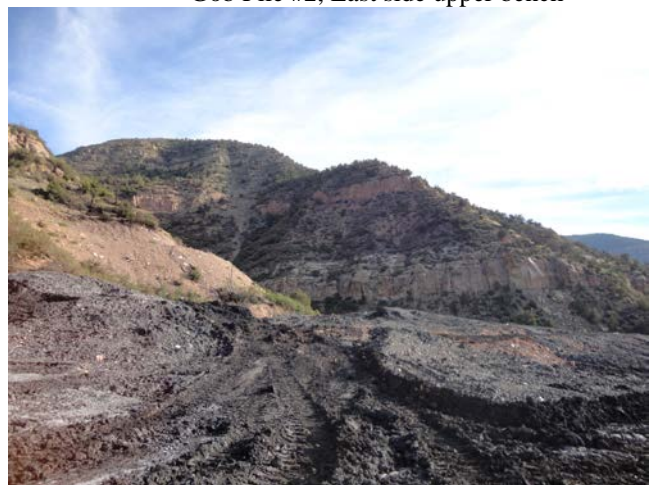
Gob Pile #2, end dumped gob on upper bench of expansion area

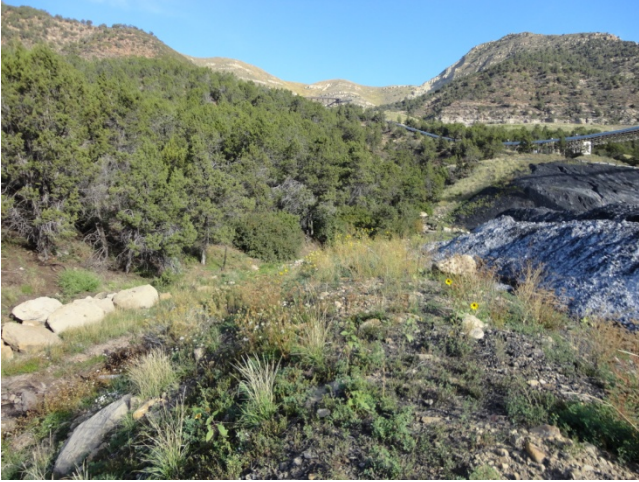
Berm on Coal Stockpile bench outslope

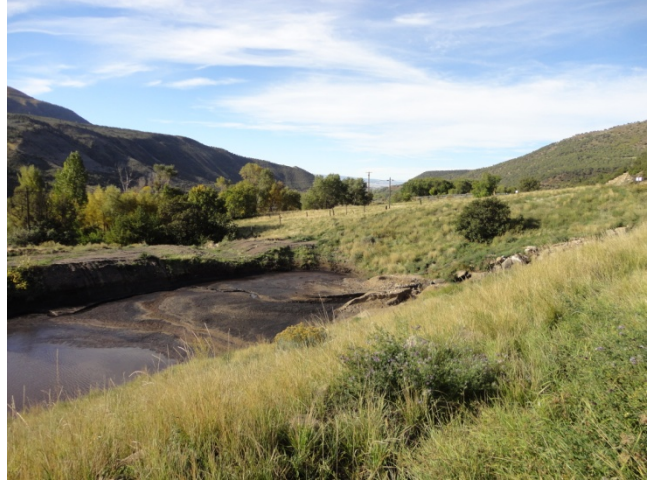
Pond B inlet on B Gulch

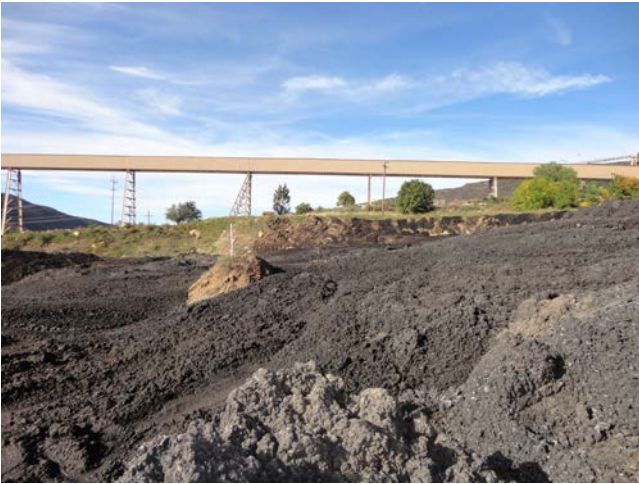
Gob Pile #3: Gob was being placed on the west end of the pile, west of the haul road into the disposal area. Cover material east of the road was being salvaged and placed in the approved stockpile area.

Dumped gob at Gob Pile #3

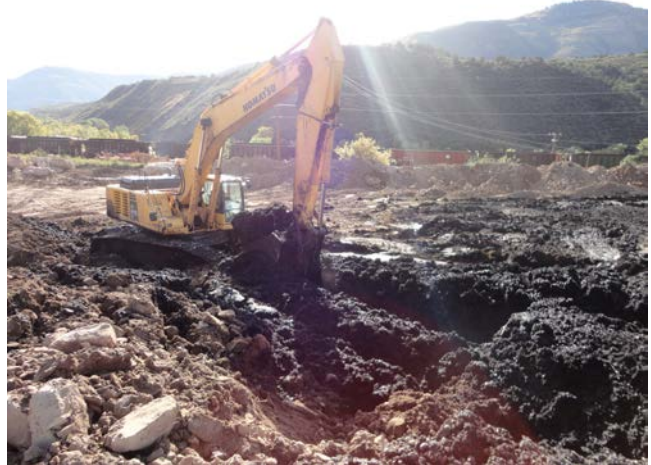
Excavator trenching gob for drainage at Gob Pile #3

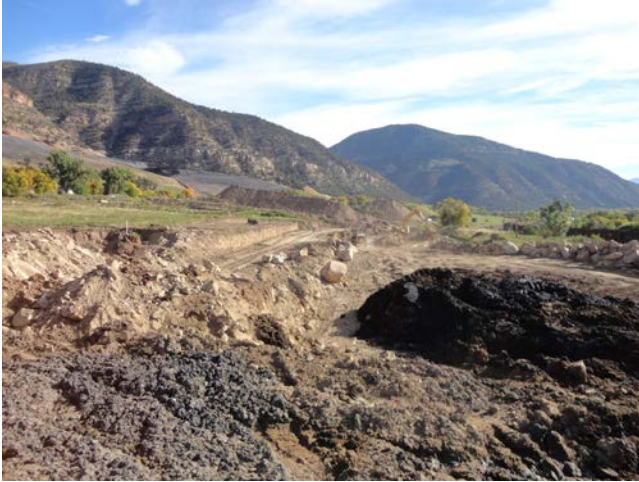
Subsoil excavation at Gob Pile #3

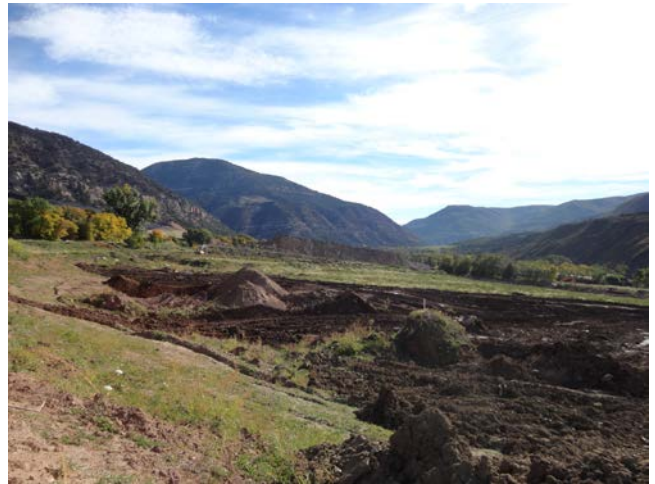
Topsoil and subsoil removal at Gob Pile #3

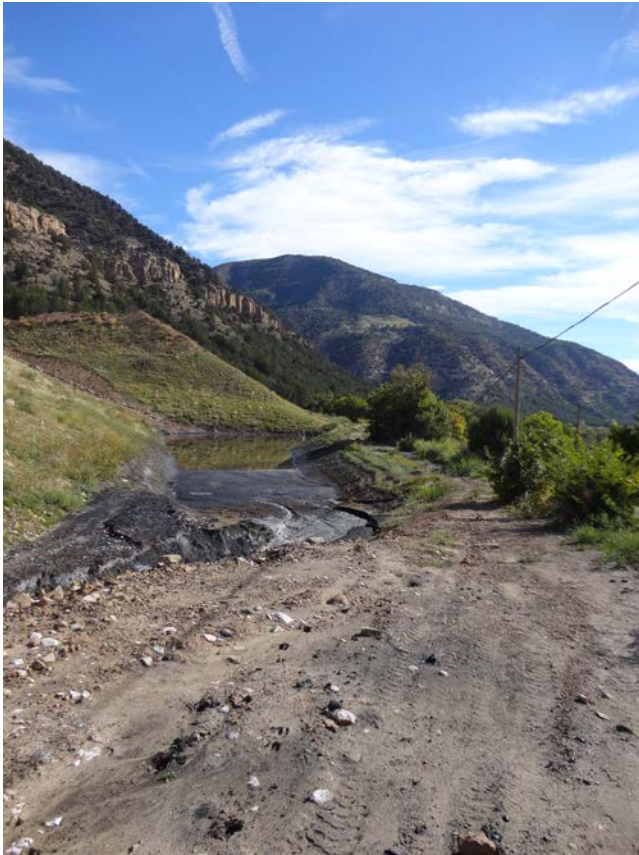
Pond F from inlet side

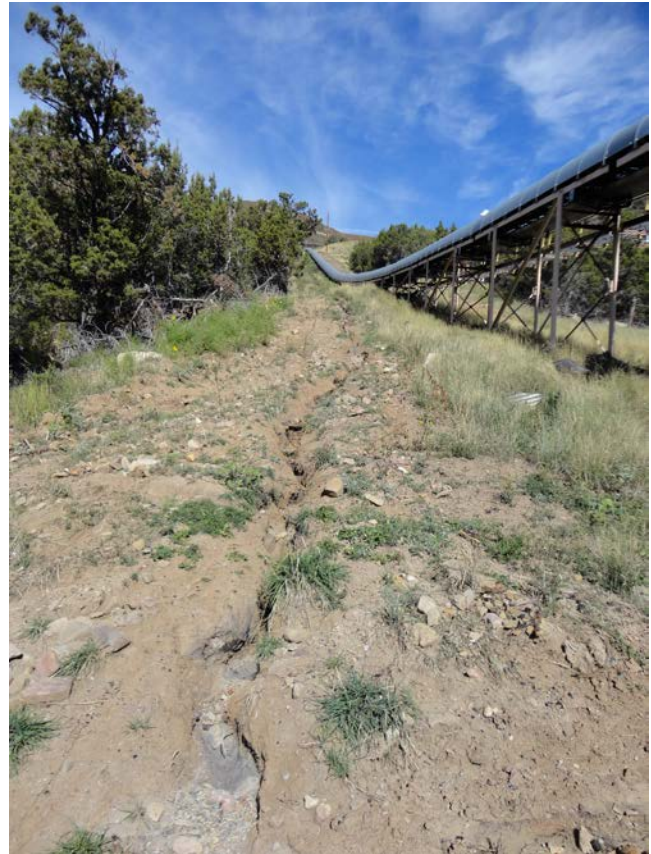
There was a large gully coming off of the water tank bench adjacent to the conveyor area, extending down to the haul road just above Curve 2. Map 20 indicates that there should be a berm on the south side of the pad to direct water to the B Gulch drainage west of the conveyor. Recent storms (in excess of the 10 yr - 24 hr event) had caused flows to breach the berm. The operator indicated that the berm would be restored and the gully repaired. He also indicated that a revision may be requested to install a half-culvert or armored channel to bring drainage directly to the road ditch rather than west to B Gulch.

Gully to down to water tank bench

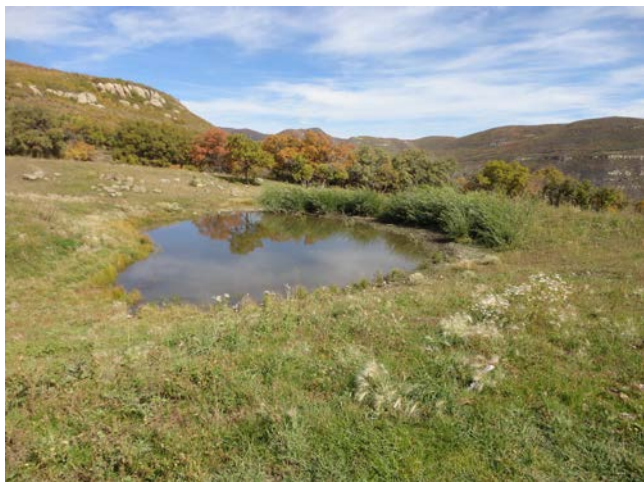
Spring and lower Pond 22

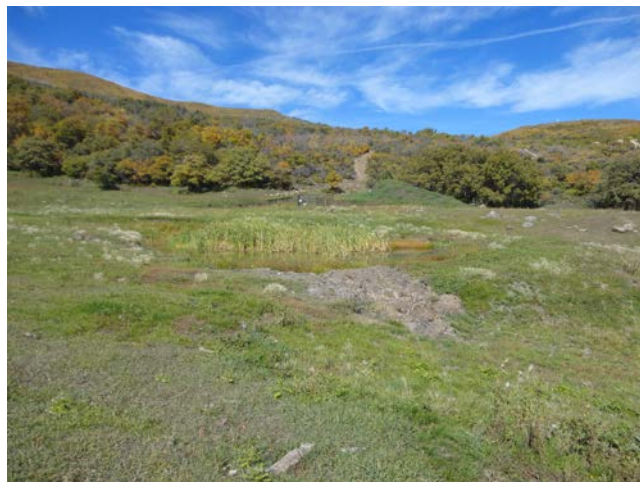
Spring and upper Pond 22

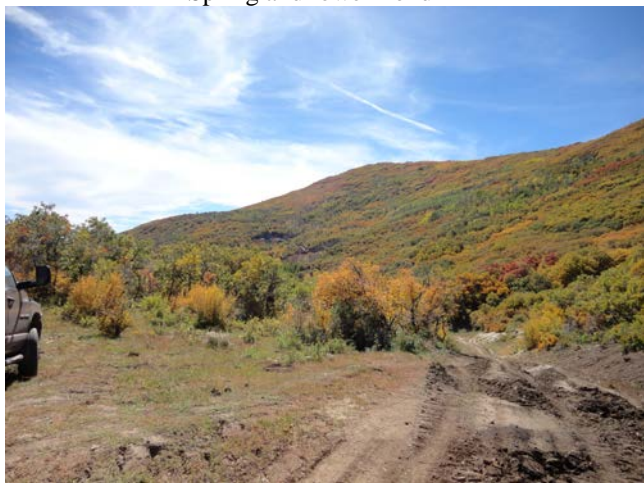
Gob vent boreholes along the B14 longwall panel were being developed. B14A was passively venting; B14B had been drilled and the mud pit regraded, but no pump had been attached; B14C had been drilled, and the mud pit needed to be pumped out and backfilled; B14D had been drilled, this mud pit was also still open; B14E was being graded and the mud pit excavated; a bulldozer was working on opening the road to B14F.

Drill pads GVB-B14C and -B14D

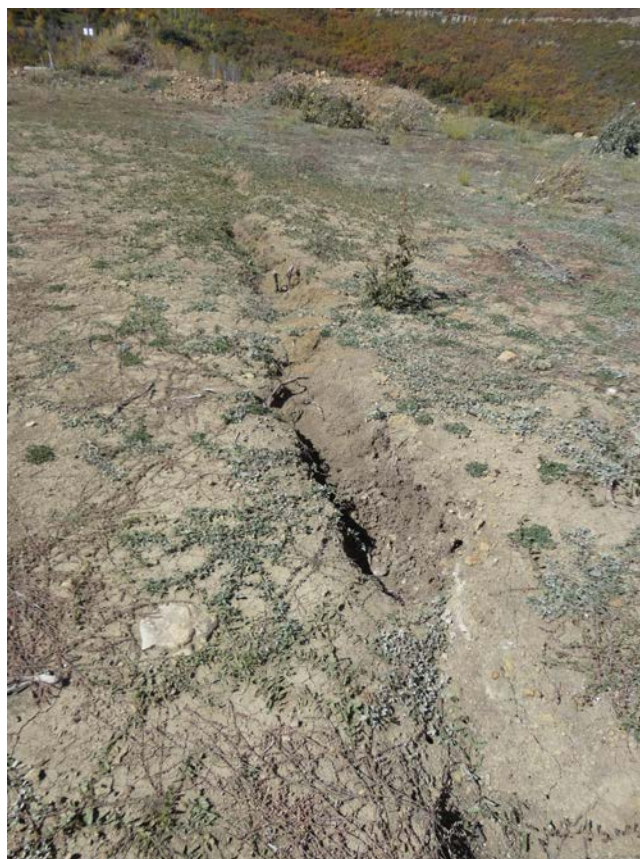
Subsidence cracks were observed at gob vent boreholes GVB-B12D and GVB-B14A. The cracks at GVB-B14A were very minor, with no displacement, and about 5' long; the crack at GVB-B12D was approximately 8" wide, with no displacement, and about 20' long. Ponds and Spring 22 were holding water. There were no subsidence cracks visible in the vicinity of the ponds.

Subsidence crack at GVB-B12D
