### COLORADO DIVISION OF RECLAMATION, MINING AND SAFETY COAL PROGRAM INSPECTION REPORT

Permit Number: C-1981-033 Mine Name: Bear Mine Operator: Bear Coal Company, Inc. Operator Address: Mr Daniel Bear 1326 War Emblem Lane Rock Springs, WY 82901 County: Gunnison Operation Type: Underground Permit Status: Revoked Ownership: Federal

Inspection Start Date: October 2, Inspection Start Time: 15:44 Inspection End Date: October 2, 2 Inspection End Time: 16:30			<b>Inspection Type:</b> Coal Complete Inspection <b>Inspection Reason:</b> Normal I&E Program <b>Weather:</b> Clear
Joint Inspection Agency:		Joint Inspection Contacts:	
None			
Post Inspection Agency:		Post	Inspection Contacts:
None			
Inspector(s):	Inspector	r's Sig	nature: Signature Date:
Susan L. Burgmaier	Susan	Bring	10/08/2013

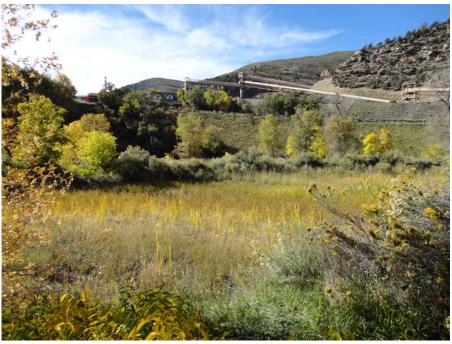
Sediment Pond

The sedimentation pond was dry. The treatment pond held water, and the portal spring was flowing to the North Fork of the Gunnison River via the treatment pond.

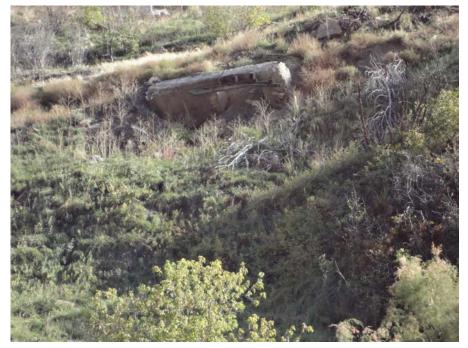
The backfilled and regraded portal slopes appeared to be stable, but there is a concrete support structure that had been buried during reclamation that is protruding from the backfilled slope. It appears that the material around the structure is settling; the structure is protruding more at each monthly inspection.

Concrete abutment in portal backfill area

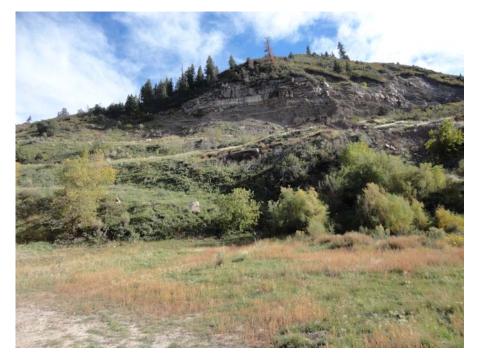
Backfilled and regraded portal faceup and slide area
