**COLORADO DIVISION OF RECLAMATION, MINING AND SAFETY**  
**MINERALS PROGRAM INSPECTION REPORT**  
**PHONE: (303) 866-3567**

<b>MINE NAME:</b> Amzak Pit	<b>MINE/PROSPECTING ID#:</b> M-2003-003	<b>MINERAL:</b> Gravel and sand	<b>COUNTY:</b> La Plata
<b>INSPECTION TYPE:</b> Monitoring	<b>INSPECTOR(S):</b> Kate A. Pickford	<b>INSP. DATE:</b> September 19, 2013	<b>INSP. TIME:</b> 12:00
<b>OPERATOR:</b> Consolidated Constructors, Inc.	<b>OPERATOR REPRESENTATIVE:</b>	<b>TYPE OF OPERATION:</b> 112c - Construction Regular Operation	
<b>REASON FOR INSPECTION:</b> Normal I&E Program	<b>BOND CALCULATION TYPE:</b> Complete Bond	<b>BOND AMOUNT:</b> \$118,787.00	
<b>DATE OF COMPLAINT:</b> NA	<b>POST INSP. CONTACTS:</b> None	<b>JOINT INSP. AGENCY:</b> None	
<b>WEATHER:</b> Clear	<b>INSPECTOR'S SIGNATURE:</b>

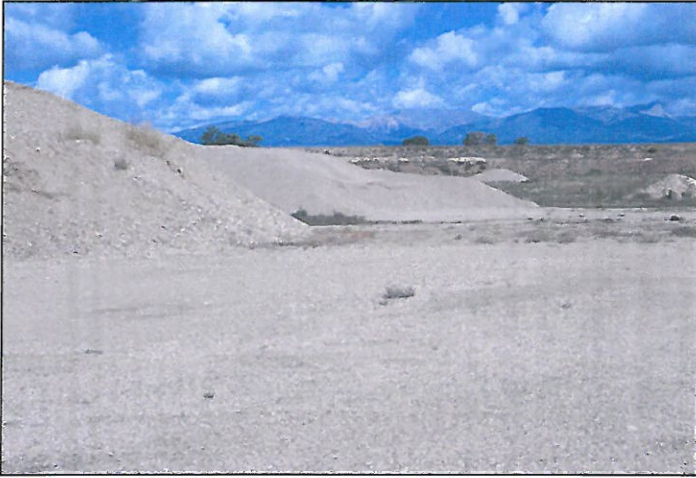
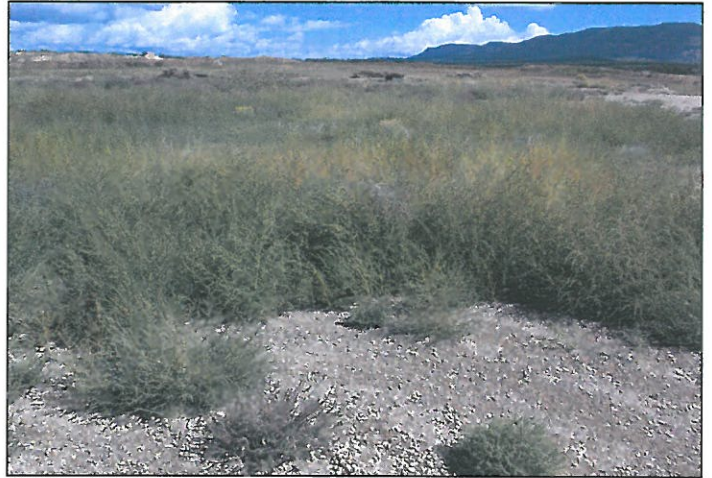
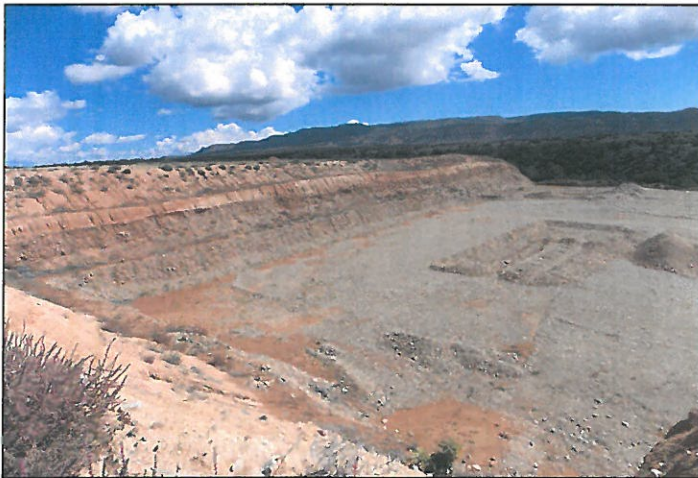
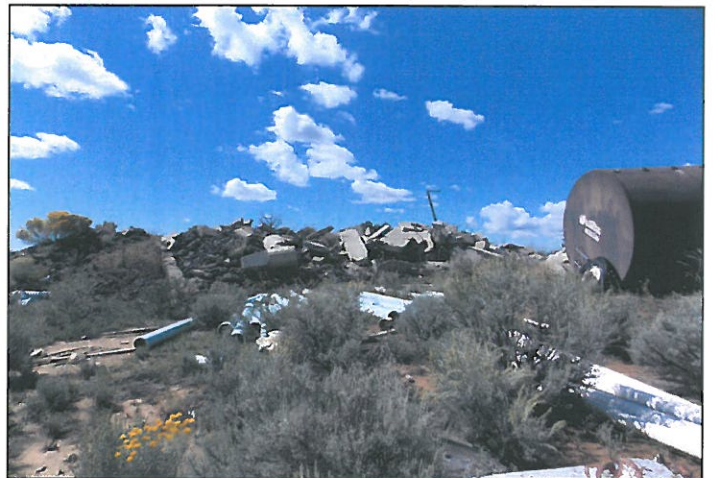
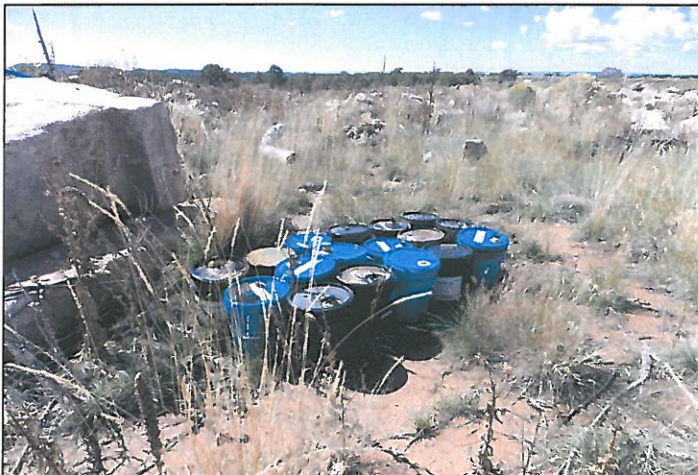
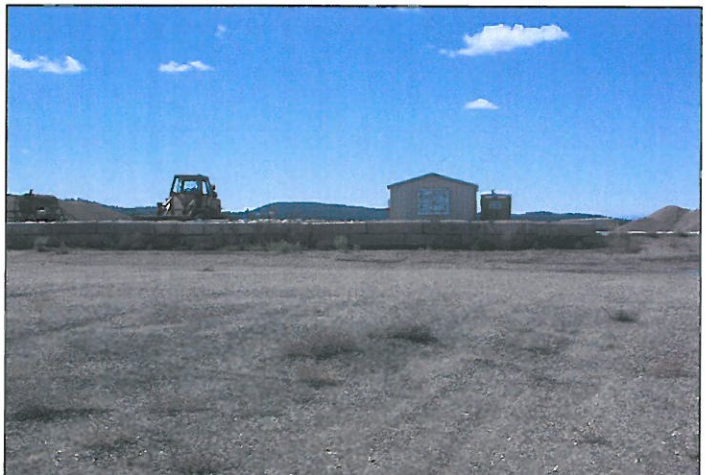
**PHOTOGRAPHS**

**PROBLEM/POSSIBLE VIOLATION:** Problem: Improper storage and containment of fuels and/or other hazardous materials was present on site.

**PROBLEM/POSSIBLE VIOLATION:** Problem: There are state-listed noxious weeds present on site. This is a problem for failure to employ weed control methods for state listed noxious weed species within the permitted area, and to reduce the spread of weeds to nearby areas as required by Section 3.1.10 (6) of the rule.

The upper area contains a large amount of Knapweed. This is considered a noxious weed and must be controlled under a weed control plan. See the problem cited in the problem section of this report. There is topsoil stockpiled in the upper area, as well as various material stockpiles. It appears that there is adequate topsoil present for reclamation of the site.

On the south side of the upper area there are various piles of debris and junk. There is a large pile of concrete and three large tanks that smell of petroleum. The operator should be aware that if he intends to bury these materials onsite or use them as backfill, he must comply with Rule 3.1.5(9). Also, located on this portion of the site are seventeen 5-gallon buckets that appear to contain used oil. This is a problem related acid and toxic chemicals. See the problem cited in the problem section of this report.

**CORRECTIVE ACTIONS:** The 5-gallon buckets of petroleum product must be removed from the site or placed in a secondary containment structure. Please supply photo documentation that all containers have been removed from the site on or before the corrective action date.

**CORRECTIVE ACTIONS:** All storage tanks, petroleum and any hazardous materials on site for any period of time shall have appropriate secondary containment. The site will also have to comply with all applicable SPCC requirements. Please supply photo documentation that all containers containing hazardous materials have been removed from the site on or before the corrective action date.

**CORRECTIVE ACTIONS:** Implement approved weed control plan and provide proof to the Division that this has been done. Please supply proof that the Knapweed has been sprayed or removed by the resolution date listed.  
**CORRECTIVE ACTION DUE DATE:** 11/11/13
