**COLORADO DIVISION OF RECLAMATION, MINING AND SAFETY  
MINERALS PROGRAM INSPECTION REPORT  
PHONE: (303) 866-3567**

<b>MINE NAME:</b> Franklin and Freighters Friend Shafts	<b>MINE/PROSPECTING ID#:</b> P-2007-069	<b>MINERAL:</b> Gold, zinc, silver and	<b>COUNTY:</b> Clear Creek
<b>INSPECTION TYPE:</b> Mineral Prospect Inspection	<b>INSPECTOR(S):</b> T C. Wait	<b>INSP. DATE:</b> October 9, 2013	<b>INSP. TIME:</b> 10:00
<b>OPERATOR:</b> COAG Corporation	<b>OPERATOR REPRESENTATIVE:</b> Mickey Fouts/John Miner	<b>TYPE OF OPERATION:</b> MP - Mineral Prospecting

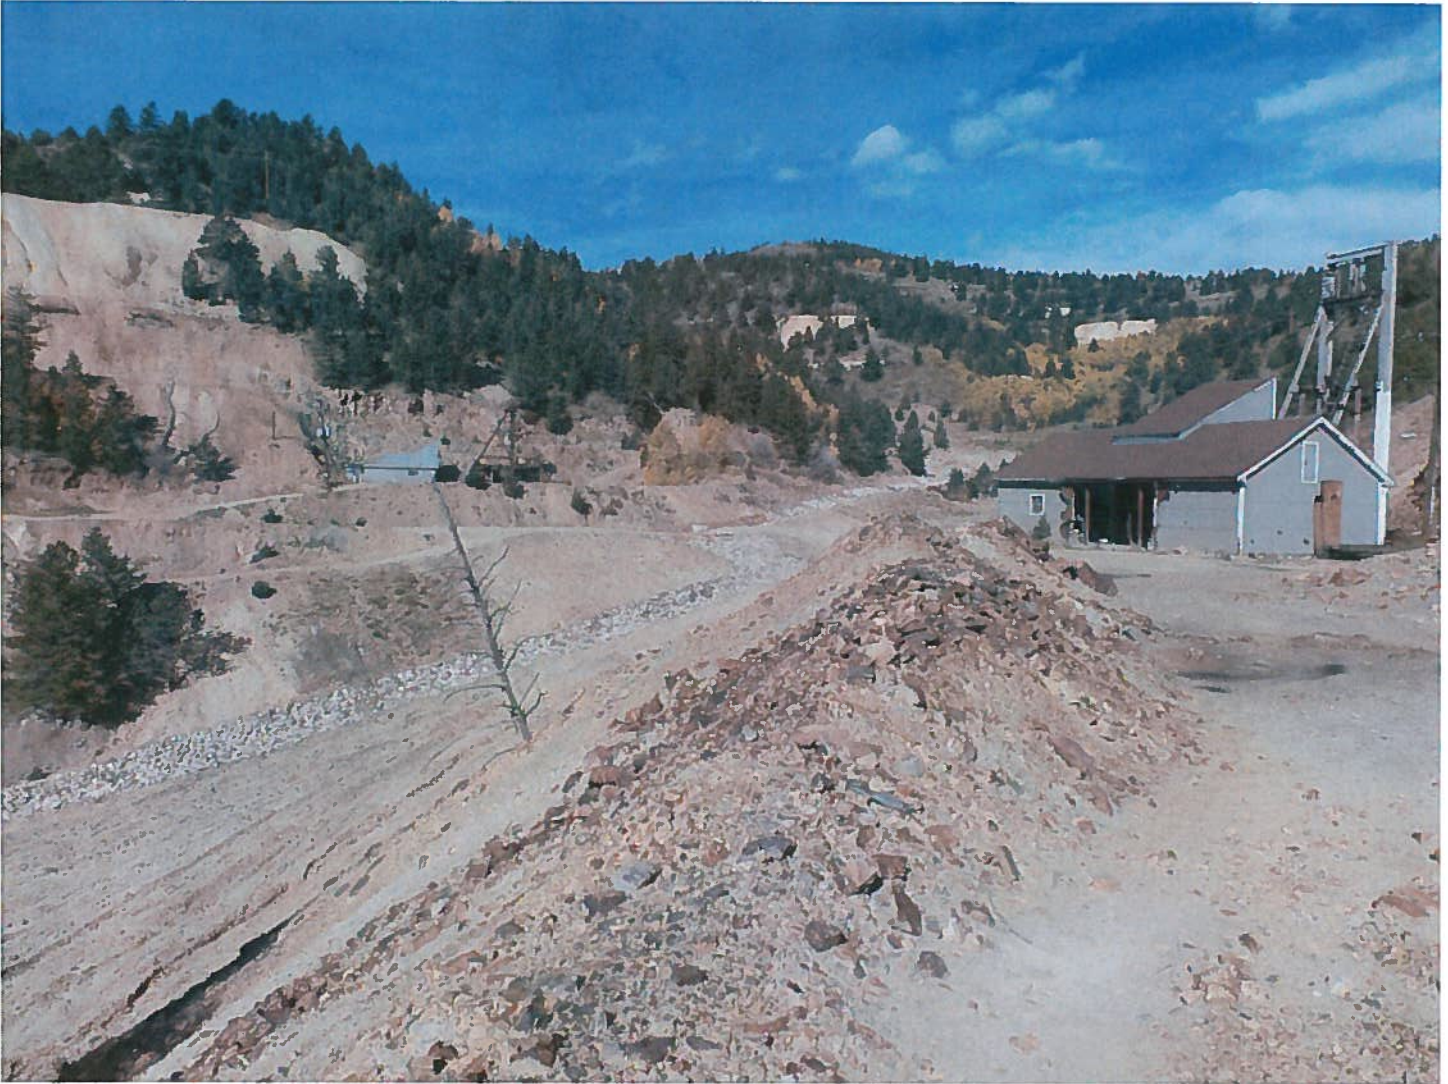
As stated above, portions of the site were reclaimed by DRMS in 2009 after the Franklin Mine permit was revoked (unrelated to this NOI permit). There is minimal vegetation regrowth from this reclamation effort. Additionally, there are areas that are severely eroded/washed out from the rain in September 2013. Some of the bank above the Freighters Friend shaft house appears to have rolled toward the southern wall of the structure, despite the stabilization fence on the slope above. Some areas of soil staining from equipment were noted, although it is not clear if this is related to the NOI activity or not.

Photo 1: Freightier's Friend shaft (left background) and Franklin shaft (right foreground) with 2009 reclamation work, looking up Gibson Gulch (view to NW).

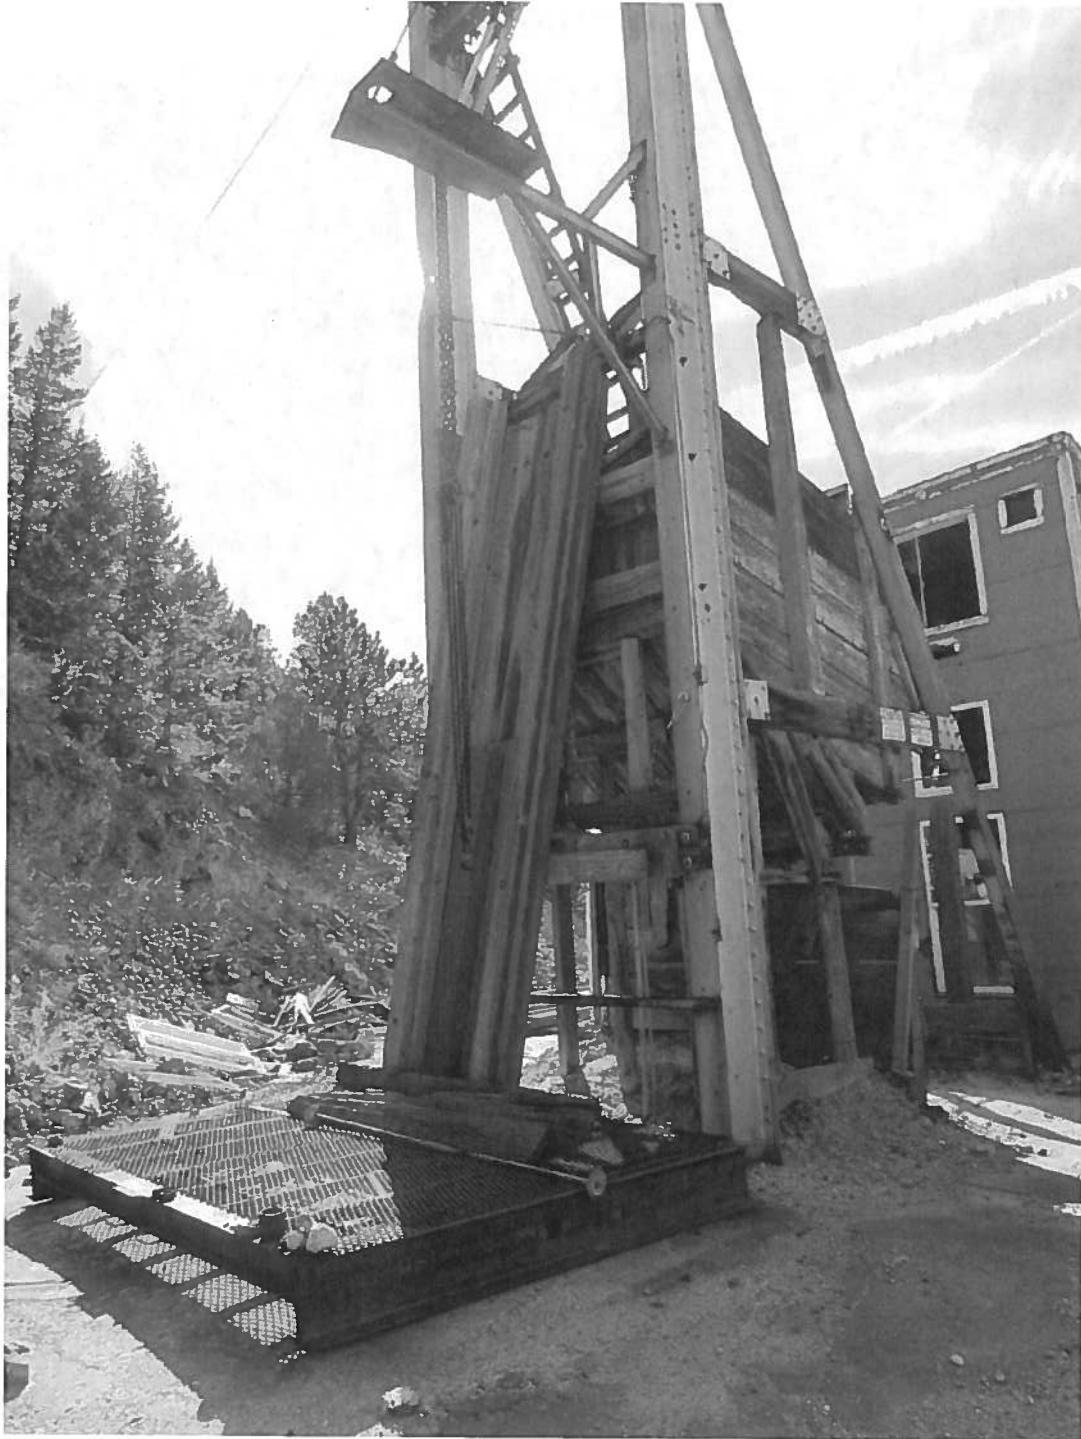
Photo 2: Franklin Shaft with metal cover. Debris/trash in background.

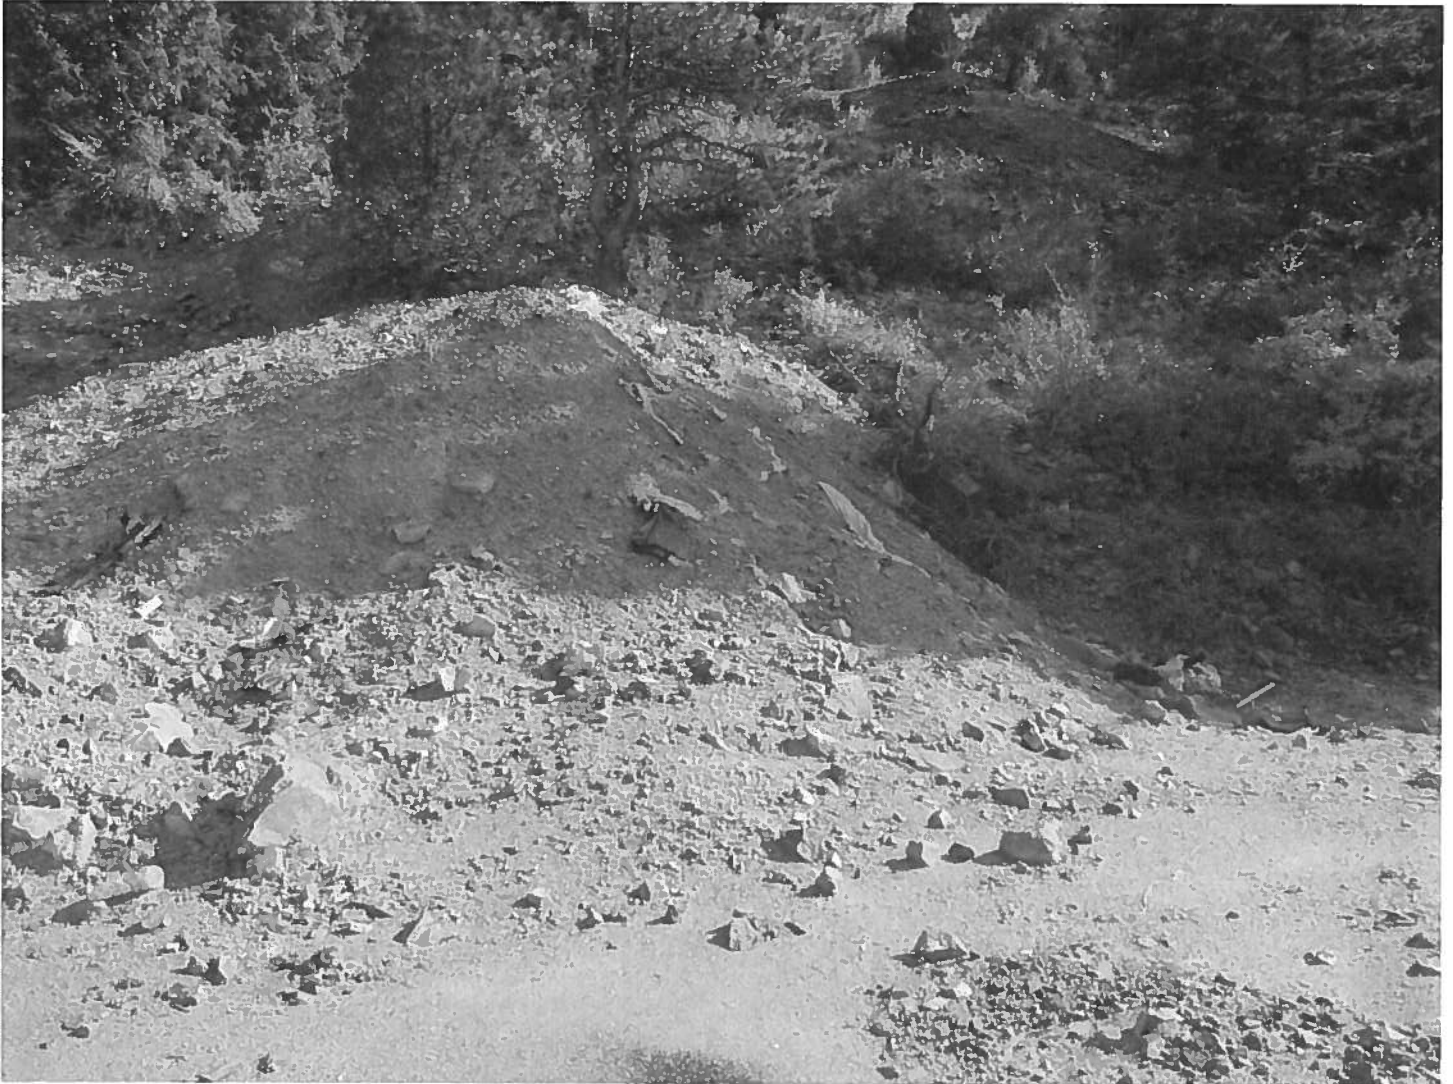
This NOI permit indicates that minimal surface disturbance was proposed related to the NOI. The shafts and tunnels, buildings, and roads disturbances pre-date the NOI. No new disturbance was noted during the inspection, with the exception of a small pile of debris east of the Franklin Shaft house.

Photo 3: Small pile of soil/debris east of Franklin Shaft house.

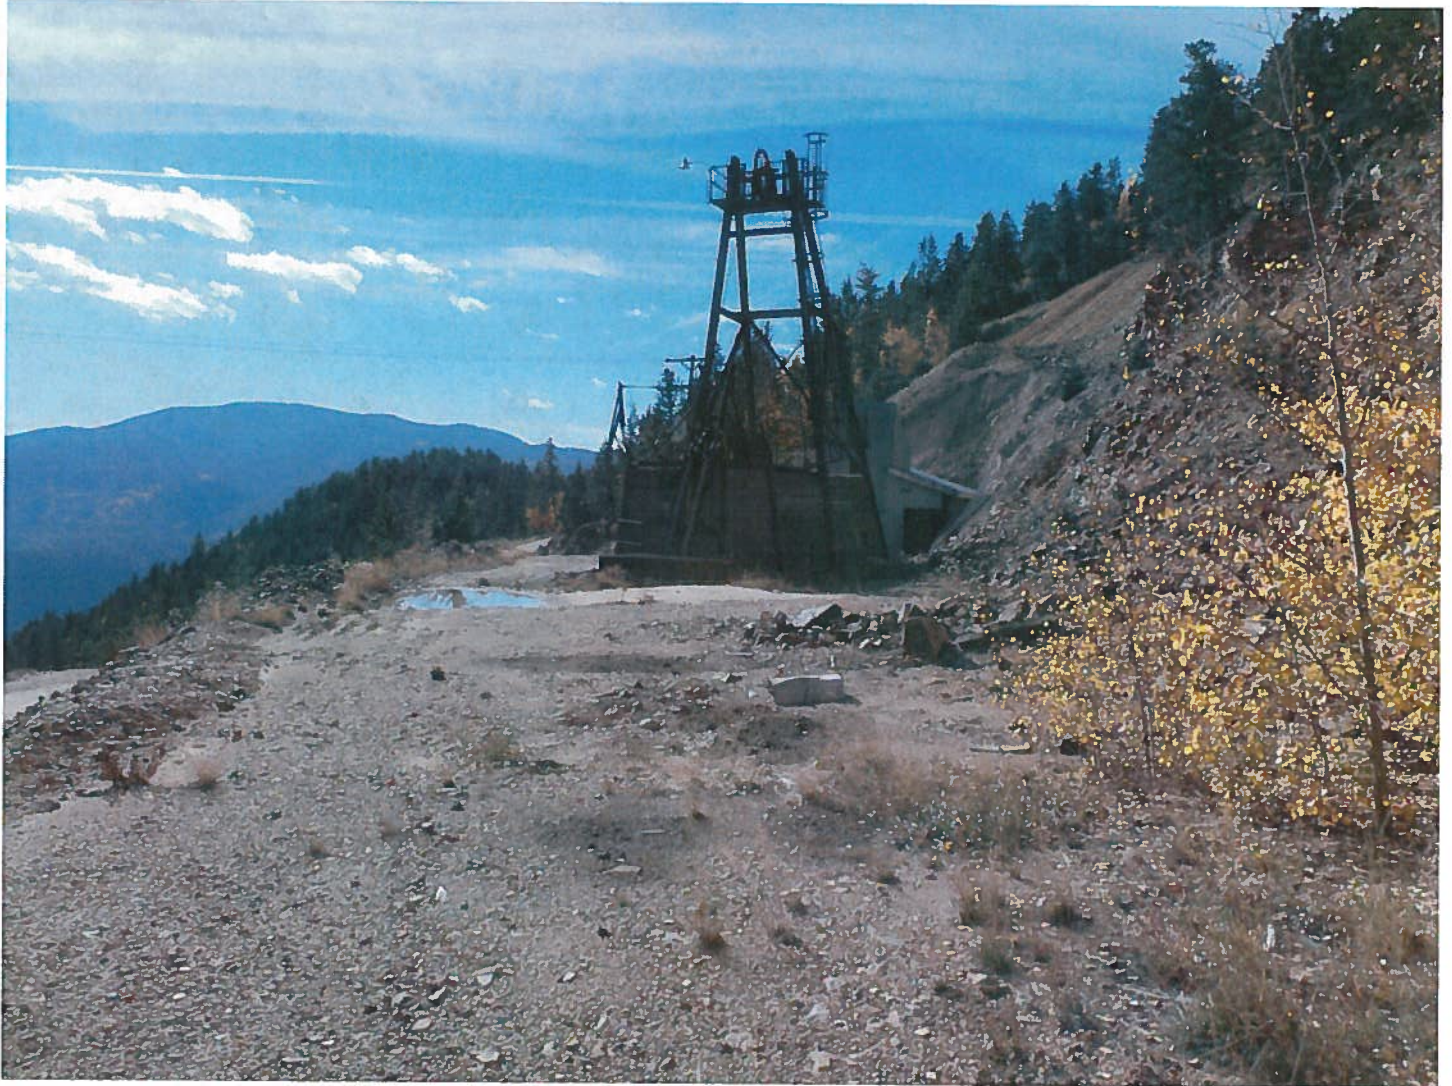
Photo 4: Freightier's Friend shaft and shaft house (background) with soil stains in foreground.

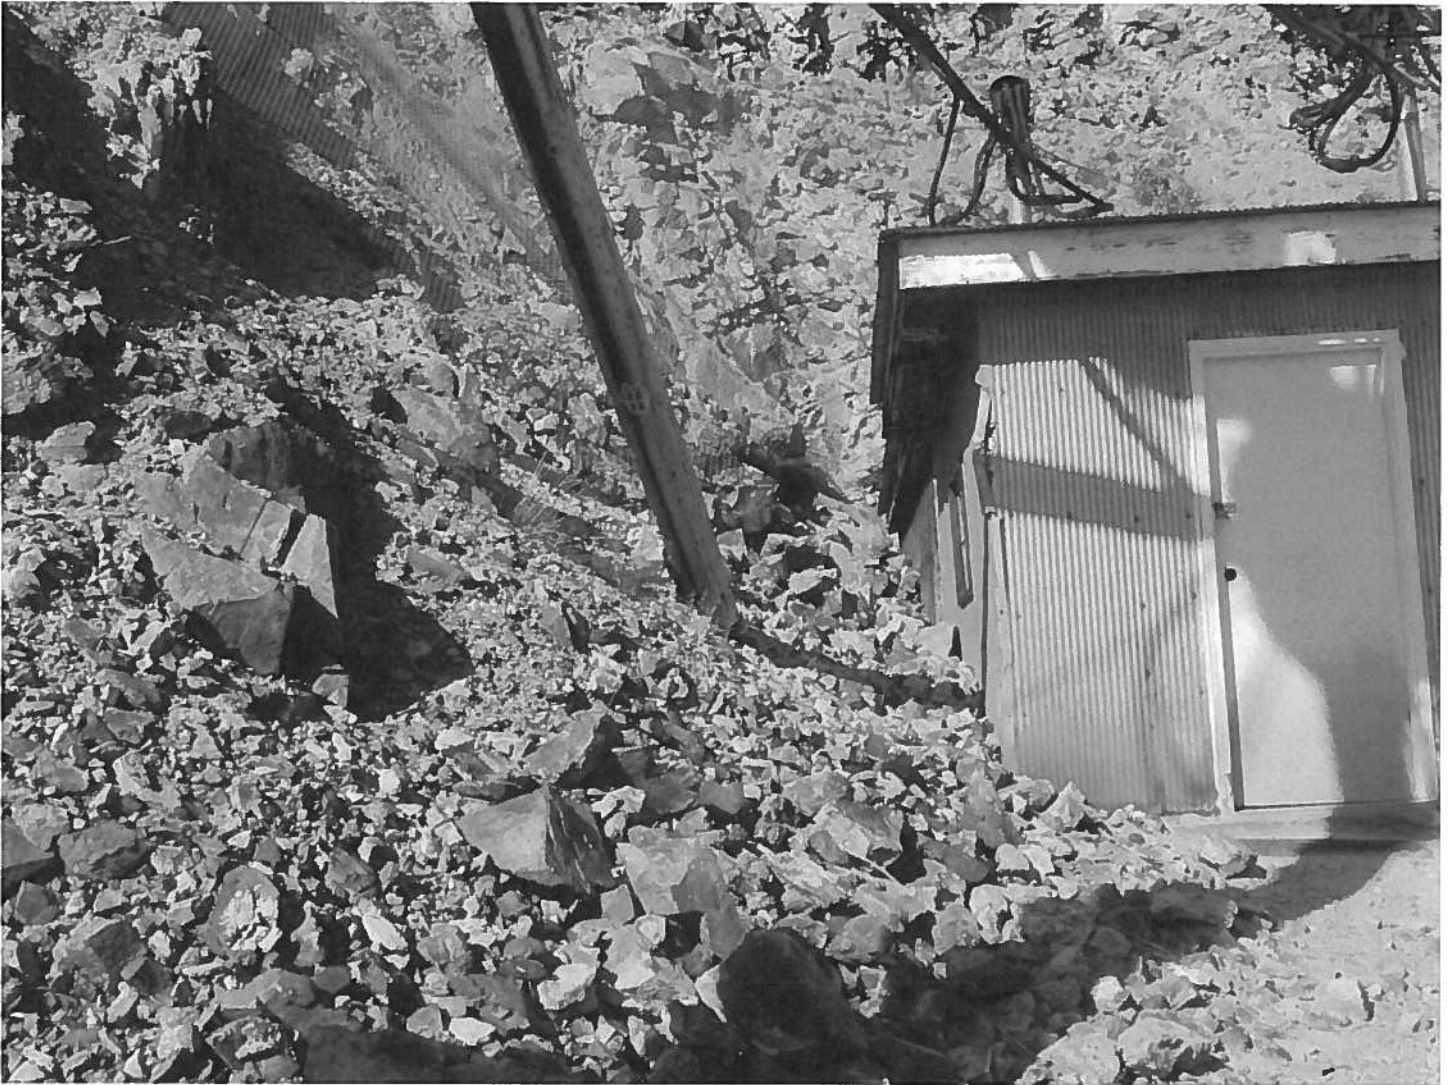
Photo 5: Slope sloughing/rolling into southern wall of Freighter's Friend shaft house. Note chainlink fencing as stabilization effort.

The site is generally in good condition, given the heavy mining history of the site. Continued slope sloughing may be a problem near the Freighters Friend shaft, and may need additional stabilization to prevent further slope ravel.

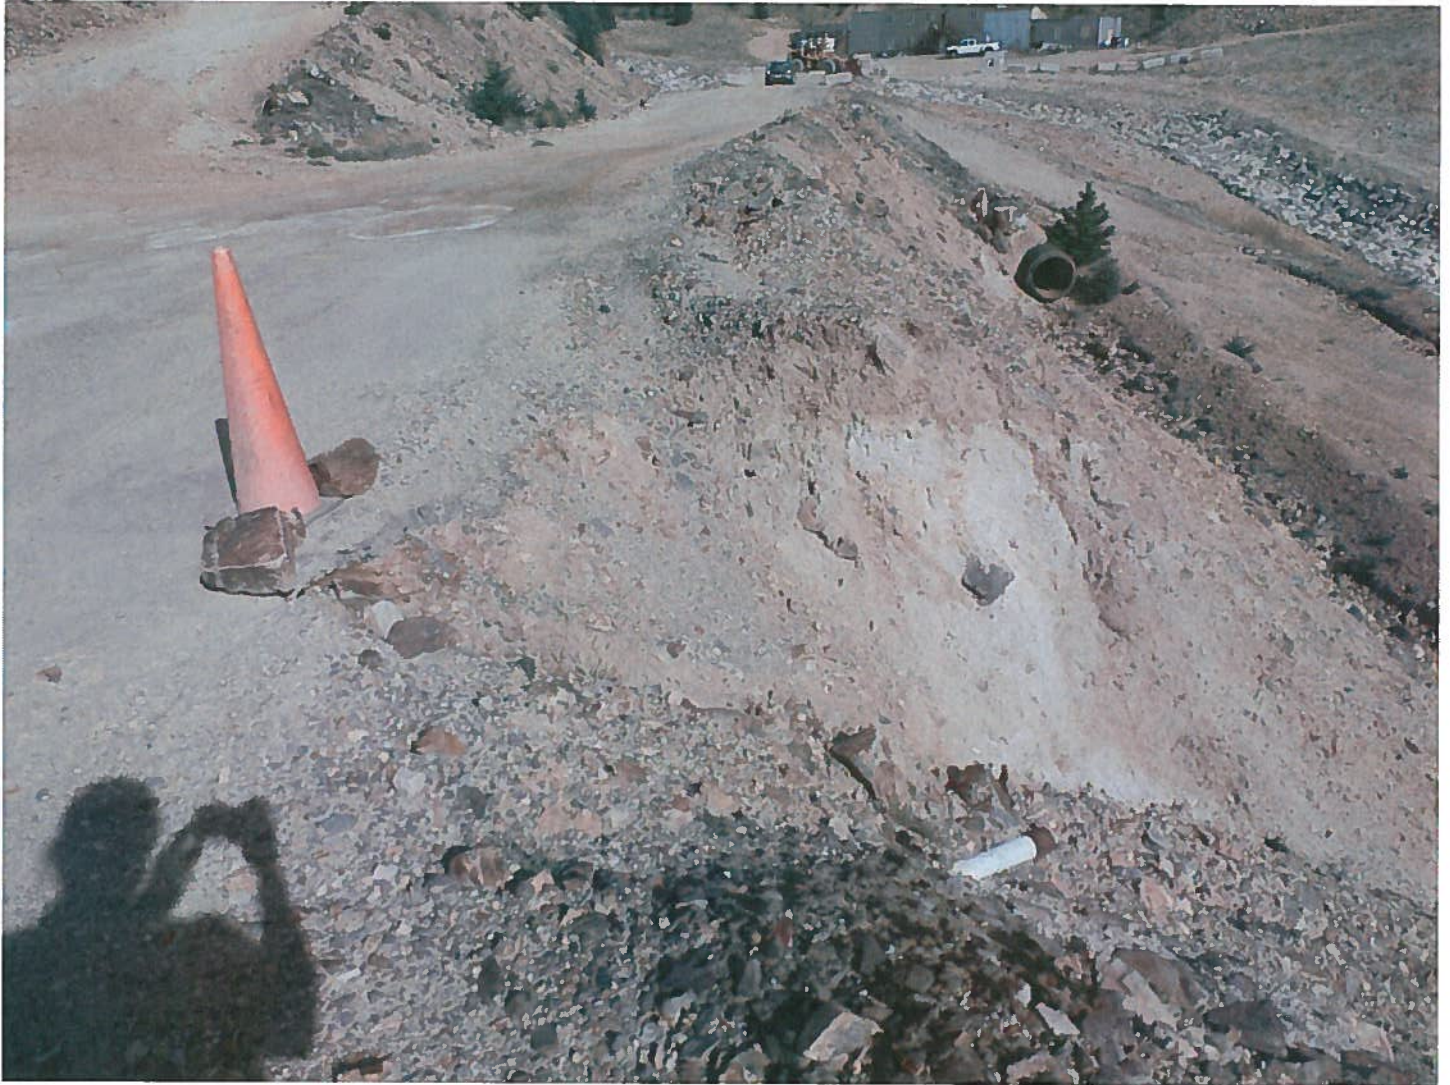
Photo 6: Erosion and exposed pipe along access road from September 2013 rains.
