COLORADO DIVISION OF RECLAMATION, MINING AND SAFETY COAL PROGRAM INSPECTION REPORT

Permit Number: C-1981-014 Mine Name: Southfield Mine Operator: Energy Fuels Coal, Inc. Operator Address: Mr. George Patterson P.O. Box 459 Florence, CO 81226	County: Fremont Operation Type: Underground Permit Status: Permanent Cessation Ownership: Private
	Operator Representative Present: None
Operator Representative Signature: (Field Issuance Only)

Inspection Start Date: October 9, 2013 Inspection Start Time: 09:30 Inspection End Date: Inspection End Time:	Inspection Type: Coal Partial Inspection Inspection Reason: Normal I&E Program Weather: Clear
Joint Inspection Agency: None	Joint Inspection Contacts:
Post Inspection Agency: None	Post Inspection Contacts:
Inspector(s): Robert D. Zuber, P.E.	Inspector's Signature: <i>Robert D. Zuber</i> Signature Date: 10/10/13

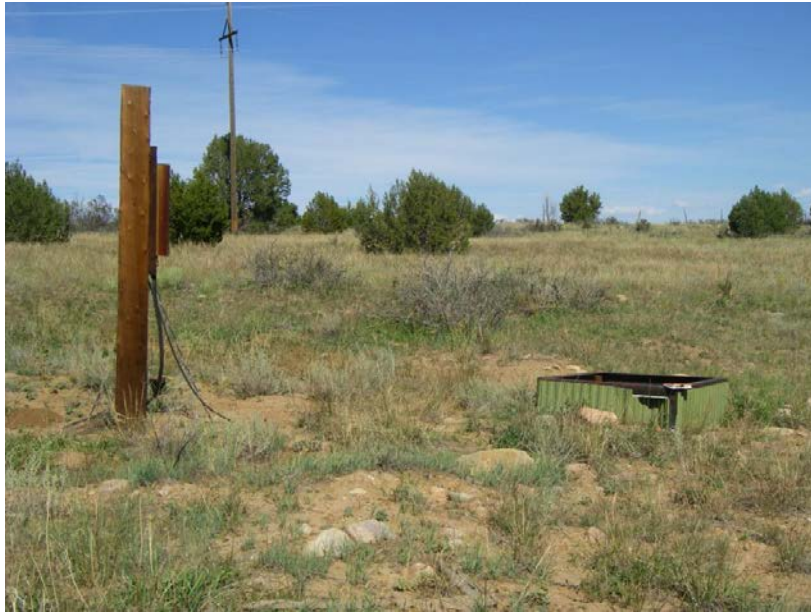
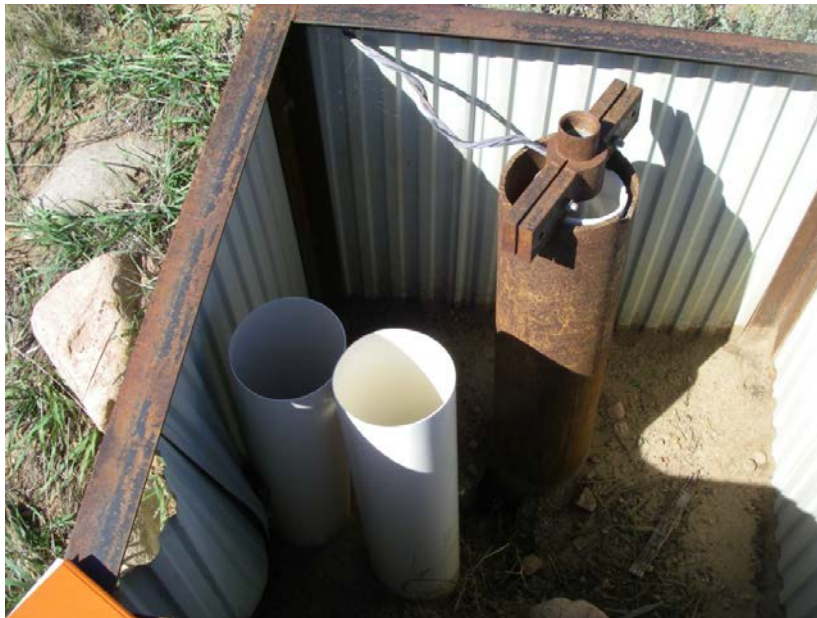
Another well near MW-NW was observed during the inspection, and is likely the other well recently observed by a representative of DWR (and discussed in a 10/7/2013 e-mail by landowner Linda Saunders). The well includes three PVC pipes, a 4' x 4' metal box at the surface, and an electrical breaker box on a pole. The location of this second well can be described as follows:

- Approximately 150 feet west of Newlin Creek
- Approximately 200 feet east of County Road 15
- More or less due south of a pump station (apparently owned by the Town of Florence).

Based on a review of Map 12 in the PAP, this second well is in the same location as the Zenith 2 well.

Well near MW-NW (possibly Zenith 2 Well)

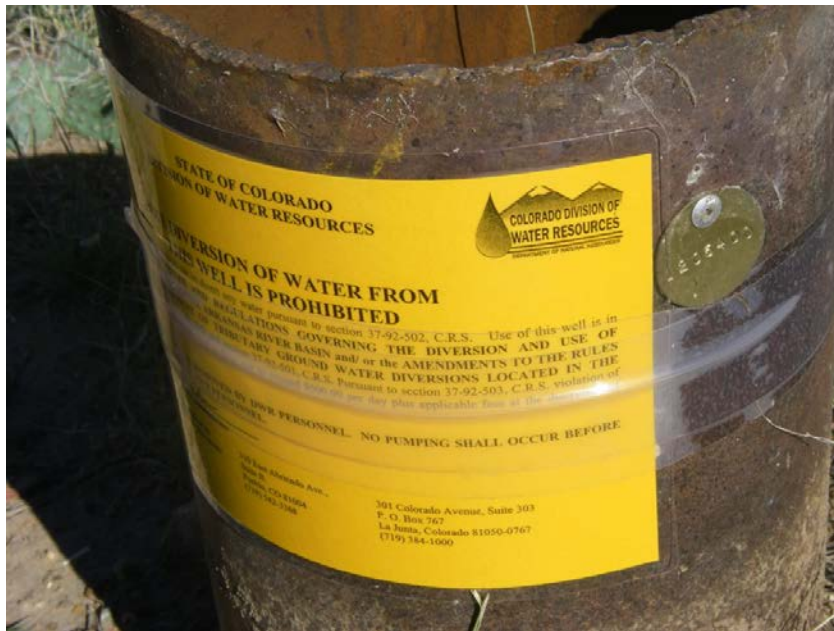
Well MW-NW was observed. After the steel cap was removed, a notice from the Colorado Division of Water Resources (DWR) and a metal tag were seen on the casing. The notice indicates that diversion of water from the well is prohibited. The tag number is 1205400.

Well MW-NW (notice and tag appear to be recently attached to casing)

Abatement Description: Remove the obstruction from MW-NW or establish a replacement water monitoring well that intercepts the Southfield Mine workings in the Red Arrow or Jack O' Lantern Coal seam.

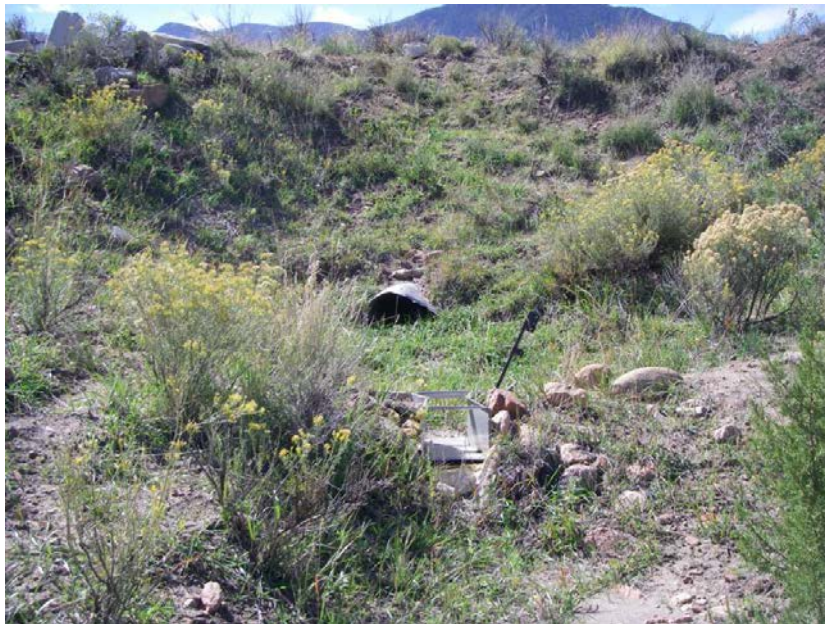
- The primary spillway of Pond 5 is half full of sediment at the downstream end and requires maintenance.
- The primary spillway of Pond 4 contains bullet holes that should be plugged.

Pond 5 primary spillway below dam

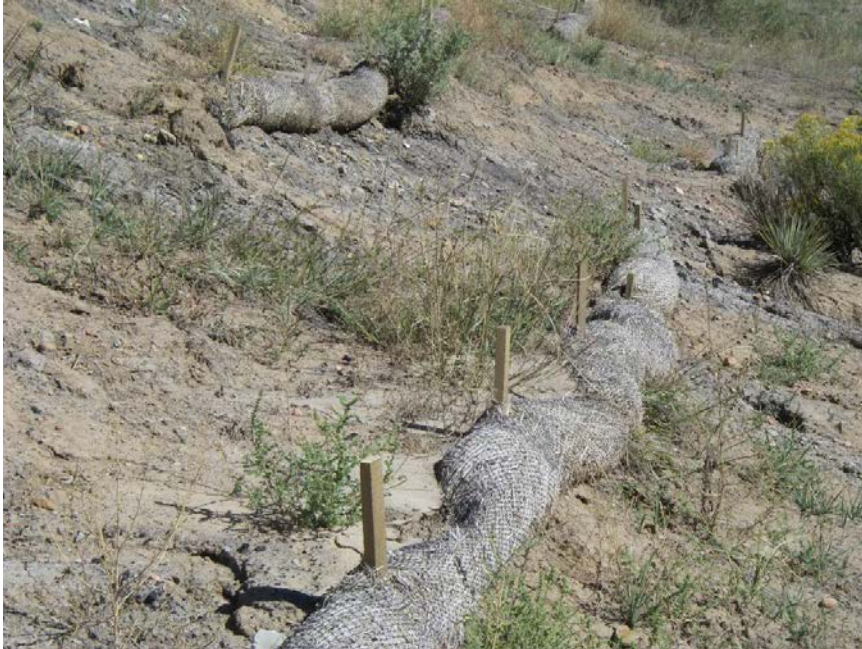
The wattles near the gravel parking lot in the facilities area require maintenance: sediment needs to be removed from behind them. Stability of this hillside would be more likely if more wattles were added.

Wattles in facility area (near gravel parking lot)

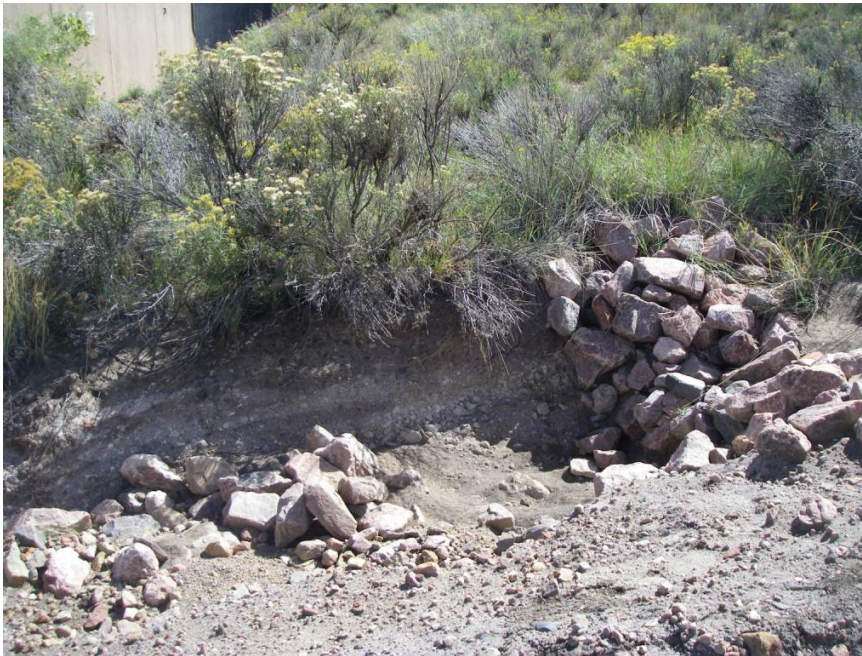
In the ditch near the truck tunnel, there is no significant erosion at the check dams, but this should be monitored. These structures are more likely to continue functioning if more riprap is added (there is a pile across the road).

Check dam near truck tunnel
