COLORADO DIVISION OF RECLAMATION, MINING AND SAFETY COAL PROGRAM INSPECTION REPORT

Permit Number: C-1981-012 Mine Name: New Elk Mine Operator: New Elk Coal Company, LLC Operator Address: Mr Mark Haywood 12250 Highway 12 Weston, CO 81091	County: Las Animas Operation Type: Underground Permit Status: Temporary Cessation Ownership: Private
	Operator Representative Present: Vince Masarotti
Operator Representative Signature: (Field Issuance Only)

Inspection Start Date: October 1, 2013 Inspection Start Time: 15:00 Inspection End Date: October 3, 2013 Inspection End Time: 16:30	Inspection Type: Coal Complete Inspection Inspection Reason: Normal I&E Program Weather: Clear
Joint Inspection Agency: None	Joint Inspection Contacts:
Post Inspection Agency: None	Post Inspection Contacts:
Inspector(s): Leigh D. Simmons	Inspector's Signature:

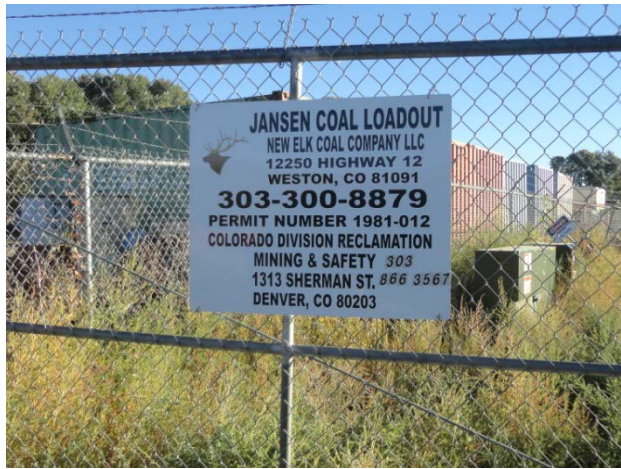
The Mine ID sign was complete.

Photo 1: Mine ID sign at Jansen Loadout (in compliance)

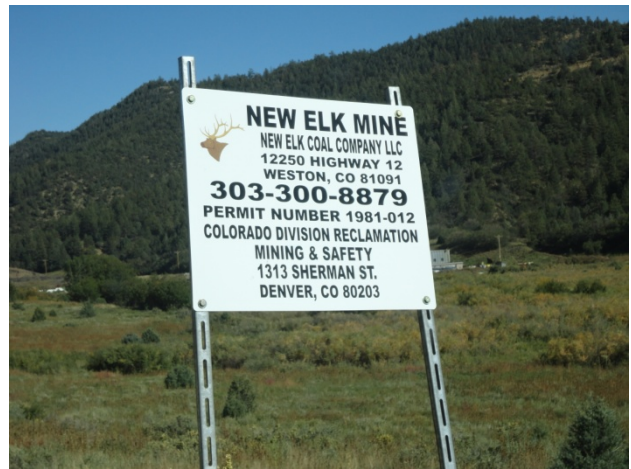
Mine ID signs have not yet been brought into full compliance. See photos 1-4. **All the signs must be the same; they must all be durable; and they must all show the phone number for the Division (303 866 3567), while the mine remains in temporary cessation.**

Photo 2: Mine ID sign at west of permit boundary (not in compliance)

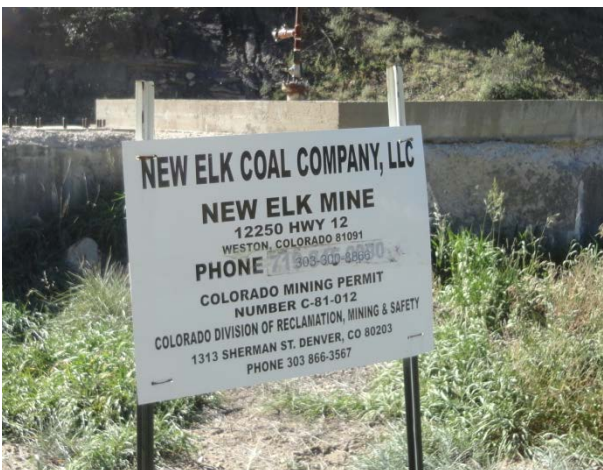
The mine ID signs had not yet been replaced. Although all required information was shown, the temporary alterations had deteriorated. **The signs should be replaced with permanent signs.**

Photo 3: Mine ID sign at first Apache Canyon airshaft (not in compliance)

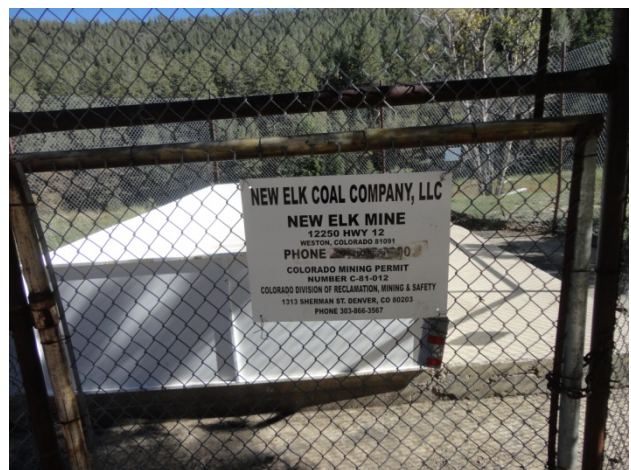
Photo 4: Mine ID sign at second Apache Canyon airshaft (not in compliance)

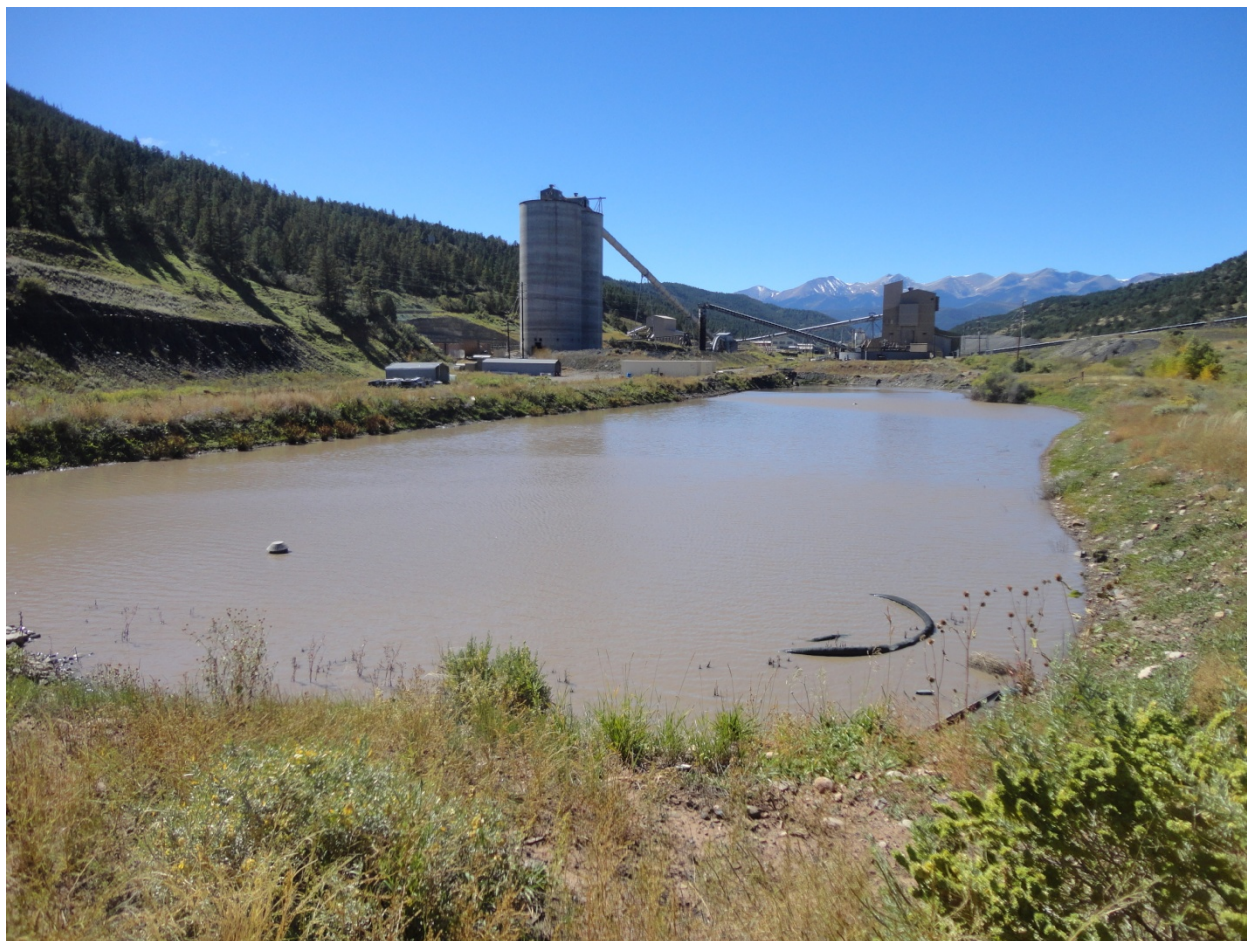
- Pond 1 was inspected. The embankments and spillways were in good order. All ditches and culverts in the area were clear and functional.
- Ponds 6 and 7 were both inspected; no problems were observed with the pond structures. Pond 6 had not yet been lined. Pond 7 had a very high water level and the gate valve on the primary spillway outlet was closed. The following text is taken from page 2.05-10a of the permit:

A staff gage will be installed on or adjacent to the riser pipe of Pond 007 identifying the water level (7337.3 ft) adequate to retain a 10 year 24 hour storm without discharging over the emergency spillway.

It is critically important that NECC maintain the designed capacity in pond 7 in order to deal with the runoff from future storms. As shown in photo 5, the level of water in the pond is almost to the top of the primary spillway riser, and no staff gauge is visible. **Water should be discharged from the pond, following treatment with a flocculant if necessary, as soon as possible until the required capacity is restored.** Photo 6, taken in October, 2012, shows the riser at a much lower water level – no staff gauge is visible. **If not already present, the staff gauge should be constructed so that the pond level may be easily monitored.**

Photo 5: Pond 7 needs to discharge

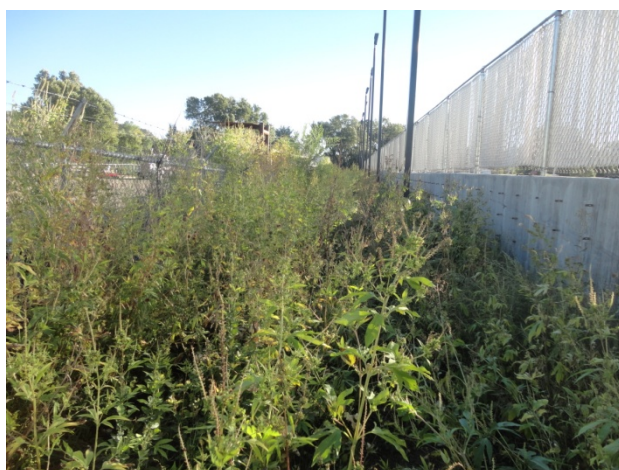
Vegetation around the site was dense and shoulder high. **The vegetation should be cleared.**

Photo 6: Overgrown vegetation at Jansen Loadout

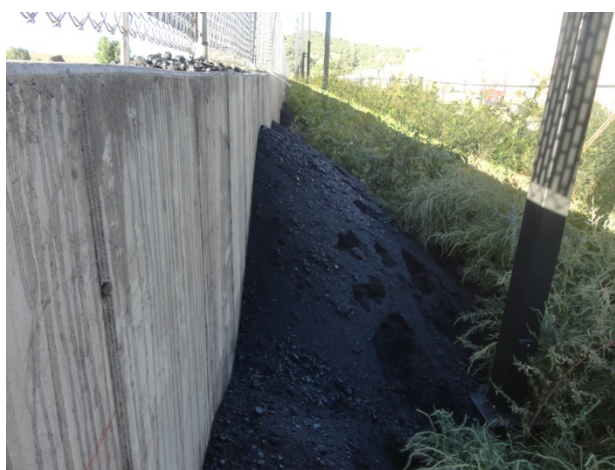
Coal had spilled over the retaining wall. **The spilled coal should be cleaned up.**

Photo 7: Spilled coal at Jansen Loadout

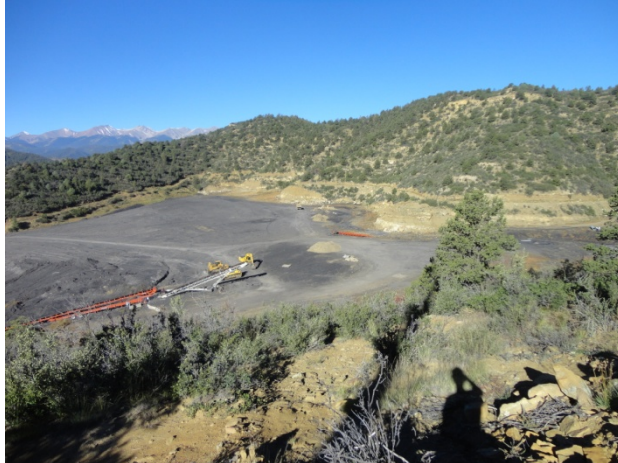
Photo 8: RDA

The RDA was stable and well-drained. Some refuse that had spilled off the RDA conveyor belt had not yet been cleared. **It was previously agreed that this could be shoveled back onto the conveyor when the belt is run to winterize the wash plant.**

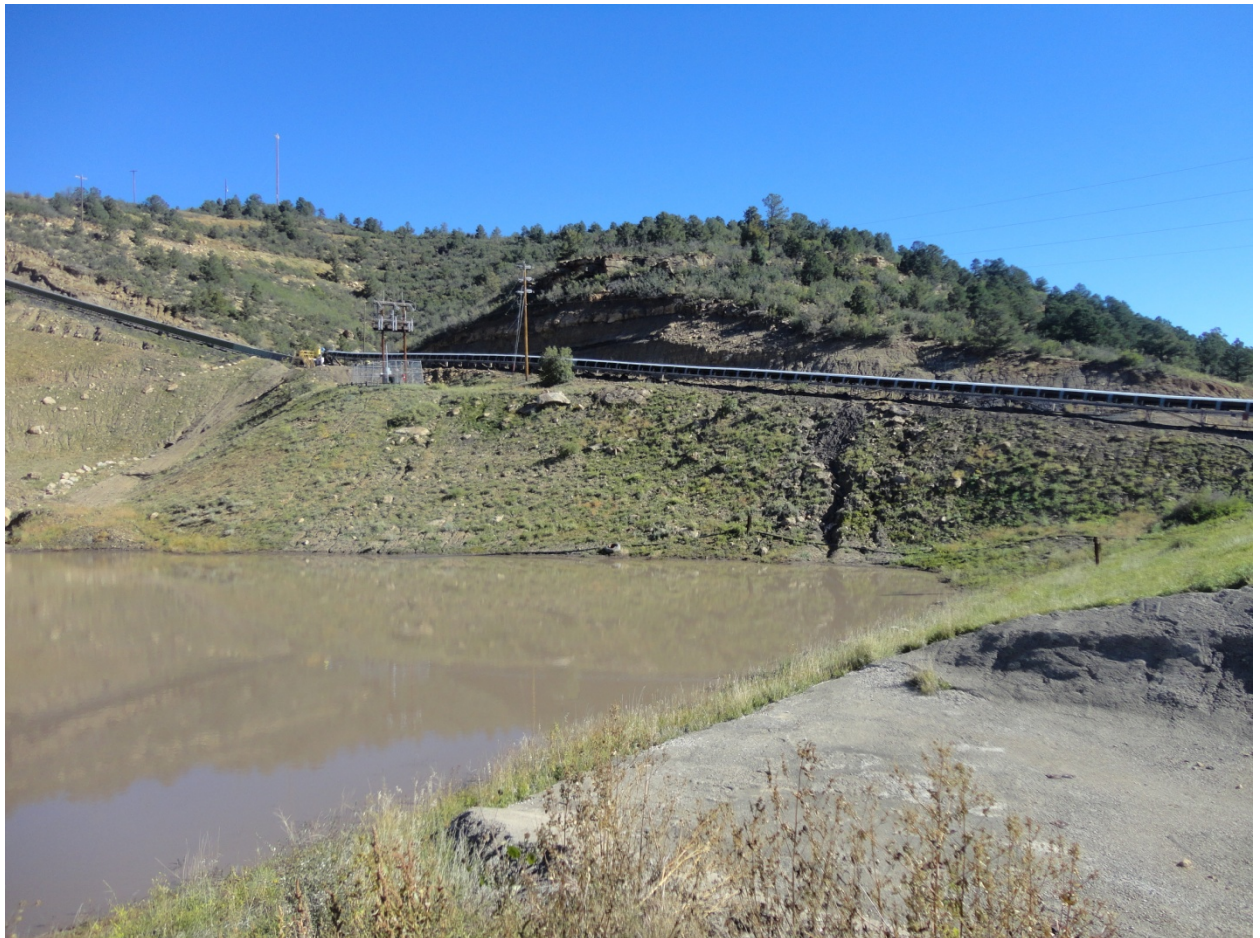
- The cell phone pads were inspected, no problems were observed.
- Culvert C41 had been restored. The related projects are yet to be completed (moving soil, re-grading road, cut small road ditch, build water bar, fill gullies above pond 8 and re-seed repairs). Mr Masarotti estimated that there was a weeks worth of work for 3 people in order to complete everything.
- Containment 5 and pond 8 were both holding water – the sediment levels of each will need to be assessed when the water level drops.
- The rock drain on the eastern side of pond 8 shows a little movement between the first and second benches, but does not warrant repair.
- The RDA access road and all the culverts underneath it were in good shape.

Photo 10: Erosion around pond 8, scheduled for repair

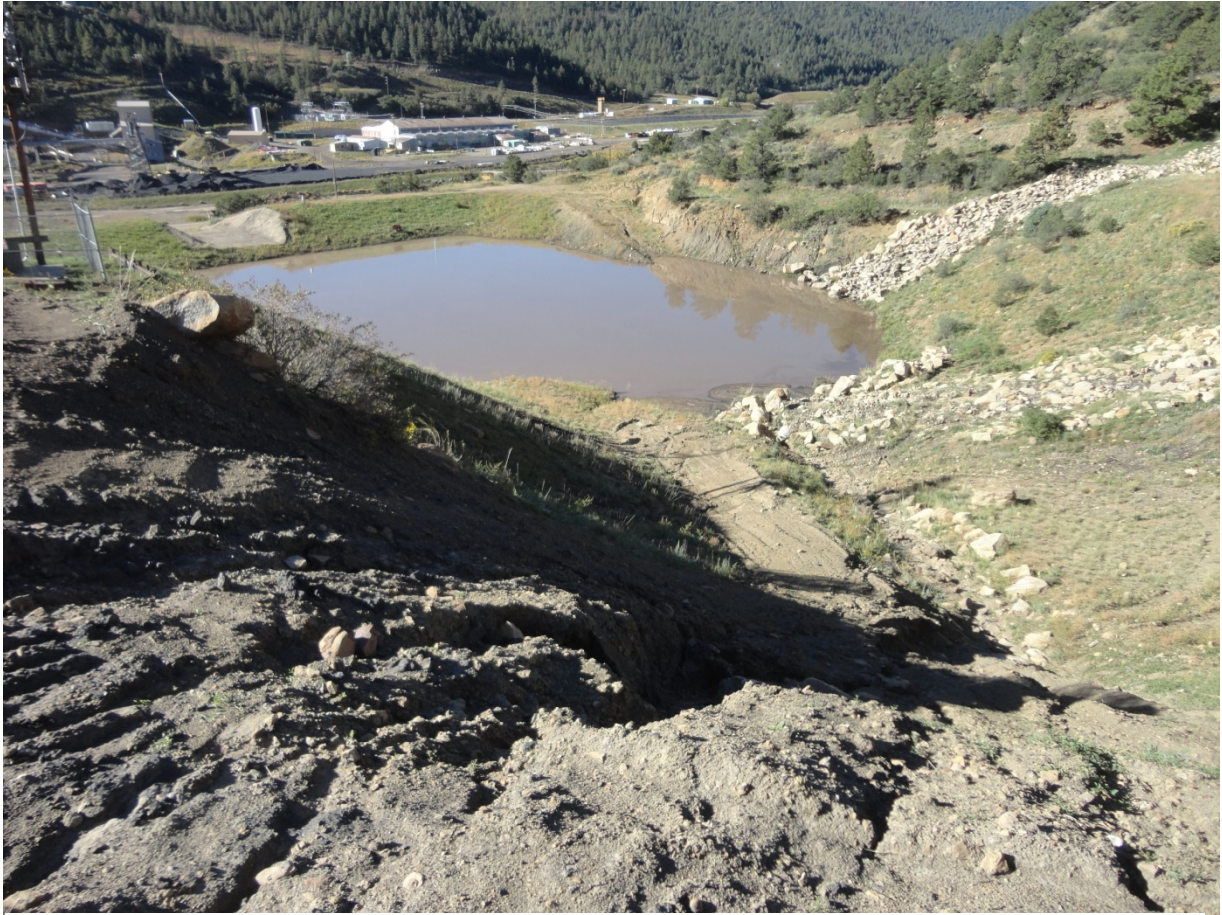
Photo 11: Pond 8 from above, showing where temporary gully repair had partially washed out

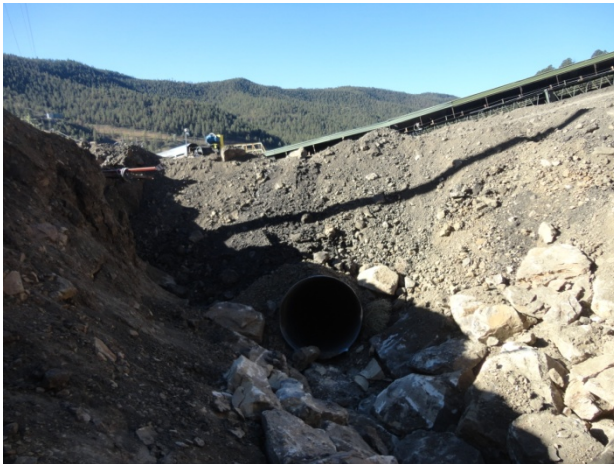
Photo 12: Restored culvert C41

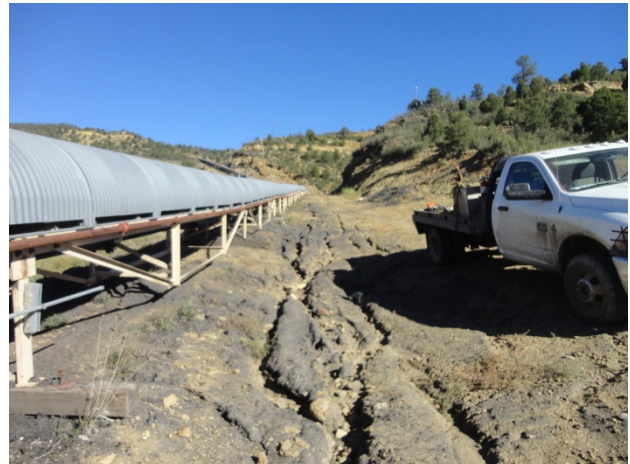
Roads were generally in good condition. However the road up to the water tanks has not yet been re-graded (but was still passable). The light use road beside the RDA conveyor is scheduled to be repaired to allow access to the belt (at the time of the inspection it was impassable).

Photo 13: Damaged light use road, scheduled for repair

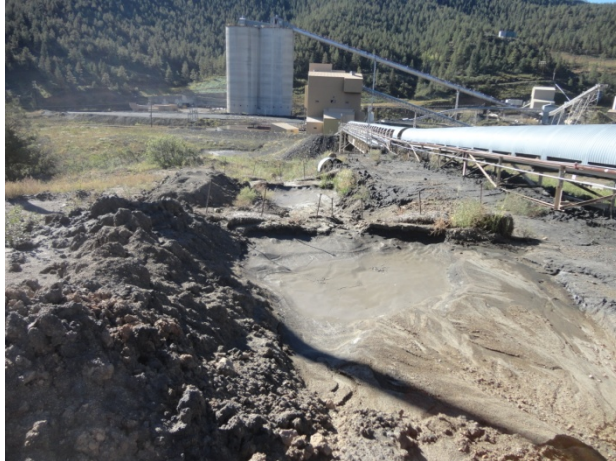
Photo 14: Sediment traps above containment 5

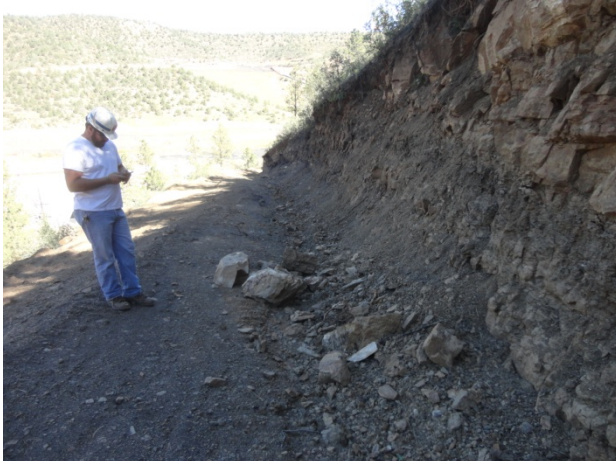
- The water monitoring sites were inspected. No problems were noted.
- The new water tanks were inspected. No problems were noted.
- The diversion ditch D26 was inspected. Some rocks had recently fallen into the ditch. **The rocks should be cleared.** The trash in the concrete section of the ditch was removed during the inspection.

Photo 16: Fallen rocks to clear from D26

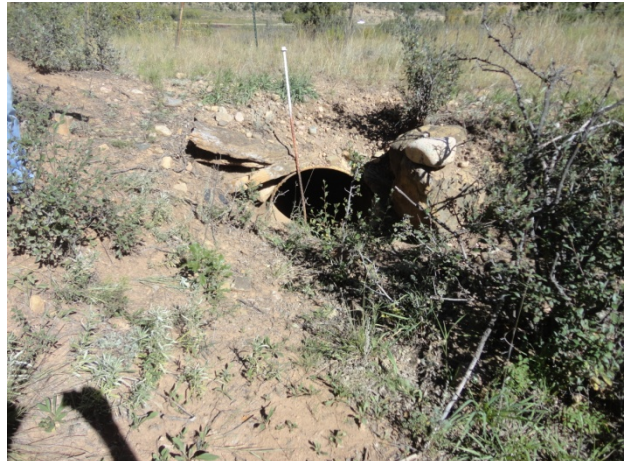
- Culvert C21 had not yet been cleaned. **C21 should be cleaned at the inlet, at least, as soon as possible.**
- The old water tank and substation SAEs showed no new disturbance.

Photo 17: Inlet of C21 to be cleared

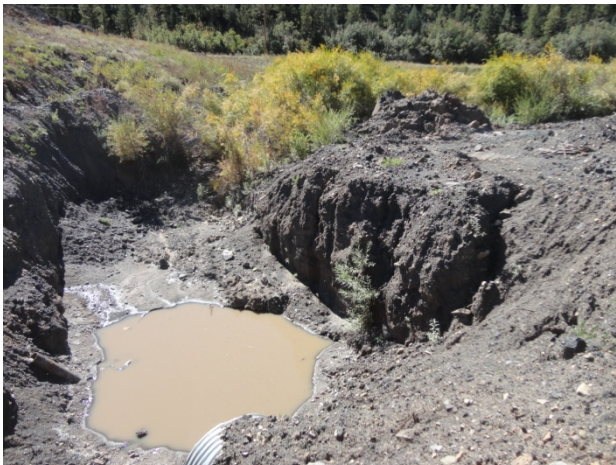
- Culverts C2 and C3 were both clear. There was a little more work to do at the inlet to C3, which will involve moving some material around, but also taking some away. **The surplus material should be moved away when the work is complete.** It was agreed that the small stand of willows above the inlet was a good thing, as long as the ditch is able to convey the necessary amount of water.

Photo 18: Inlet of C3 work in progress

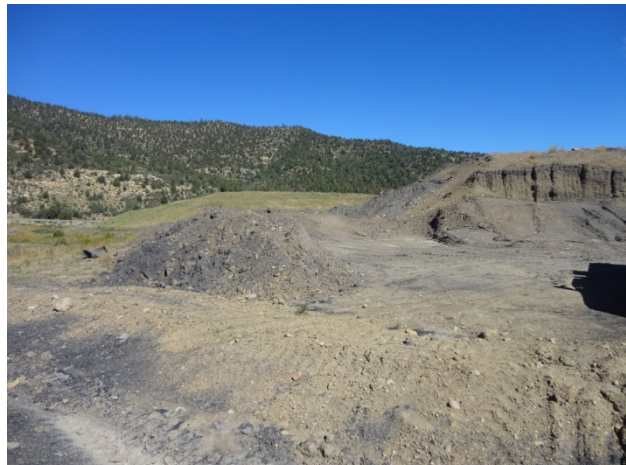
The soil storage area was in good order, with the different piles distinct from each other. The ditch cleanings continue to be stored at the far western end of the soil storage area - **it must be stressed that this is a temporary measure.**

Photo 19: Ditch cleanings temporarily stored next to subsoil pile

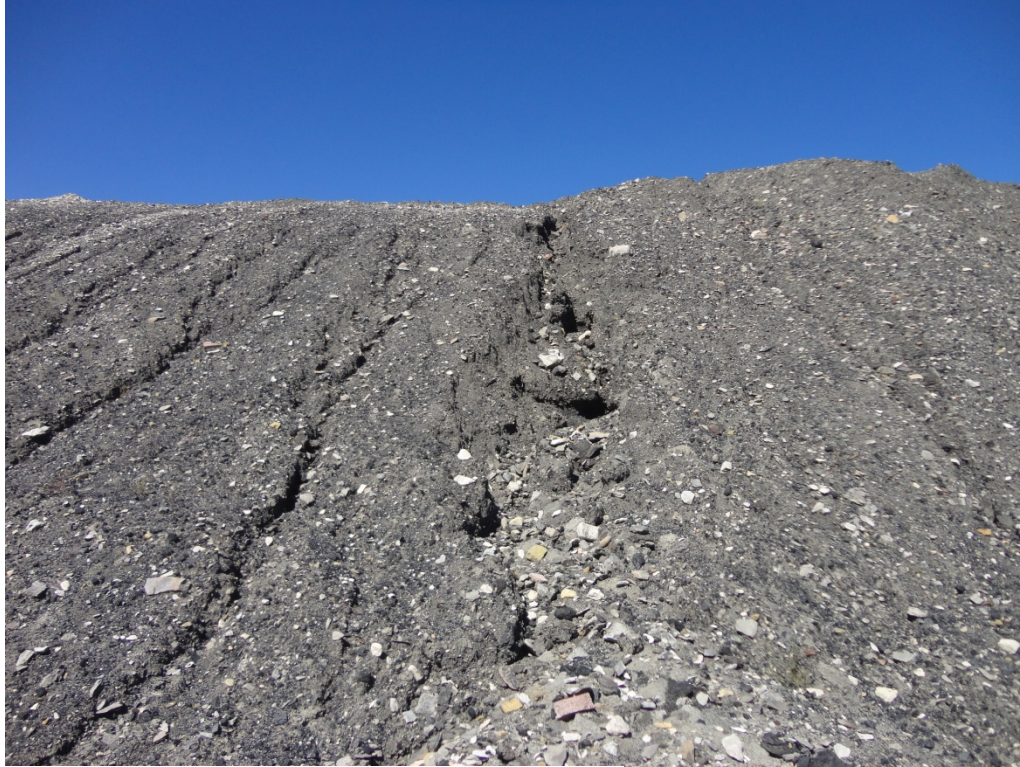
The Development Waste Disposal Area (DWDA 2) appeared stable however surface erosion was evident. This continues to cause maintenance issues in the surrounding ditches.

Photo 20: Surface erosion of DWDA2

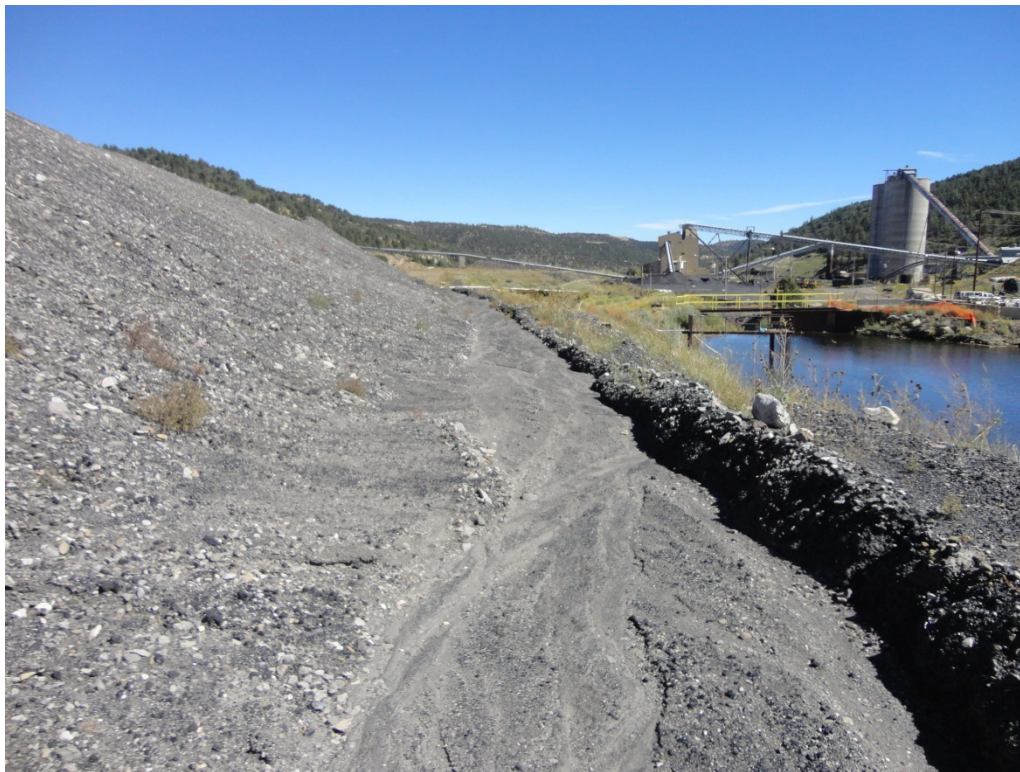
Photo 21: D14

- No further work had taken place to re-grade ditch D14, because the ground was judged to have been too soft. The ditch had not breached again, although accumulated sediment had risen to within 6-8” of the top of the ditch. The date by which this abatement must be complete had previously been extended to November 4, 2013.
- The upland diversion ditch had been surveyed, and the survey data submitted to the Division.
- Culvert C41 had been restored, and the area around it filled and graded. Although work continues in the same area, the work necessary to abate the violation had been completed.

Abatement Description: Ditch D14 should be restored to the approved design.
