COLORADO DIVISION OF RECLAMATION, MINING AND SAFETY COAL PROGRAM INSPECTION REPORT

Permit Number: C-1996-084 Mine Name: Lorencito Canyon Mine Operator: New Elk Coal Company, LLC Operator Address: Mr Mark Haywood 12250 Highway 12 Weston, CO 81091	County: Las Animas Operation Type: Surface Permit Status: Permanent Cessation Ownership: Private
	Operator Representative Present: Vince Masarotti
Operator Representative Signature: (Field Issuance Only)

Inspection Start Date: October 1, 2013 Inspection Start Time: 15:00 Inspection End Date: October 2, 2013 Inspection End Time: 14:00	Inspection Type: Coal Complete Inspection Inspection Reason: Normal I&E Program Weather: Clear
Joint Inspection Agency: None	Joint Inspection Contacts:
Post Inspection Agency: None	Post Inspection Contacts:
Inspector(s): Leigh D. Simmons	Inspector's Signature:

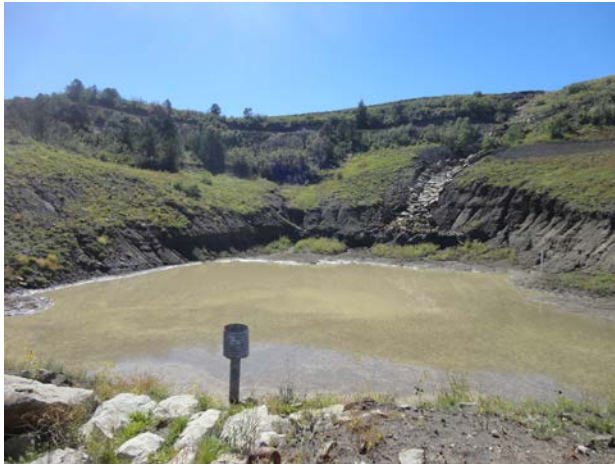
Photo 1: Pond 9/9b

Pond 9/9b was just discharging. The silt fence on the emergency spillway was in good shape and the armoring in the recently repaired gully looked good. Two other erosive gullies around the pond should be monitored - they look likely to grow, in which case they should be repaired and re-seeded. One of the gullies appeared to be caused by the discharge from an XTO culvert; it looked as though it could be physically possible to re-route the flow along a road ditch - this may be something NECC would wish to evaluate.

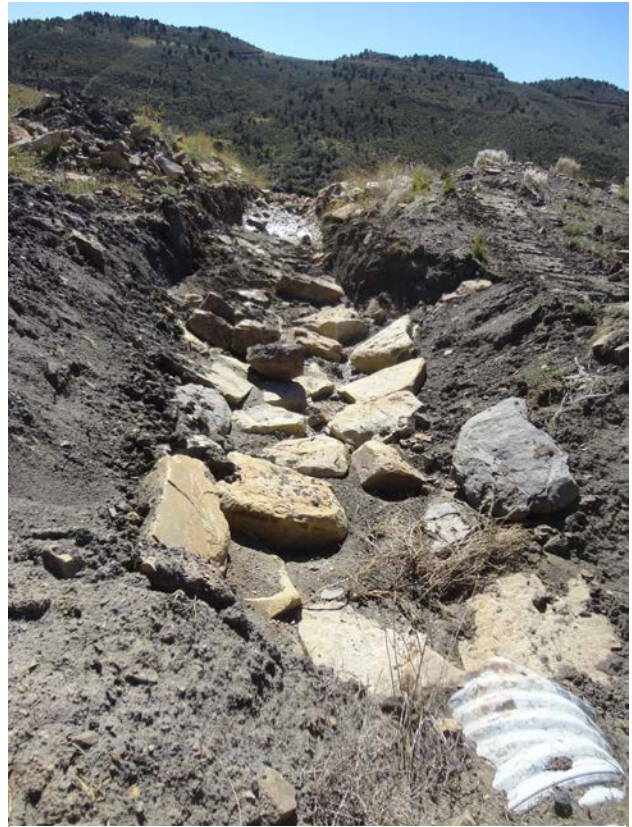
Photo 2: Armored ditch below C4

The rock drain at the outlet of culvert C4 had been lowered by ~2' and repaired to ensure that the culvert will drain properly.

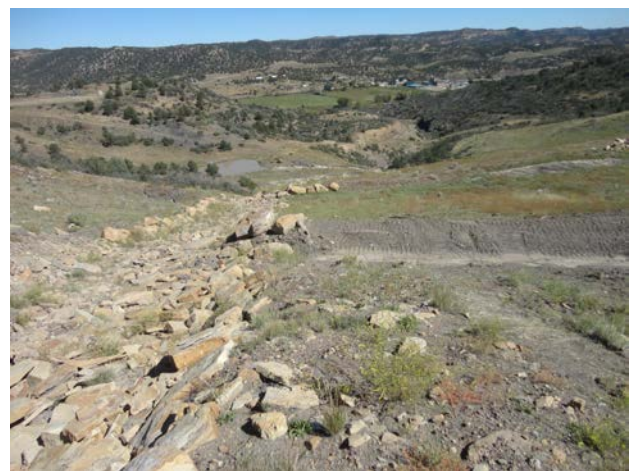
Photo 4: Repairs to top terrace of fill 8

The highest terrace on fill 8 had been cleaned out and tied back into the down-drain. **The erosion outside of fill 8 that had been noted in previous inspections should be repaired when people and equipment are on-site later in the month.**

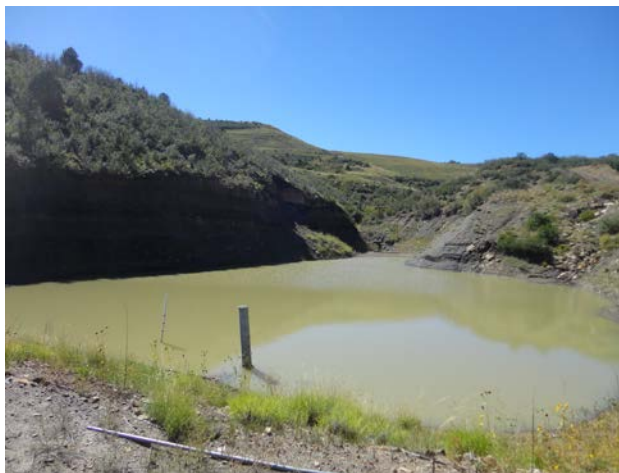
Photo 6: Pond 8

Ponds 8 and 5 were just discharging.

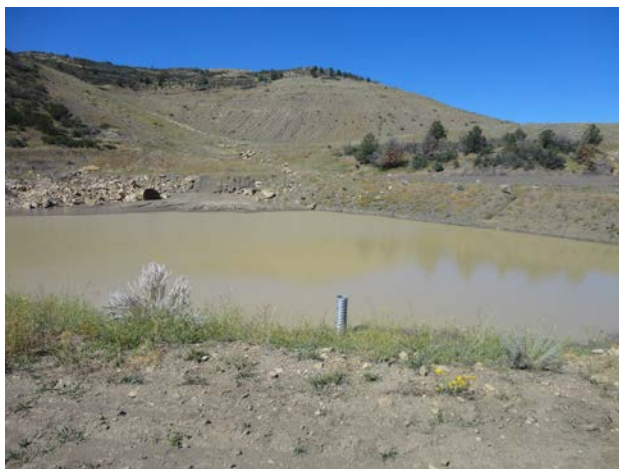
Photo 8: Pond 6

Pond 6 was holding water but not discharging. A plan was discussed to address the erosion below the emergency spillway by moving material to create a berm and allowing the area to drain back into the pond.

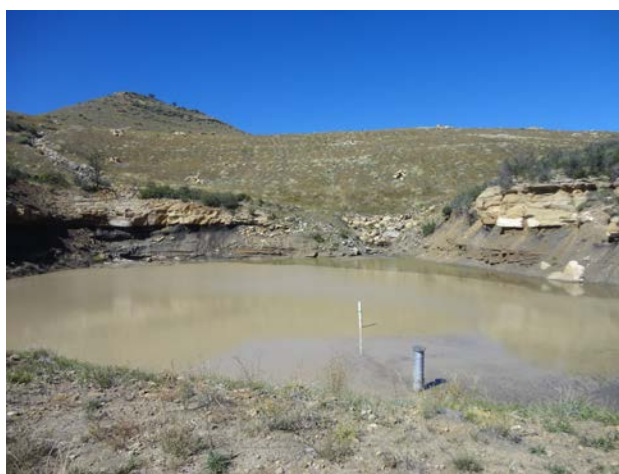
Photo 9: Pond 9a

Pond 9a was discharging by drips.

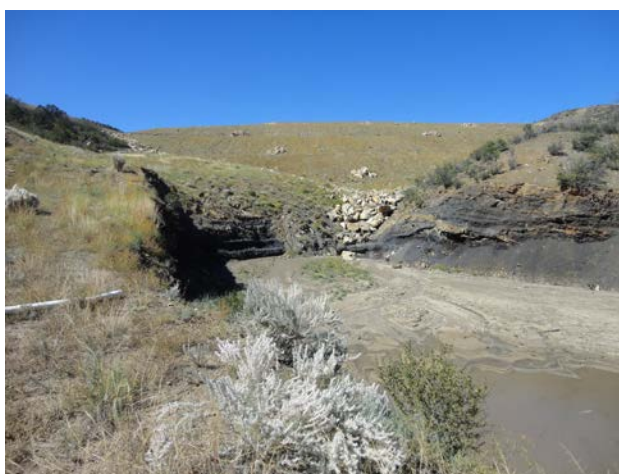
Photo 10: Pond 7

Pond 7 was holding water but not discharging. The pond appears to have a lot of spare capacity. The re-certification may demonstrate that the capacity is sufficient to meet the pond's requirements without needing to clean it out. If not, cleaning the pond will be a challenging project.
