COLORADO DIVISION OF RECLAMATION, MINING AND SAFETY COAL PROGRAM INSPECTION REPORT

Permit Number: C-1981-022 Mine Name: Elk Creek Mine Operator: Oxbow Mining, LLC Operator Address: Mr. Jim Kiger P.O. Box 535 3737 Highway 133 Somerset, CO 81434	County: Delta, Gunnison Operation Type: Underground Permit Status: Active Ownership: Federal
	Operator Representative Present: Jim Kiger
Operator Representative Signature: (Field Issuance Only)

Inspection Start Date: October 9, 2013 Inspection Start Time: 09:00 Inspection End Date: October 9, 2013 Inspection End Time: 15:30		Inspection Type: Coal Partial Inspection Inspection Reason: Normal I&E Program Weather: Cloudy	
Joint Inspection Agency: None		Joint Inspection Contacts:	
Post Inspection Agency: None		Post Inspection Contacts:	
Inspector(s): Brock F. Bowles Sandra L. Brown	Inspector's Signature:

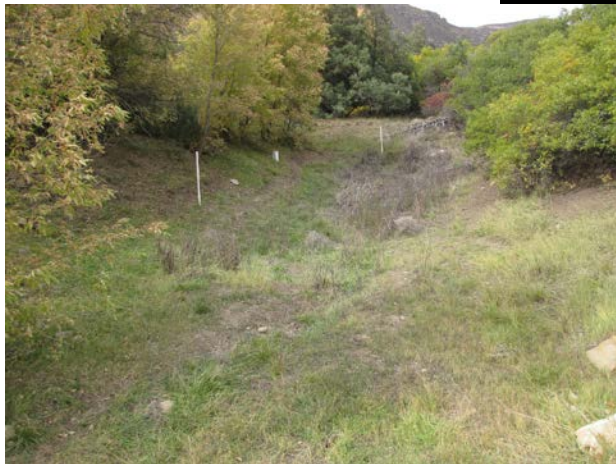
Photo 1 – Pond F

Ponds A, B and East Yard contained water but none were discharging. Ponds F (photo 1) and Hubbard Creek (photo 2) were dry and the outfalls were free and clear of debris. The pond cleanings that were drying in the East Yard pond reported in the August 6, 2013 report had been removed.

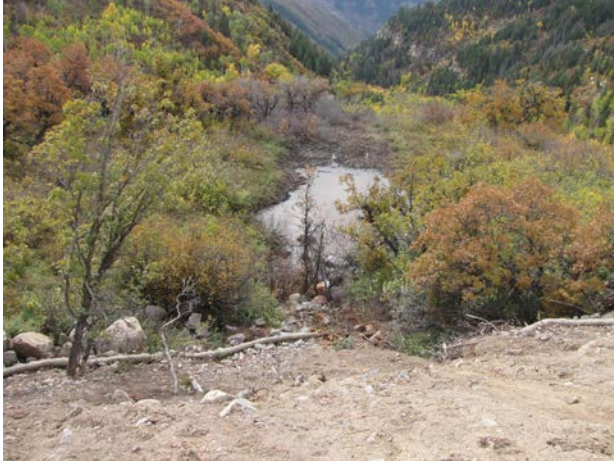
Water was not being discharged from the temporary discharge point 015B. Since the longwall miner recovery efforts have ceased, the pumps were turned off. Most of the equipment on the well pad had been removed. Some water remained in the small pond below the pad but all the other areas appeared to be dry (photo 3). Equipment was being moved to the pad-site to remove the pumps before winter. It is estimated that the pad will be reclaimed next year. The sediment control waddles around the base of the well pad need to be re-installed. Some of the stakes have pulled out and the waddles were not in contact with the soil surface.
