COLORADO DIVISION OF RECLAMATION, MINING AND SAFETY
MINERALS PROGRAM INSPECTION REPORT
PHONE: (303) 866-3567

MINE NAME: Schwartzwalder Mine	MINE/PROSPECTING ID#: M-1977-300	MINERAL: Uranium	COUNTY: Jefferson
INSPECTION TYPE: Monitoring	INSPECTOR(S): Tom Kaldenbach	INSP. DATE: March 14, 2013	INSP. TIME: 11:00
OPERATOR: Cotter Corporation	OPERATOR REPRESENTATIVE: Bob Tennant	TYPE OF OPERATION: 112d-2 - Designated Mining Operation

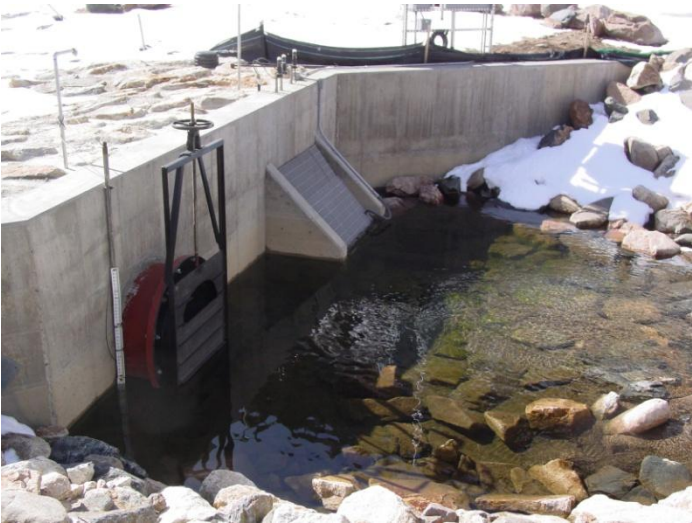
Photo 1 – Ralston Creek at upstream side of diversion wall.

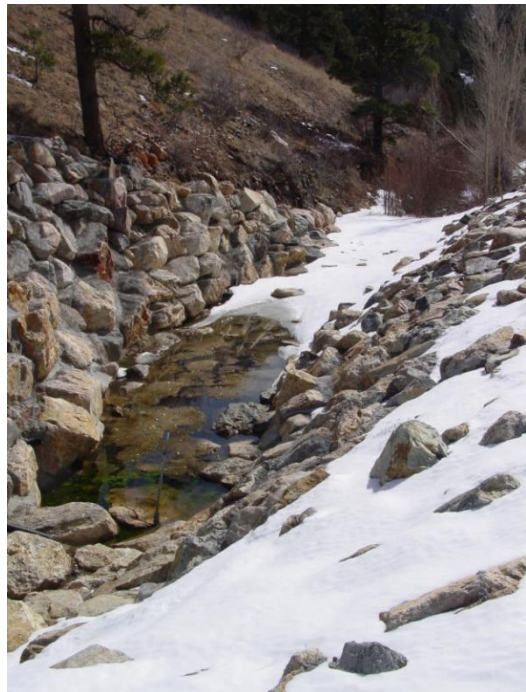
Photo 2 – Ralston Creek at downstream side of diversion wall.

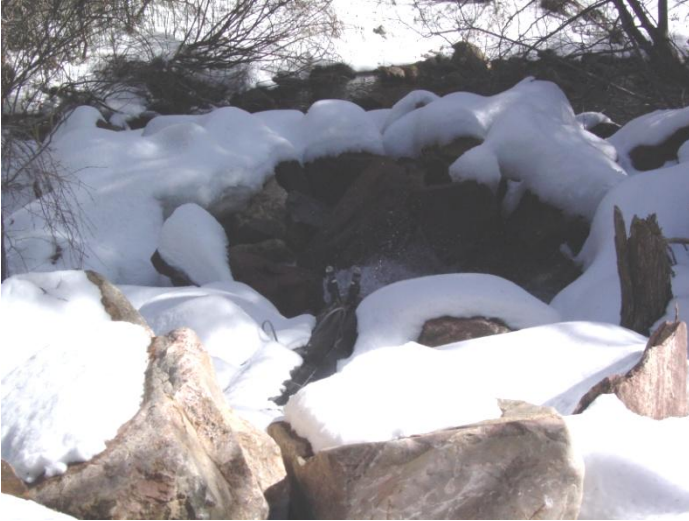
Sump water was being circulated through the ion exchange treatment plant and was discharging from the pipe near BPL at an estimated rate of between 50 and 100 gpm.

Photo 3 – Discharge from black pipe in center of photo is from ion-exchange treatment plant.

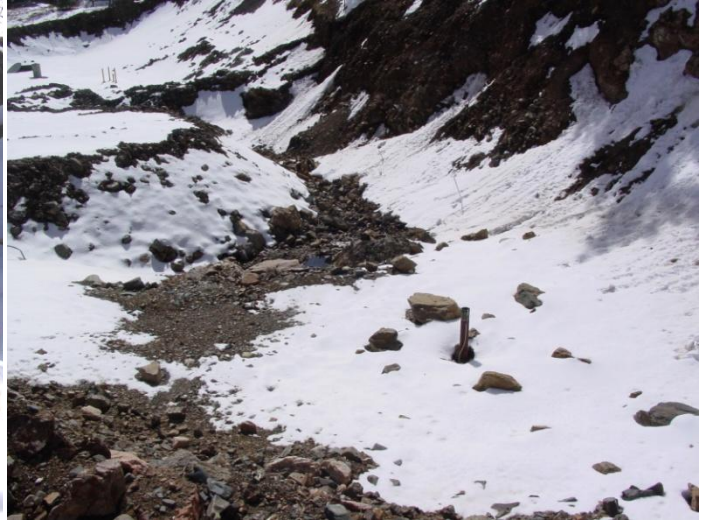
Photo 4 – Sump 10 area.

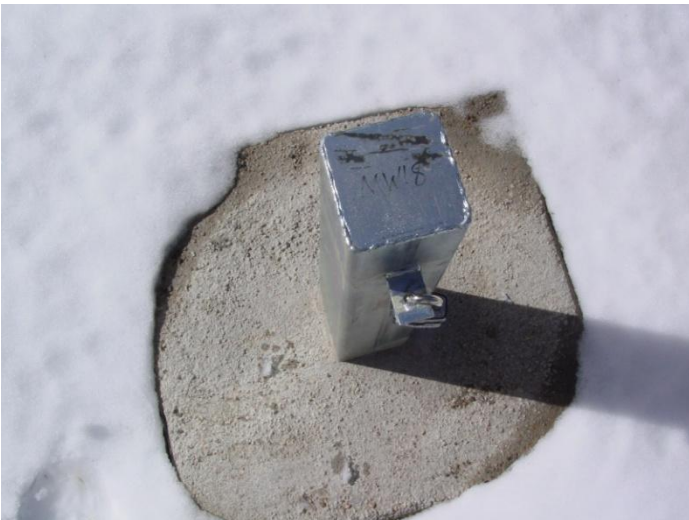
The mine operator drilled eight bedrock ground water monitoring wells in late 2012. Wellheads of three of the new wells (MW-17, MW-18, and MW-19) were seen on the inspection and appeared to have no problems.

Photo 5 – Wellhead of new bedrock ground water monitoring well MW-18 (screened interval 215 – 235 ft in Illinois Fault well near Sump 10).

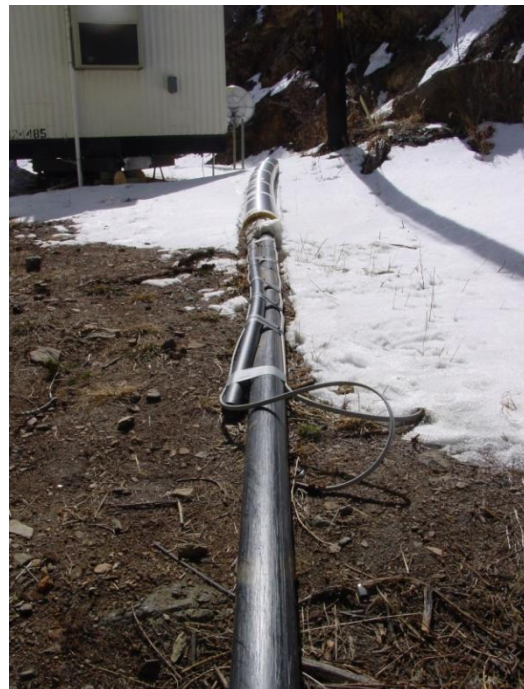
In advance of installing mine pool-dewatering equipment, a 6-inch diameter HDPE pipeline has been placed on the ground, extending from the ion exchange plant to the Steve Adit. The pipeline is insulated.

Photo 6 – Recently installed pipeline that extends from Steve Adit to ion exchange treatment plant.
