COLORADO DIVISION OF RECLAMATION, MINING AND SAFETY
MINERALS PROGRAM INSPECTION REPORT
PHONE: (303) 866-3567

MINE NAME: Schwartzwalder Mine	MINE/PROSPECTING ID#: M-1977-300	MINERAL: Uranium	COUNTY: Jefferson
INSPECTION TYPE: Surety Release Inspection	INSPECTOR(S): Tom Kaldenbach	INSP. DATE: June 14, 2013	INSP. TIME: 10:30
OPERATOR: Cotter Corporation	OPERATOR REPRESENTATIVE: John Hamrick, Ken Mushinski	TYPE OF OPERATION: 112d-2 - Designated Mining Operation

Surety Reduction Request SR-07

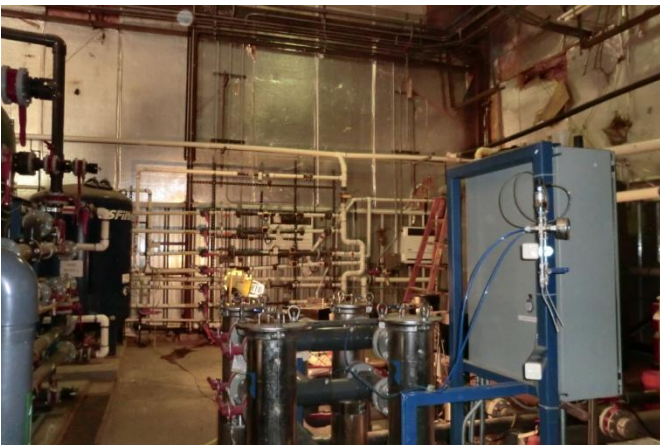
Photo 1 – Part of ion exchange treatment plant.

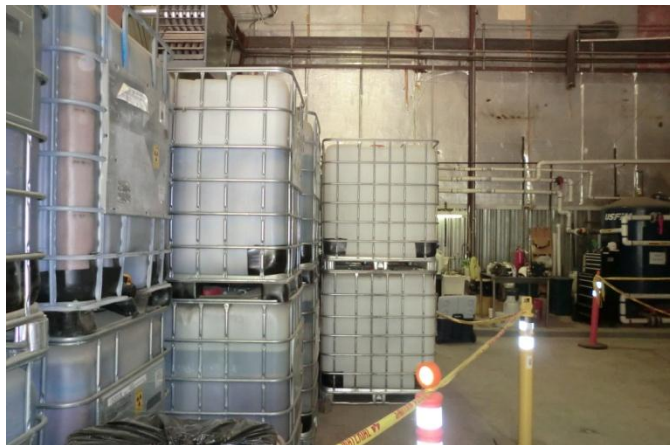
Photo 2 – Part of ion exchange treatment plant.

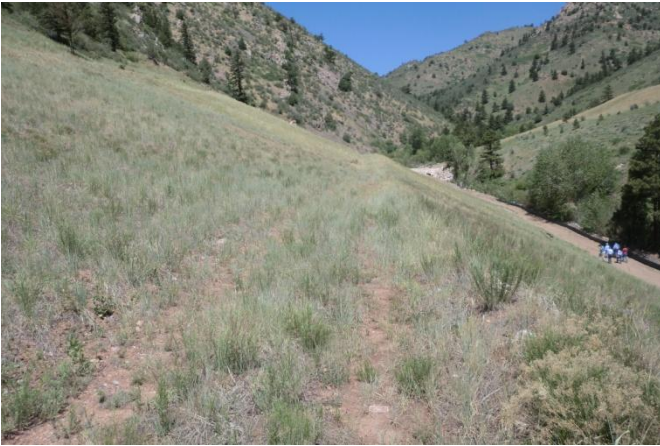
Photo 3 – South Waste Rock Pile.

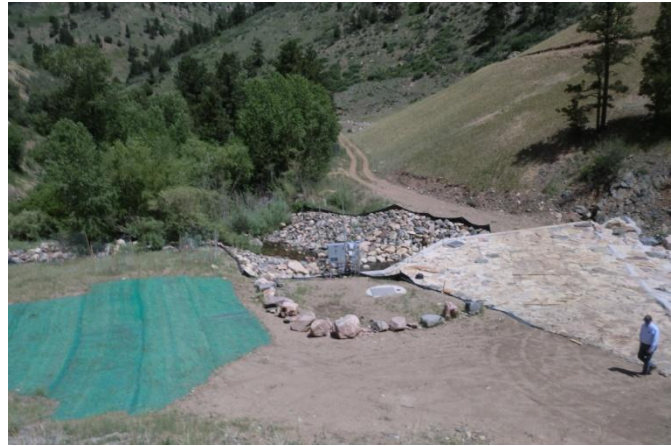
Photo 4 – Concrete apron (on right side of photo) at upstream cut-off wall of Ralston Creek diversion wall.

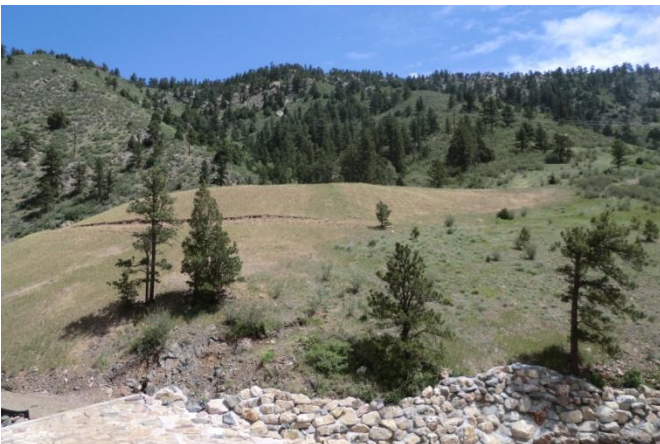
Photo 5 – North Waste Rock Pile in distance as seen from concrete apron shown in Photo 4.

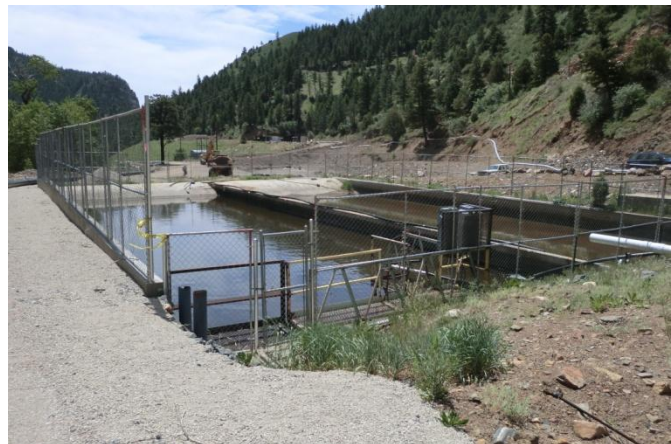
Photo 6 – Concrete-lined two-cell ponds next to ion exchange treatment plant.

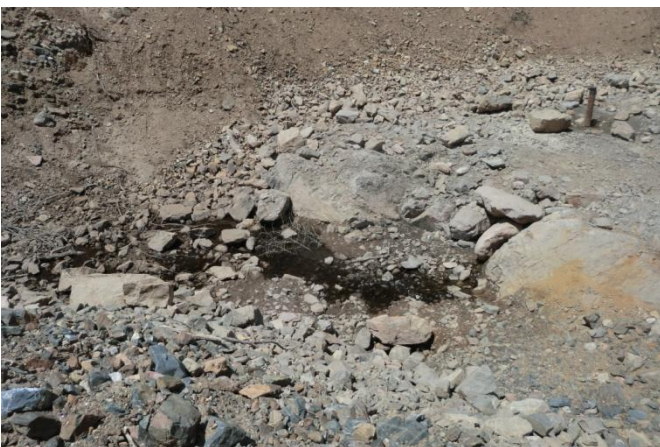
Photo 7 – Small amount of water ponded (in center of photo) in Sump 10 area. Stand pipe in upper right of photo is a grout injection hole drilled in June 2012 as part of grout curtain effort (TR-20).

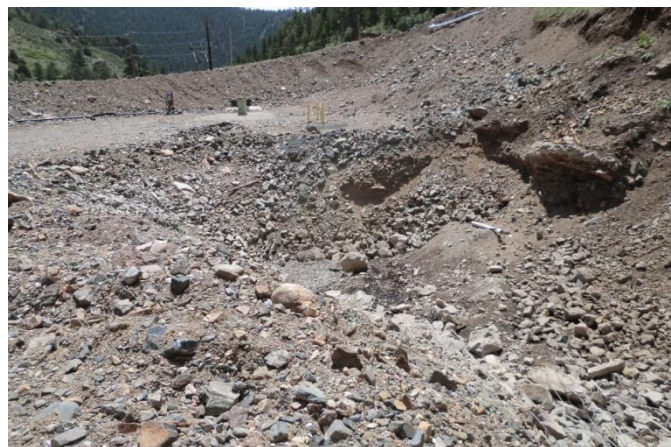
Photo 8 – Sump 10 area that was excavated for ground water investigation in 2012.

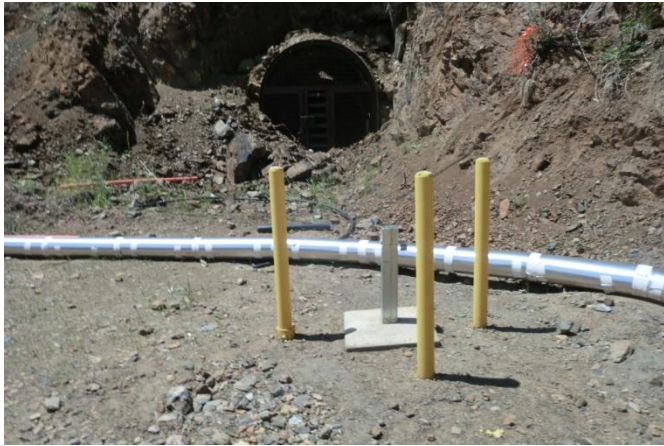
Eight new bedrock monitoring wells were approved in TR-19. The wells were drilled in late 2012. Each well was visited during this inspection. The wells are located as approved in TR-19 and no problems were found with the wellheads, as each was secured with a protective housing and marked with an identifying number. After the inspection the operator provided copies of completion information and diagrams. The wells appear to have been screened at the depths approved in TR-19 and underwent proper development.

Photo 9 – Monitoring well MW-17 (in center of 3 yellow guard pipes). MW-17 total depth is 119 feet, in or near Illinois Fault zone. Insulated silver pipe that extends from Steve Adit to IX plant (extends across photo). Pierce Adit in background.

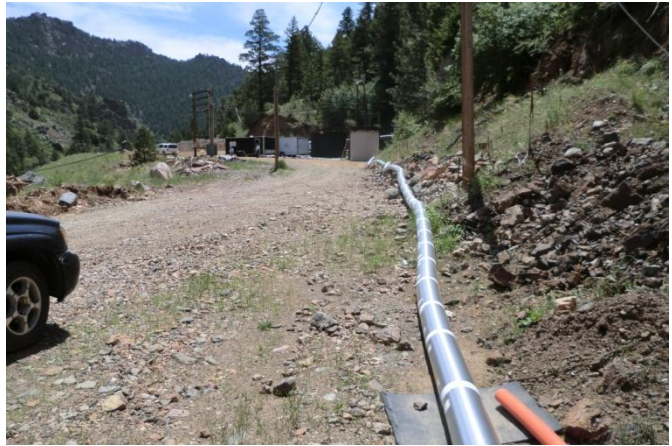
Photo 10 – Insulated silver pipe that extends from Steve Adit (in distance) to IX plant. This pipe will carry treated water from the RO unit at the Steve Adit to the ion exchange plant (but will not be treated there unless necessary). The water will be piped from the IX plant to the discharge into Ralston Creek near BPL.

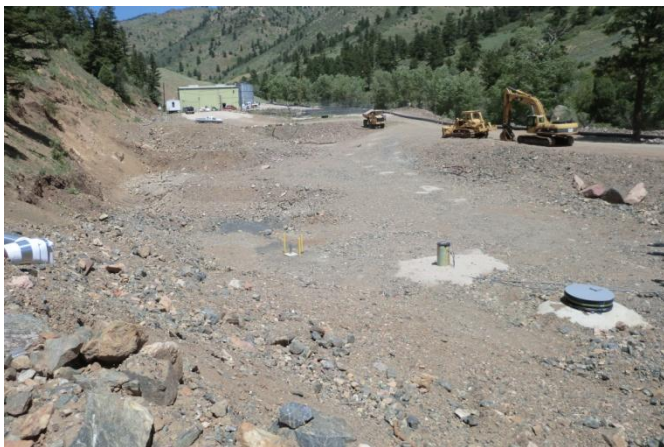
Photo 11 – Sump 10 area. IX treatment plant in distance.

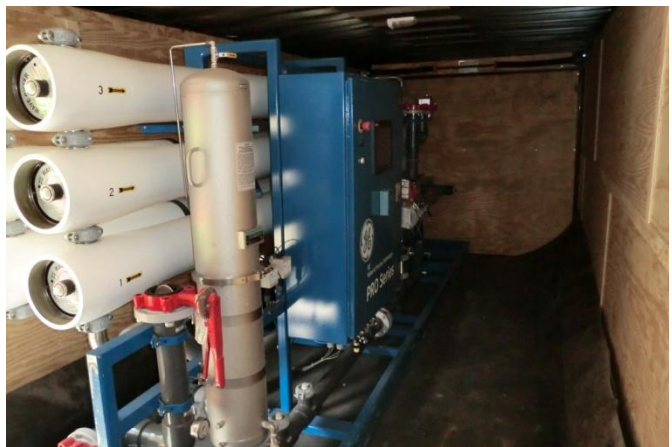
Equipment was on site for implementing the mine pool pump down and mine water treatment recently approved in Permit Amendment 4. A new reverse osmosis (RO) unit was inside a trailer outside the Steve Adit, but is not yet operating. The operator is preparing to install a pump in the mine workings for pumping down the mine pool to a minimum depth of 150 feet below the elevation of the Steve Level. The pumped mine water will be run through the RO unit, then the clean portion of the RO discharge will be routed through a pipe, via the ion exchange plant, to the Ralston Creek discharge point near BPL. The operator does not plan to run the water through the IX plant unless necessary.

Photo 12 – Reverse osmosis treatment unit in trailer at Steve Adit.

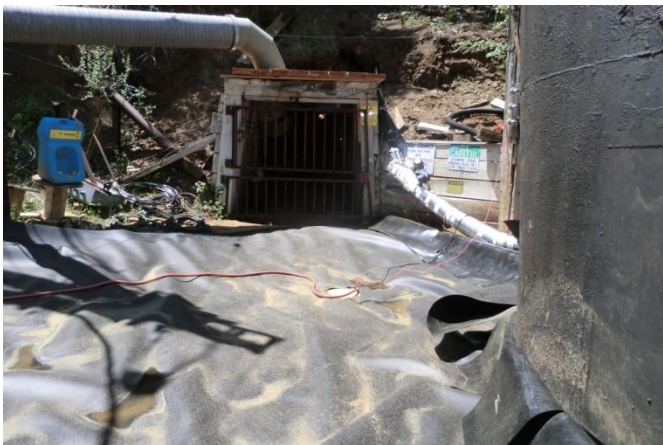
Photo 13 – Portal of Steve Adit. Insulated black tank on right side of photo.

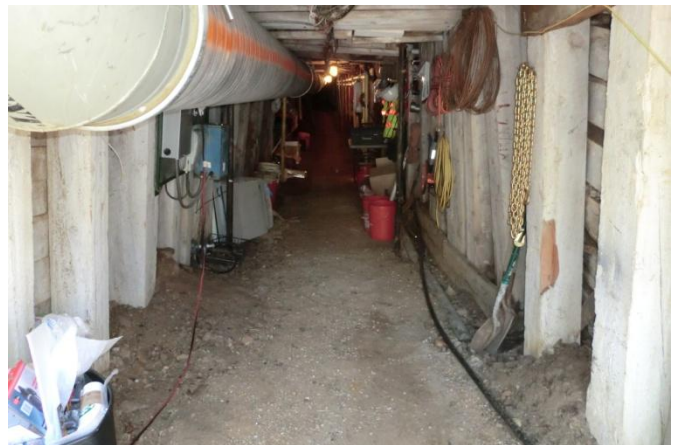
Photo 14 – View into Steve Adit from portal.

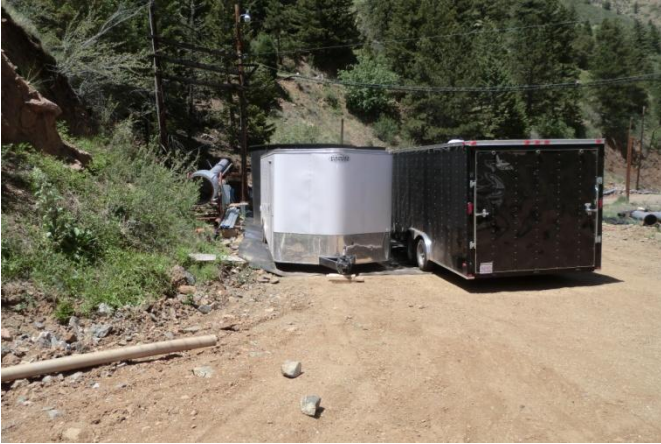
The residuals from the RO discharge at the Steve Adit (the RO treatment waste) will pass through a barium chloride treatment process inside a trailer next to the RO unit and then will be injected back into the mine pool as backfill slurry. EPA issued a determination on March 11, 2013 that injection of the backfill slurry back into the mine pool is "authorized by rule". The RO and barium chloride treatments will be conducted concurrently with biologic in-situ treatment of the mine pool water. The in-situ treatment began May 15, 2013 with the first addition of molasses and alcohol to the mine pool water.

Photo 15 –Trailers outside Steve Adit that contain treatment equipment.

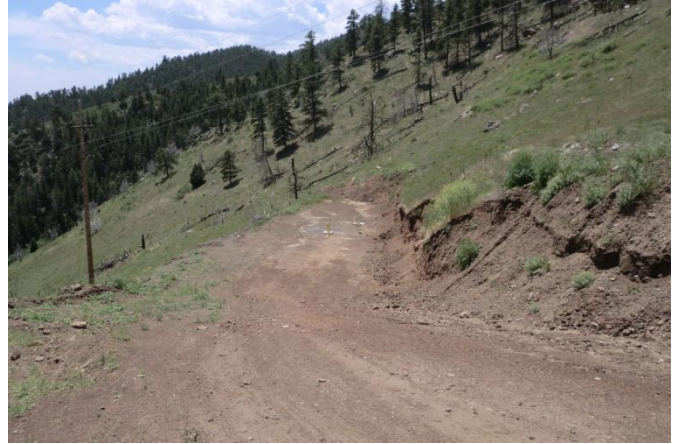
Photo 16 – Schwartz Trend well, MW-15 and 16 (stand pipes in distance near center of photo).

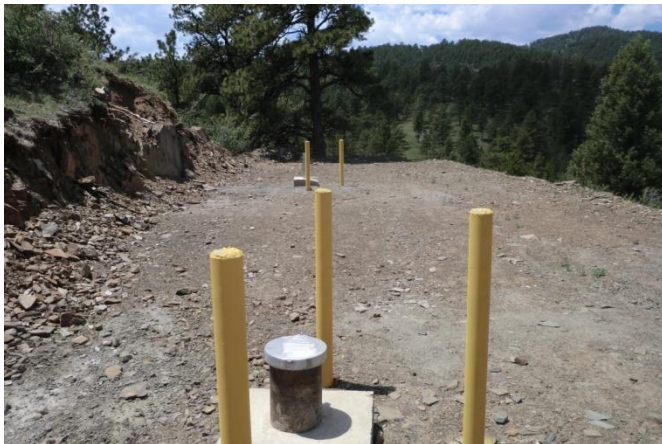
Photo 17 – MW-13 and MW-14 on top of hill.
