COLORADO DIVISION OF RECLAMATION, MINING AND SAFETY COAL PROGRAM INSPECTION REPORT

Permit Number: C-1981-017 Mine Name: Coal Basin Mines Operator: Mid-Continent Resources Operator Address: Diane Delaney 818 Colorado Ave Glenwood Springs, CO 81607	County: Pitkin Operation Type: Underground Permit Status: Revoked Ownership: Federal
	Operator Representative Present: None
Operator Representative Signature: (Field Issuance Only)

Inspection Start Date: October 8, 2013 Inspection Start Time: 13:00 Inspection End Date: October 8, 2013 Inspection End Time: 16:00	Inspection Type: Coal Complete Inspection Inspection Reason: Normal I&E Program Weather: Clear
Joint Inspection Agency: None	Joint Inspection Contacts:
Post Inspection Agency: None	Post Inspection Contacts:
Inspector(s): Brock F. Bowles Sandra L. Brown	Inspector's Signature:

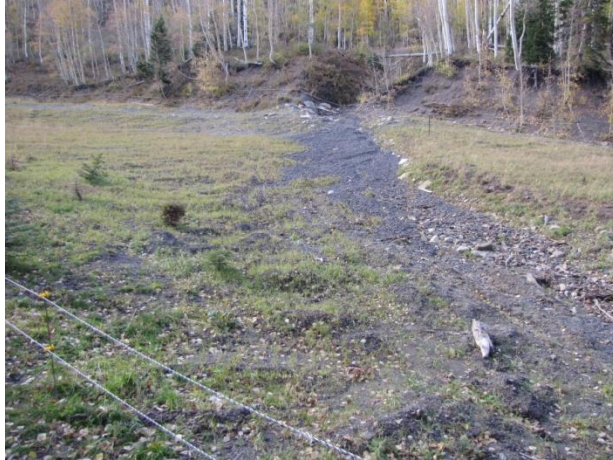
A large amount of sediment had accumulated in the channel that was installed by the Forest Service on Road B. The willows that were planted in the channel earlier in the season were gone (photo 1).

Photo 1 – Channel Across Road B

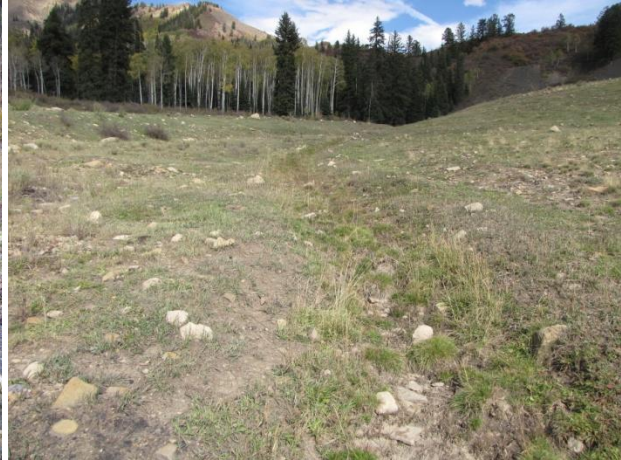
The channel on the east side of the Sutey Pile had some minor erosion but looked to be in good condition (photo 2).

Photo 2 – Channel on East Side of Sutey Pile

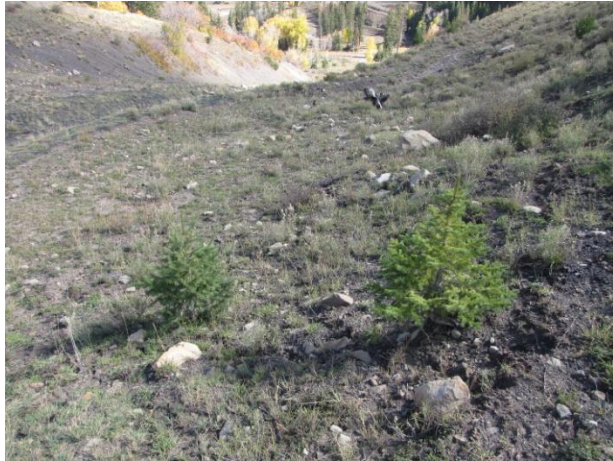
An electric fence enclosure on the Sutey Pile is being used for test plots by the Forest Service (photo 3). The vegetation on the east side of the Sutey pile has been heavily grazed. The vegetation on the west and south side of the pile had not been grazed as heavily and is in better condition. The planted spruce trees looked in good condition (photo 3). Cattle were grazing on the north side of the Sutey Pile (photo 4).

Photo 3 – Trees Growing on Sutey Pile

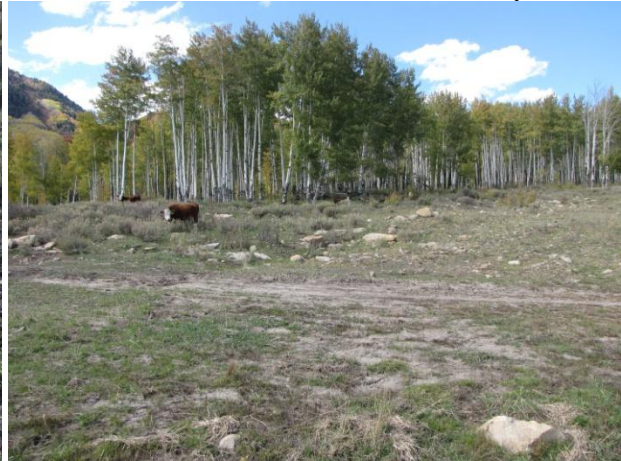
Photo 4 – Cattle Grazing on Sutey Pile
