COLORADO DIVISION OF RECLAMATION, MINING AND SAFETY COAL PROGRAM INSPECTION REPORT

Permit Number: C-1980-002 Mine Name: O.C. Mine No. 2 Operator: Robert Weaver Operator Address: Robert Weaver 2054 County Road 730 Gunnison, CO 81230	County: Gunnison Operation Type: Underground Permit Status: Revoked Ownership: Federal
	Operator Representative Present: None
Operator Representative Signature: (Field Issuance Only)

Inspection Start Date: October 10, 2013 Inspection Start Time: 12:00 Inspection End Date: October 10, 2013 Inspection End Time: 13:00	Inspection Type: Coal Complete Inspection Inspection Reason: Normal I&E Program Weather: Cloudy
Joint Inspection Agency: None	Joint Inspection Contacts:
Post Inspection Agency: None	Post Inspection Contacts:
Inspector(s): Brock F. Bowles Sandra L. Brown	Inspector's Signature:

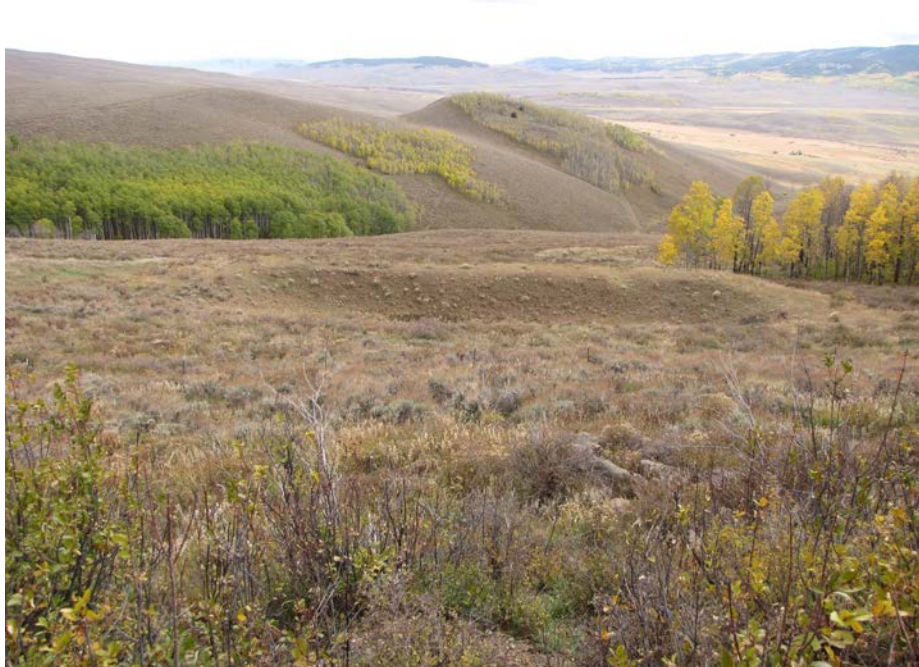
Photo 1 – Sediment Pond

The pond was dry and the banks appeared to be stable and well vegetated (photo 1). No rills or gullies were noted on the minesite.

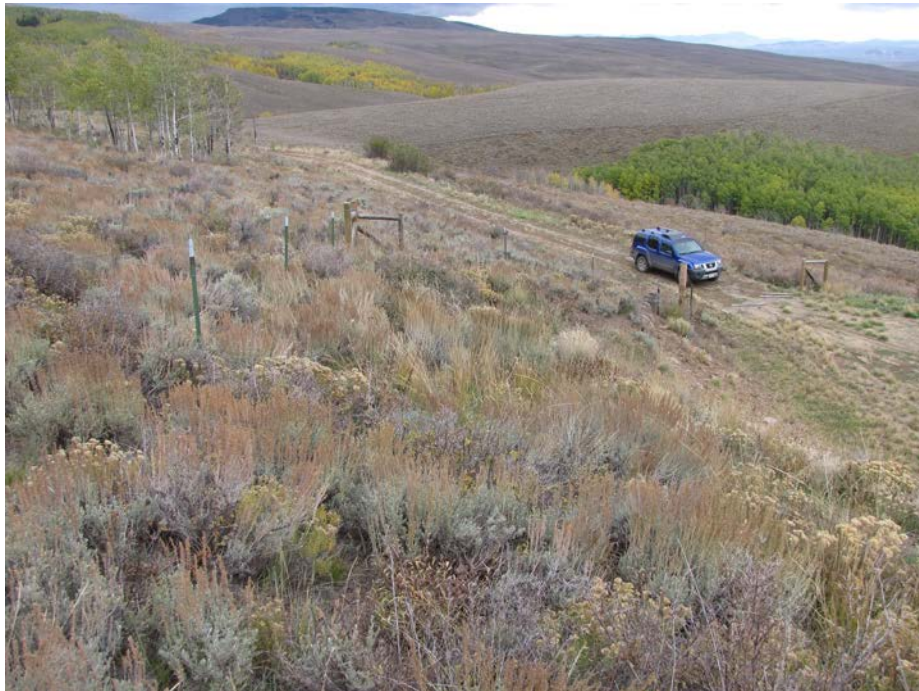
Photo 2 – Fence Around Minesite Perimeter

The fence around the minesite was in very good condition (photo 2). All gates were closed and corner post appeared to be stable. The vegetation appeared to be good and no noxious weeds were noted.
