## COLORADO DIVISION OF RECLAMATION, MINING AND SAFETY COAL PROGRAM INSPECTION REPORT

<b>Permit Number:</b> C-1981-038 <b>Mine Name:</b> Bowie No. 1 Mine <b>Operator:</b> Bowie Resources, LLC <b>Operator Address:</b> Mr Basil Bear P.O. Box 1488 Paonia, CO 81428	<b>County:</b> Delta <b>Operation Type:</b> Underground <b>Permit Status:</b> Active <b>Ownership:</b> Federal
	<b>Operator Representative Present:</b>  None Present - Aerial Inspection
<b>Operator Representative Signature: (Field Issuance Only)</b>

<b>Inspection Start Date:</b> September 25, 2013 <b>Inspection Start Time:</b> 11:31 <b>Inspection End Date:</b> September 25, 2013 <b>Inspection End Time:</b> 11:32	<b>Inspection Type:</b> Aerial Inspection <b>Inspection Reason:</b> Normal I&E Program <b>Weather:</b> Clear
<b>Joint Inspection Agency:</b>  None	<b>Joint Inspection Contacts:</b>  
<b>Post Inspection Agency:</b>  None	<b>Post Inspection Contacts:</b>  
<b>Inspector(s):</b>  Susan L. Burgmaier  Harry B. Ranney	<b>Inspector's Signature:</b>  <i>Susan Burgmaier</i>  <b>Signature Date:</b>  09/26/2013

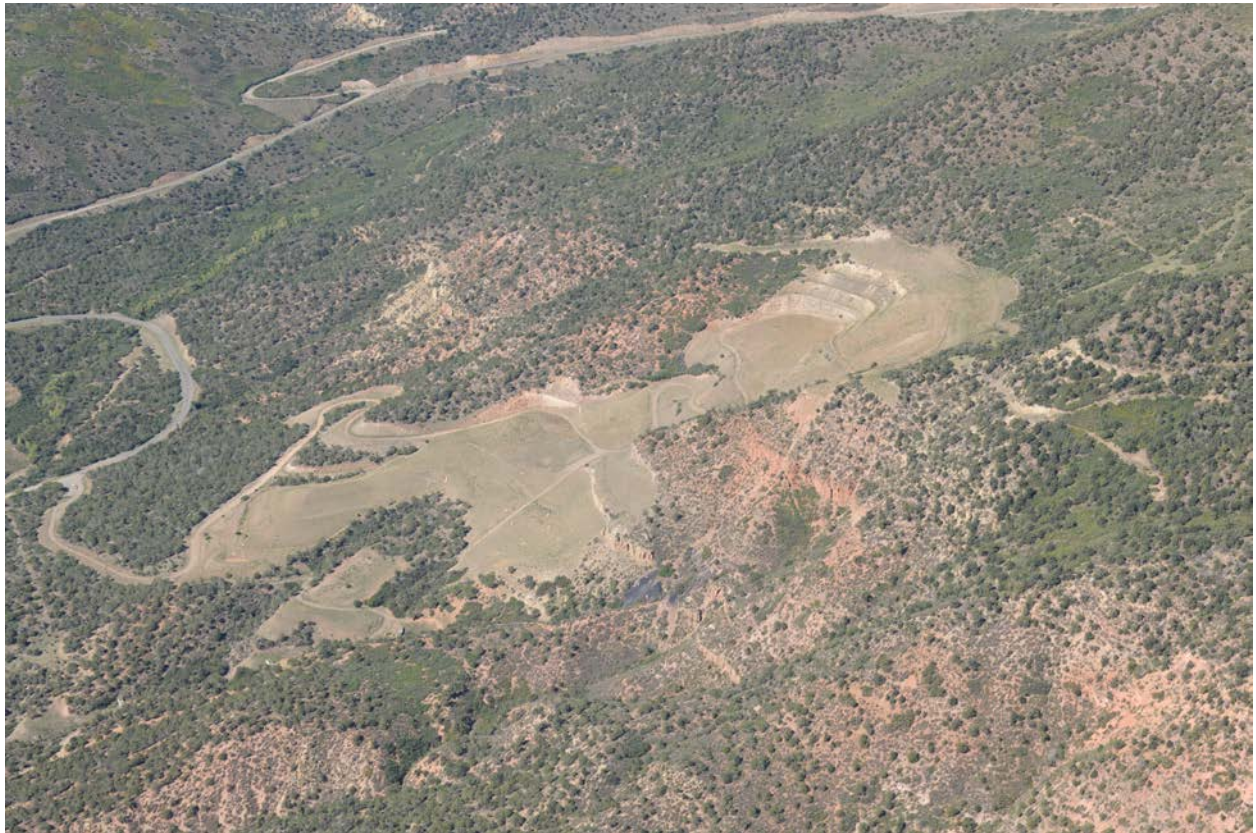
East Mine area

Backfilled and regraded slopes at the East Mine, West Mine, and ROM area all appeared to be stable with no evidence of excessive erosion, cracking, or bulging.

East Mine: The West Ridge pond held water but did not appear to be discharging. The inlet to the pond looked like it had been downcut. Pond 1 appeared to be dry; Pond 2 was holding water but did not appear to be discharging. The ROM area pond appeared to be dry.

Both refuse disposal areas at the East Mine appeared to be stable and well vegetated.
