COLORADO DIVISION OF RECLAMATION, MINING AND SAFETY
MINERALS PROGRAM INSPECTION REPORT
PHONE: (303) 866-3567

MINE NAME: Sunnyside Gold Mine	MINE/PROSPECTING ID#: M-1977-378	MINERAL: Lead, zinc, copper, iron	COUNTY: San Juan
INSPECTION TYPE: Monitoring	INSPECTOR(S): Wallace H. Erickson	INSP. DATE: September 19, 2013	INSP. TIME: 14:00
OPERATOR: Sunnyside Gold Corp	OPERATOR REPRESENTATIVE: Larry Perino	TYPE OF OPERATION: 112 - Hard Rock Regular Operation

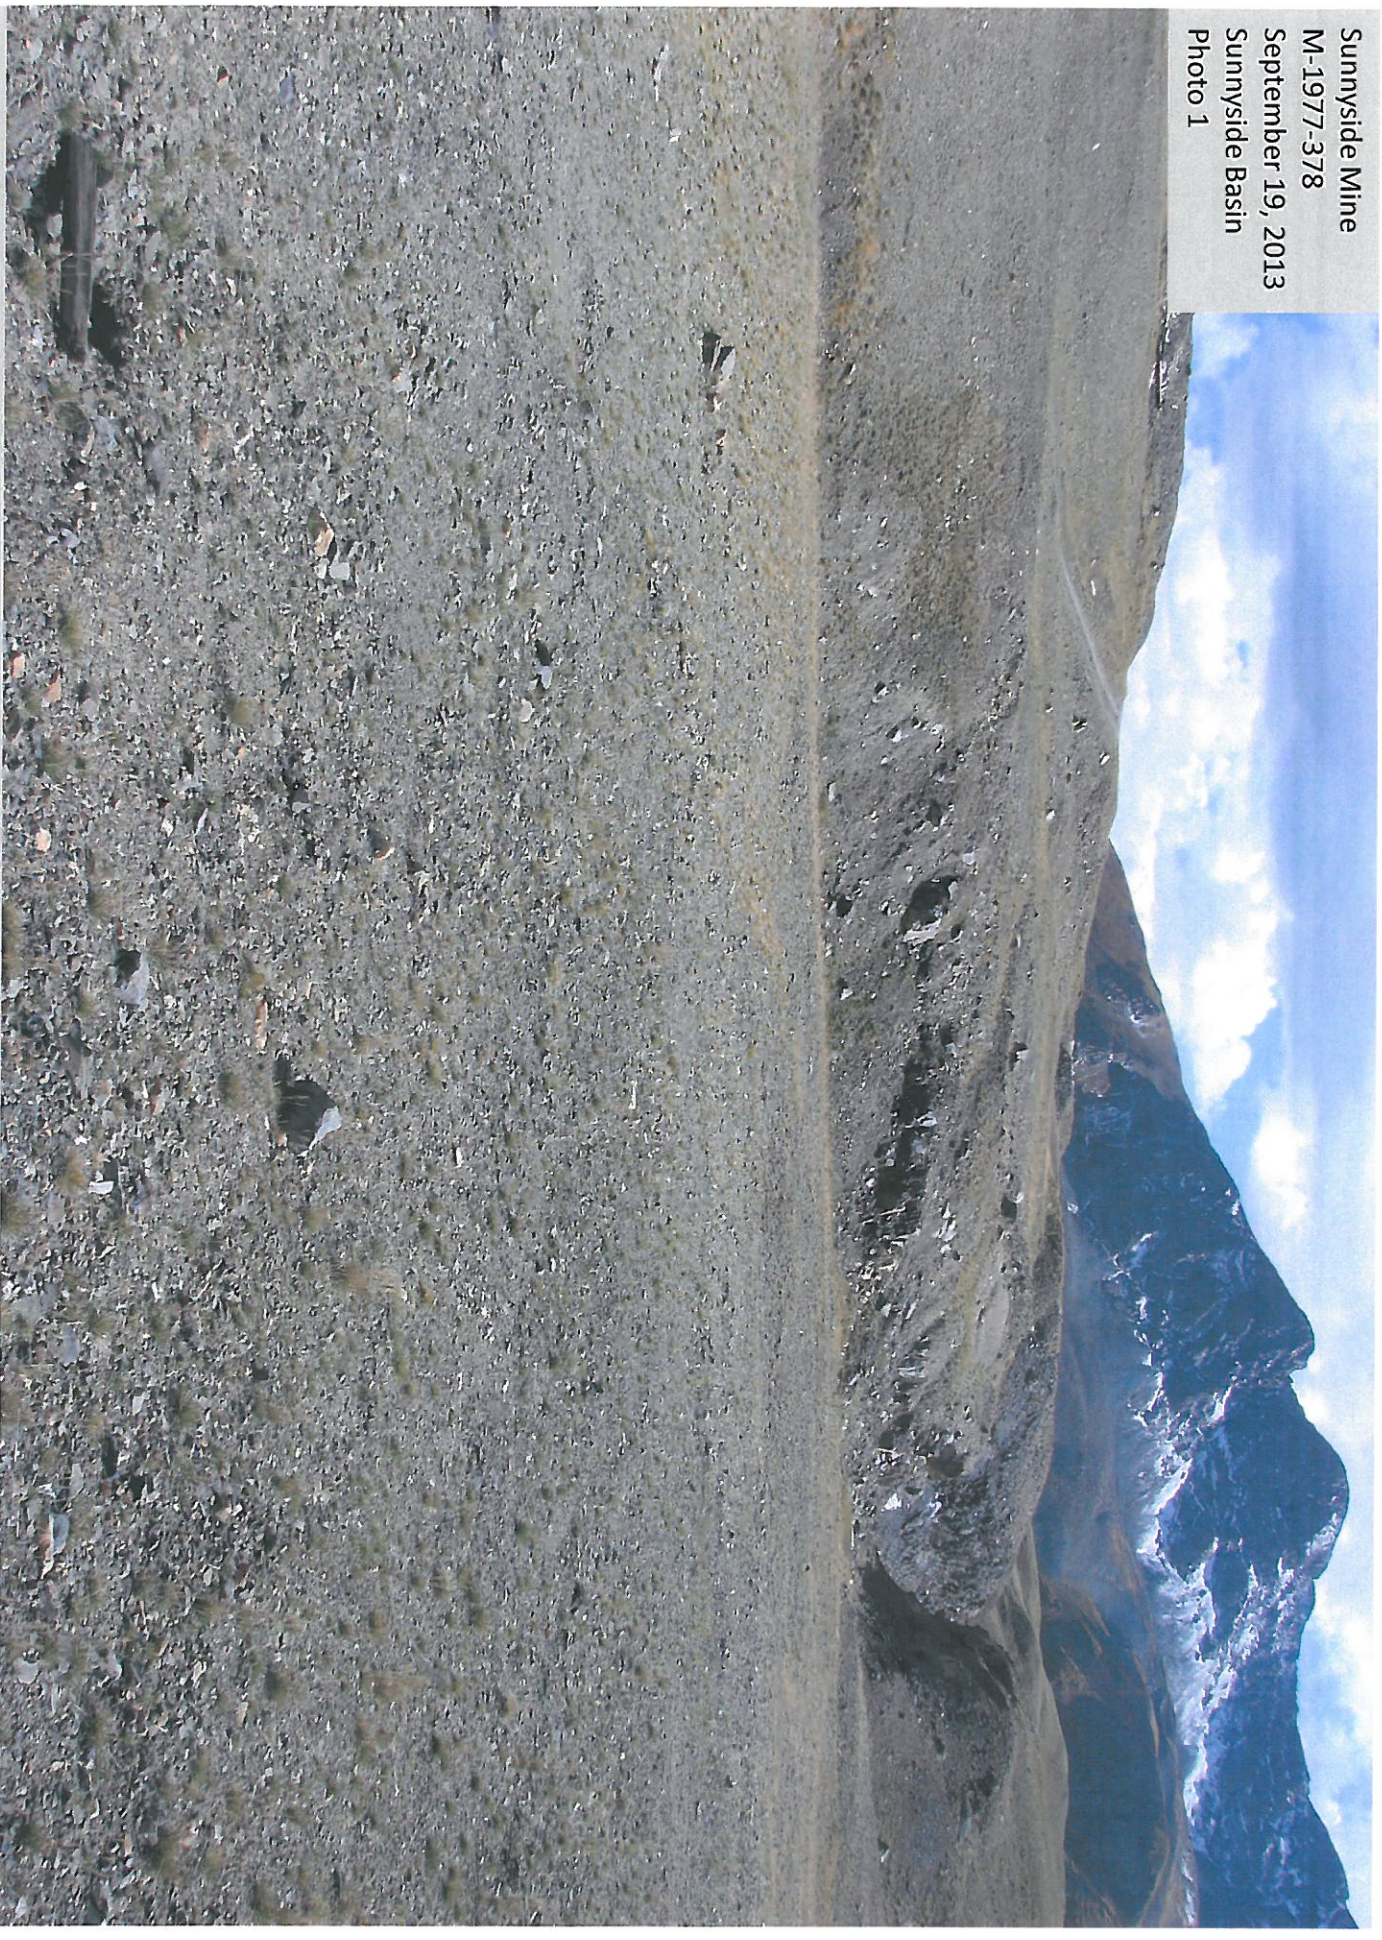
Sunnyside Mine
M-1977-378
September 19, 2013
Sunnyside Basin
Photo 1

View north, showing portions of the Lake Emma reclaimed lands located within Sunnyside Basin at 12,280 feet elevation.

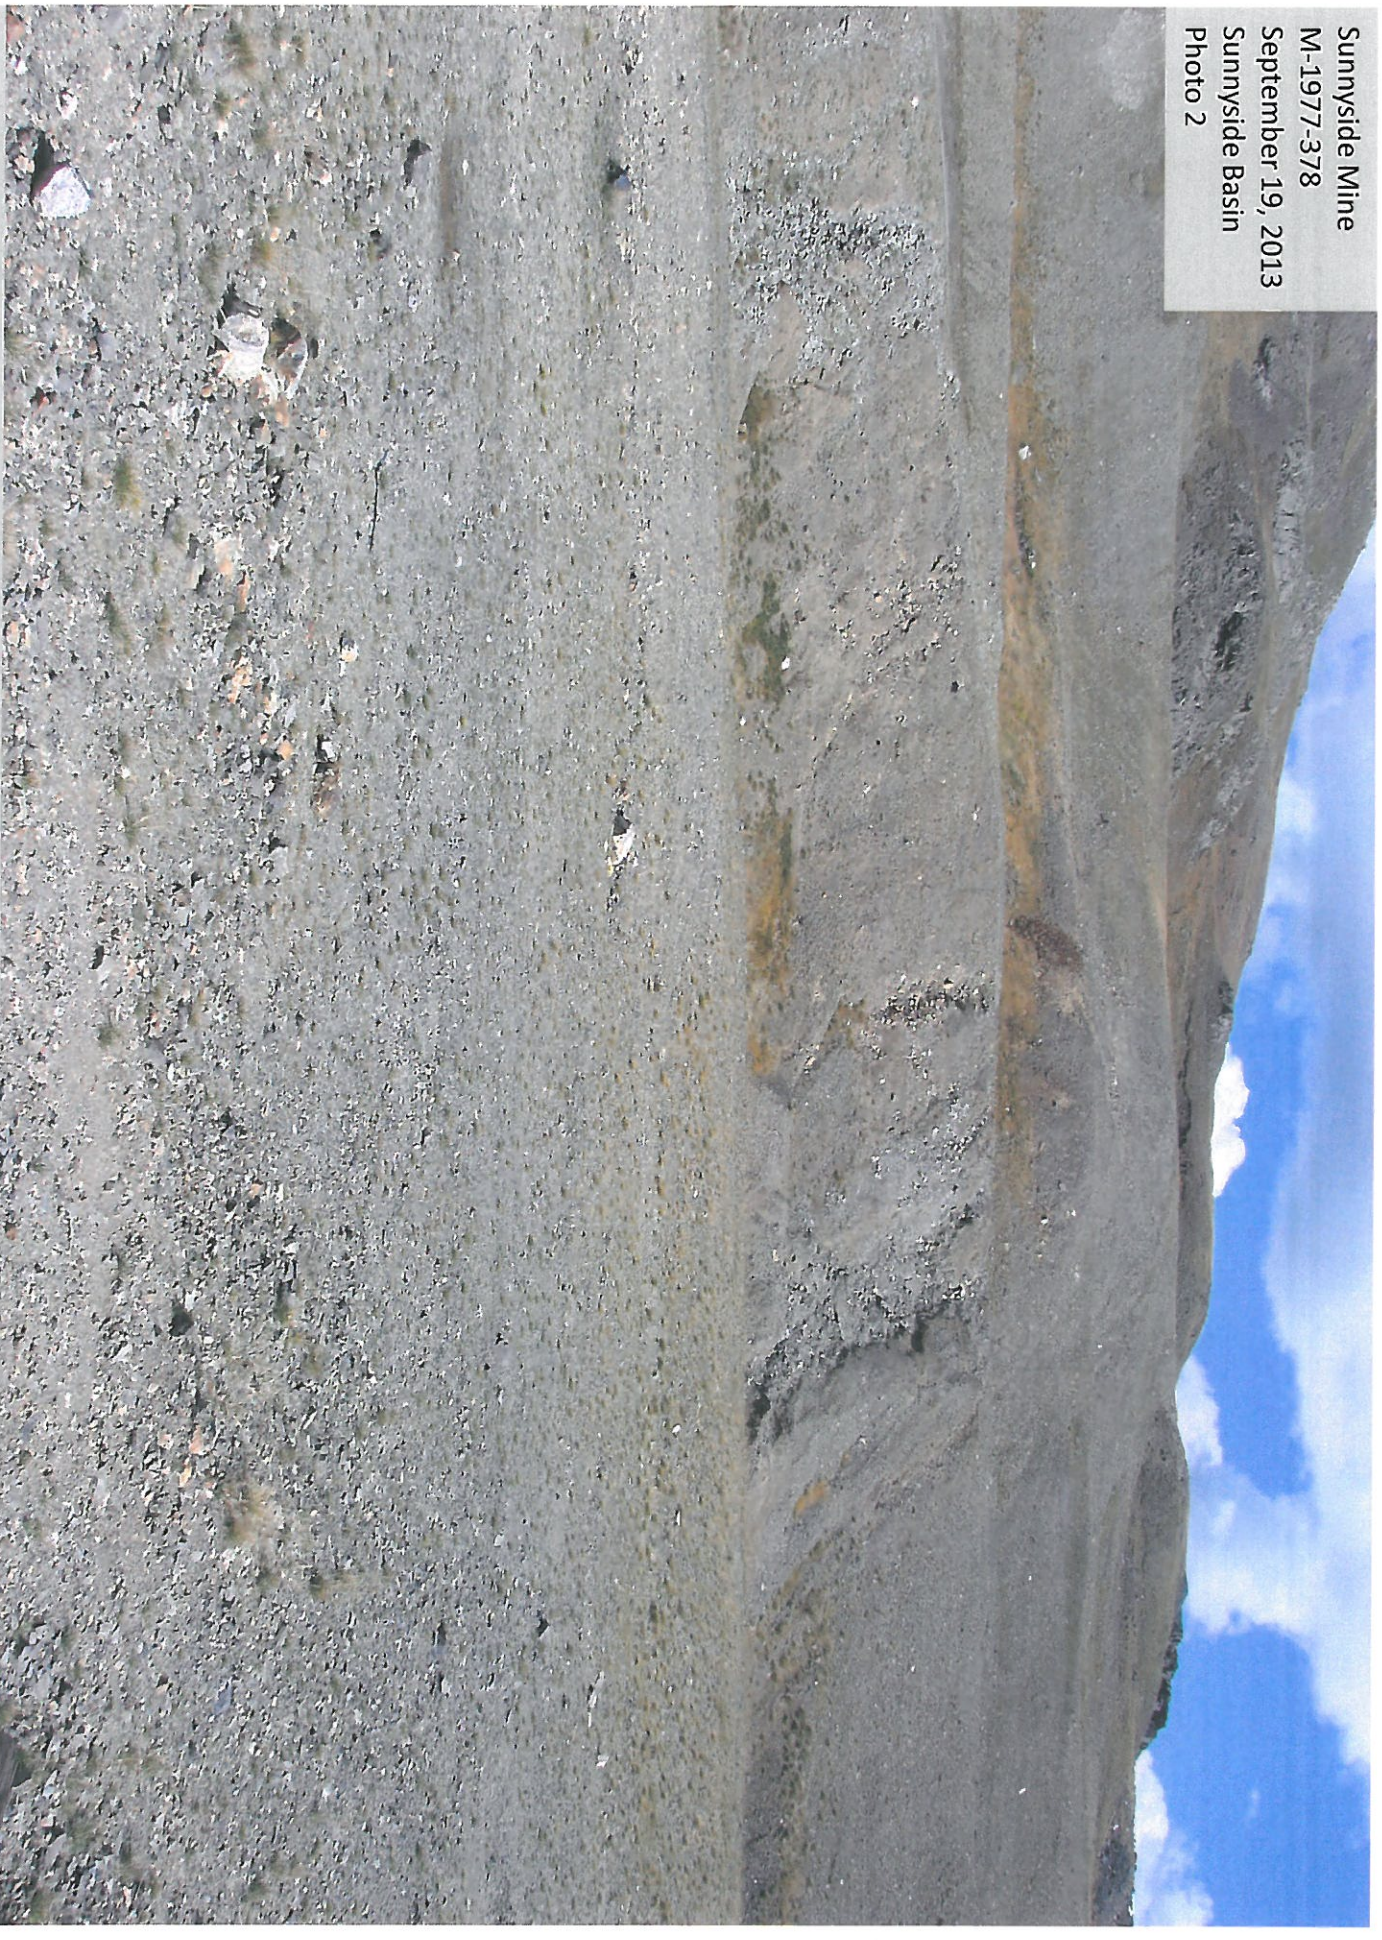
Sunnyside Mine
M-1977-378
September 19, 2013
Sunnyside Basin
Photo 2

View west, showing portions of the Lake Emma reclaimed lands located within Sunnyside Basin at 12,280 feet elevation.

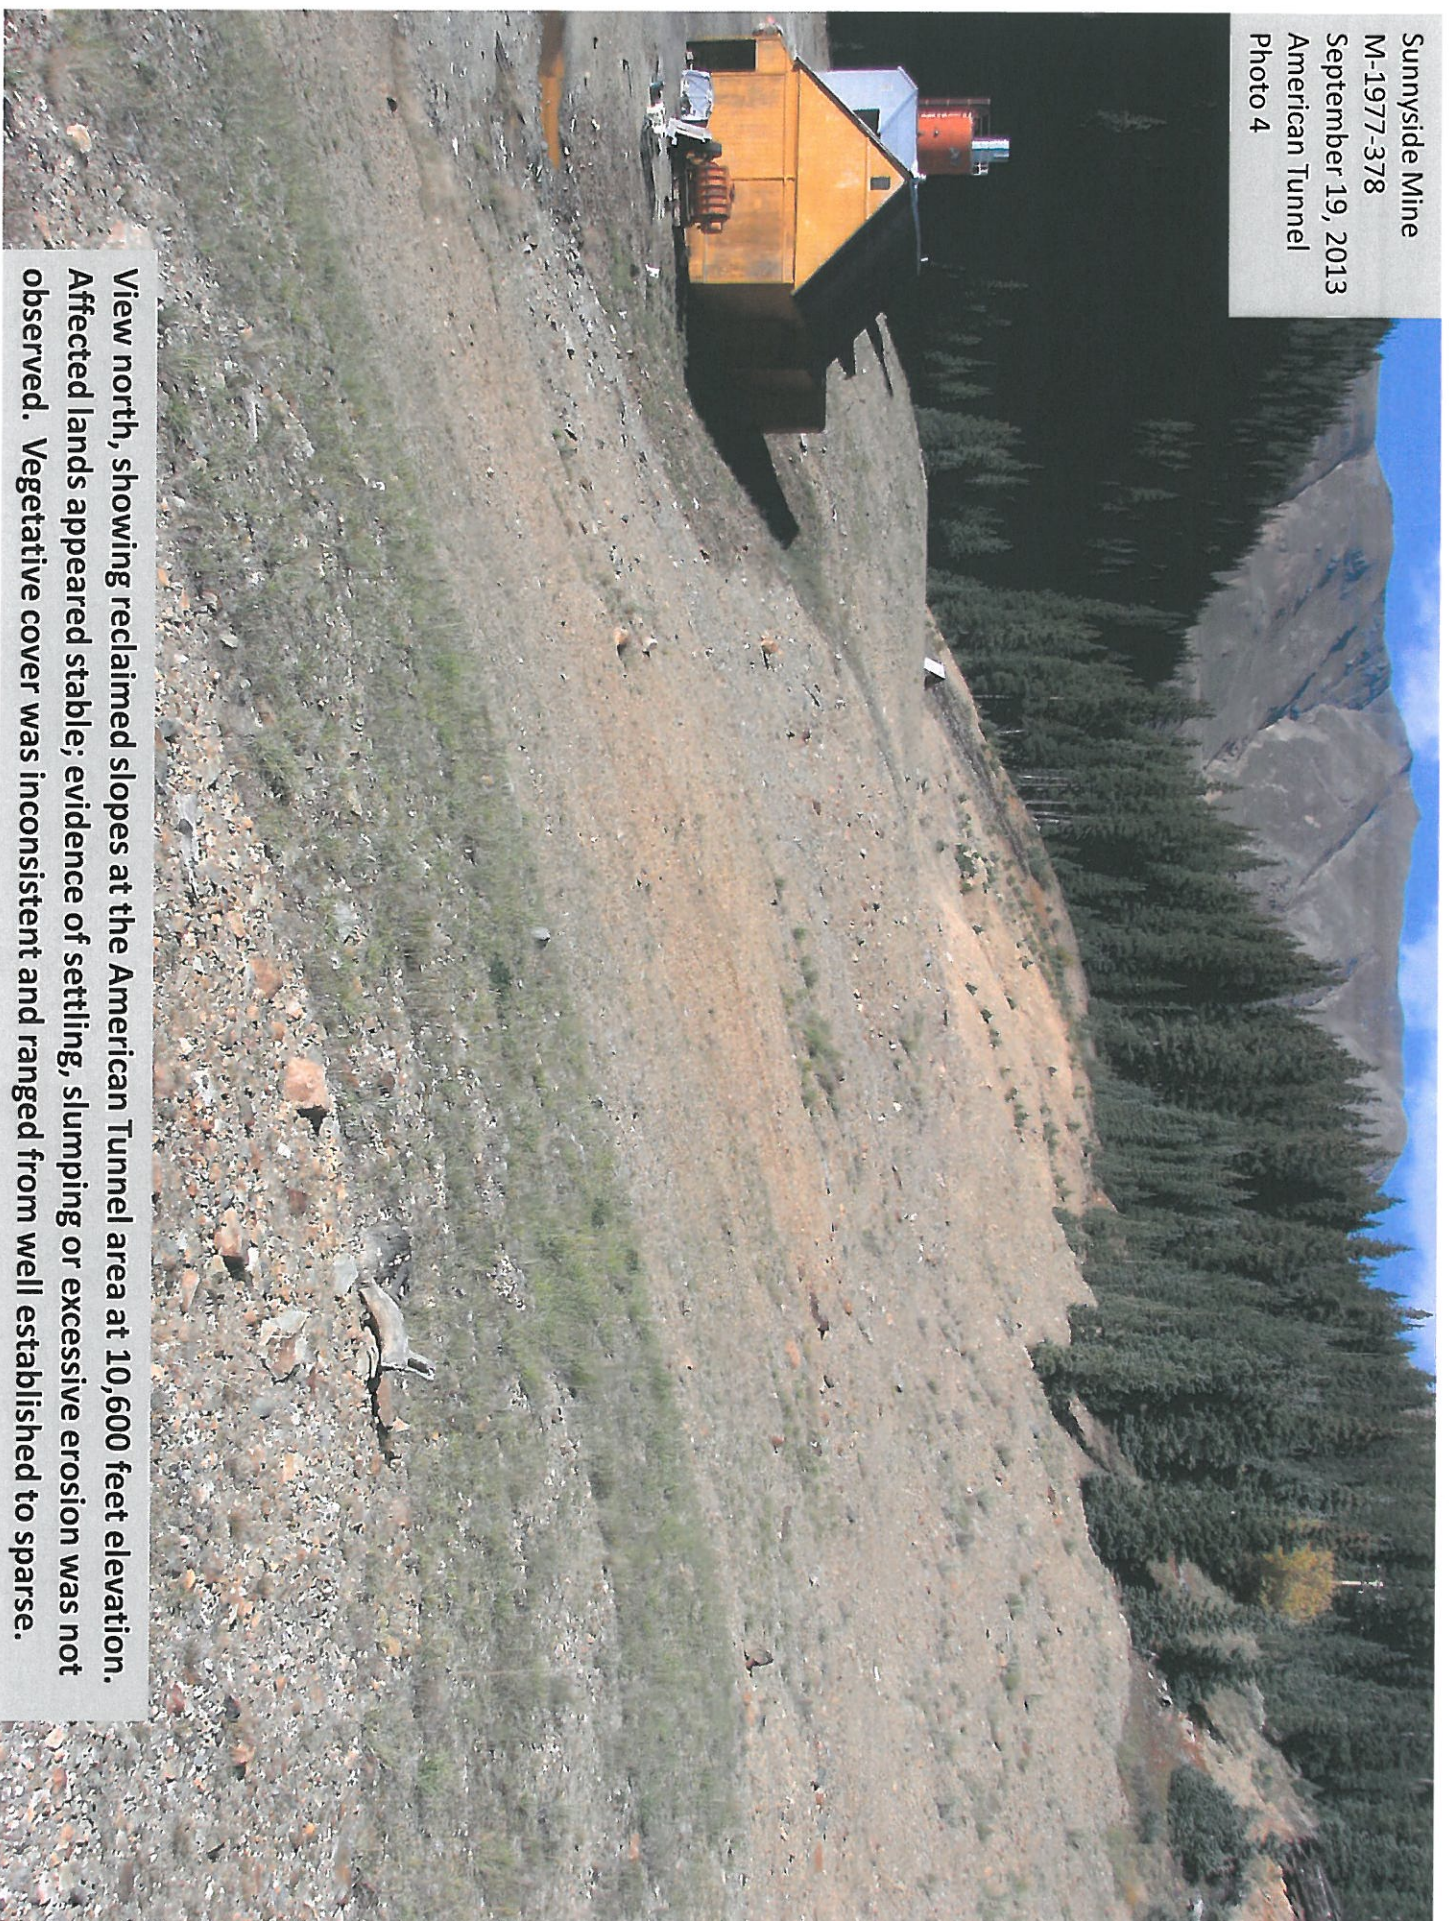
Sunnyside Mine
M-1977-378
September 19, 2013
American Tunnel
Photo 4

View north, showing reclaimed slopes at the American Tunnel area at 10,600 feet elevation. Affected lands appeared stable; evidence of settling, slumping or excessive erosion was not observed. Vegetative cover was inconsistent and ranged from well established to sparse.

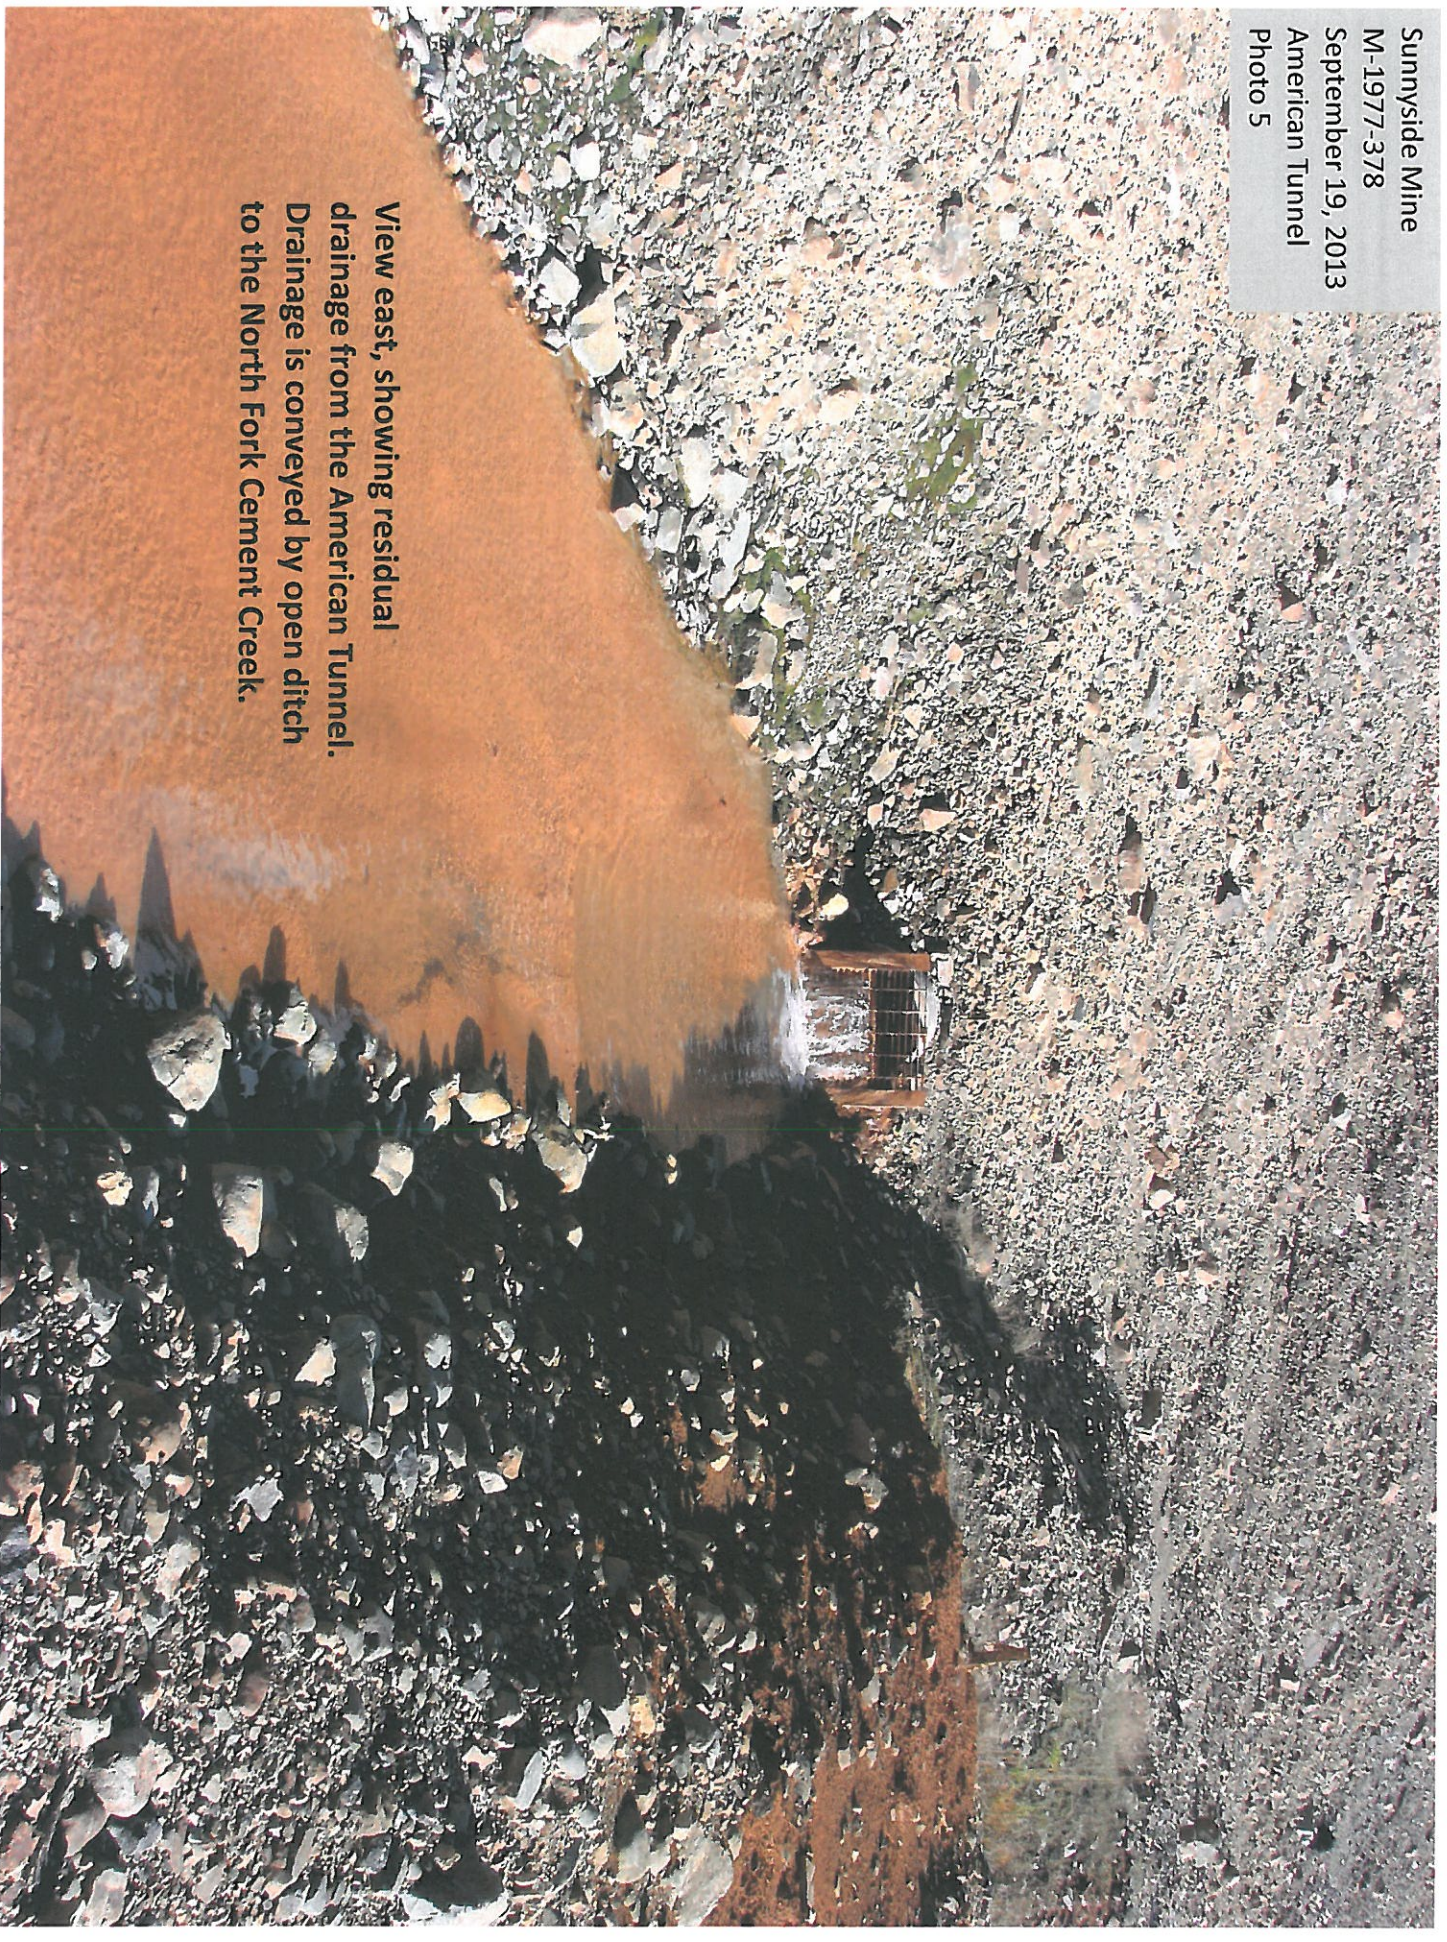
Sunnyside Mine
M-1977-378
September 19, 2013
American Tunnel
Photo 5

View east, showing residual
drainage from the American Tunnel.
Drainage is conveyed by open ditch
to the North Fork Cement Creek.

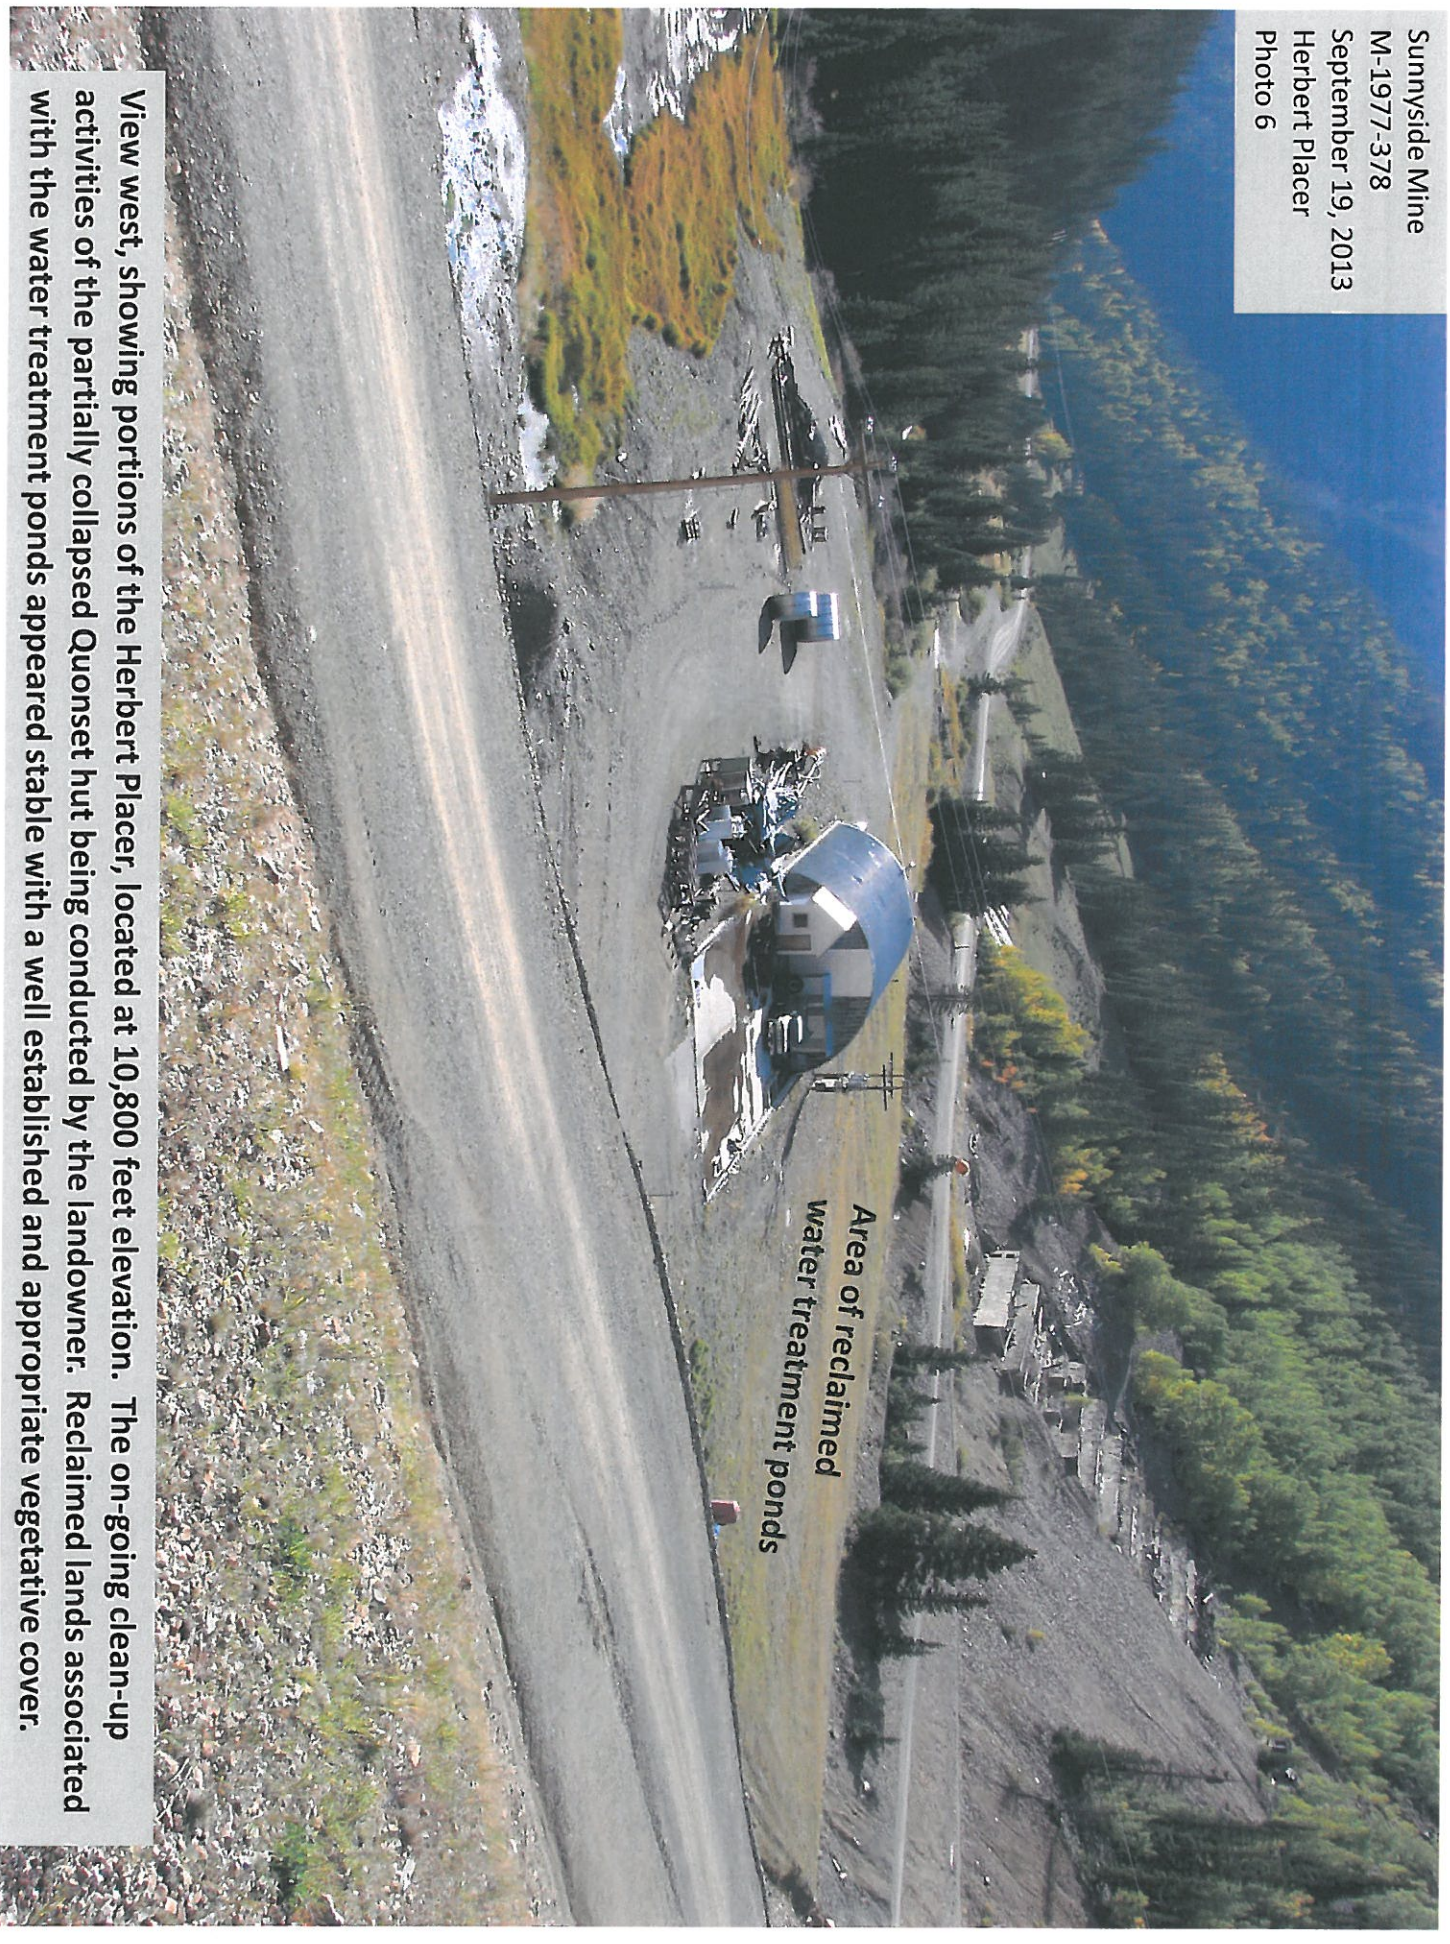
Sunnyside Mine
M-1977-378
September 19, 2013
Herbert Placer
Photo 6

The water treatment ponds, located on portions of the Herbert Placer, were reclaimed 2005-2006. As shown in photo 6, reclaimed lands appeared stable; evidence of settling, slumping or excessive erosion was not observed. Vegetative cover for the Herbert Placer was well established, diverse, and at least equal in extent of cover to the surrounding natural vegetation. Clean-up of the partially collapsed Quonset hut has not yet been completed. Prior to the partial collapse of the Quonset hut, ownership of the Herbert Placer and the Quonset hut was transferred to Todd Hennis, d.b.a. San Juan Corporation. The landowner is responsible for maintenance of the structure and is conducting the clean-up activity.

View west, showing portions of the Herbert Placer, located at 10,800 feet elevation. The on-going clean-up activities of the partially collapsed Quonset hut being conducted by the landowner. Reclaimed lands associated with the water treatment ponds appeared stable with a well established and appropriate vegetative cover.

Observations made during the inspection and recorded in this report indicate the Operator has completed reclamation for the Mayflower Tailings Pond 4 and Herbert Placer areas. The Operator is encouraged to submit an acreage reduction request, in accordance with the requirements of Rule 4.17, removing the Mayflower Tailings Pond 4 and Herbert Placer areas from the permit area for successful completion of reclamation of those lands.

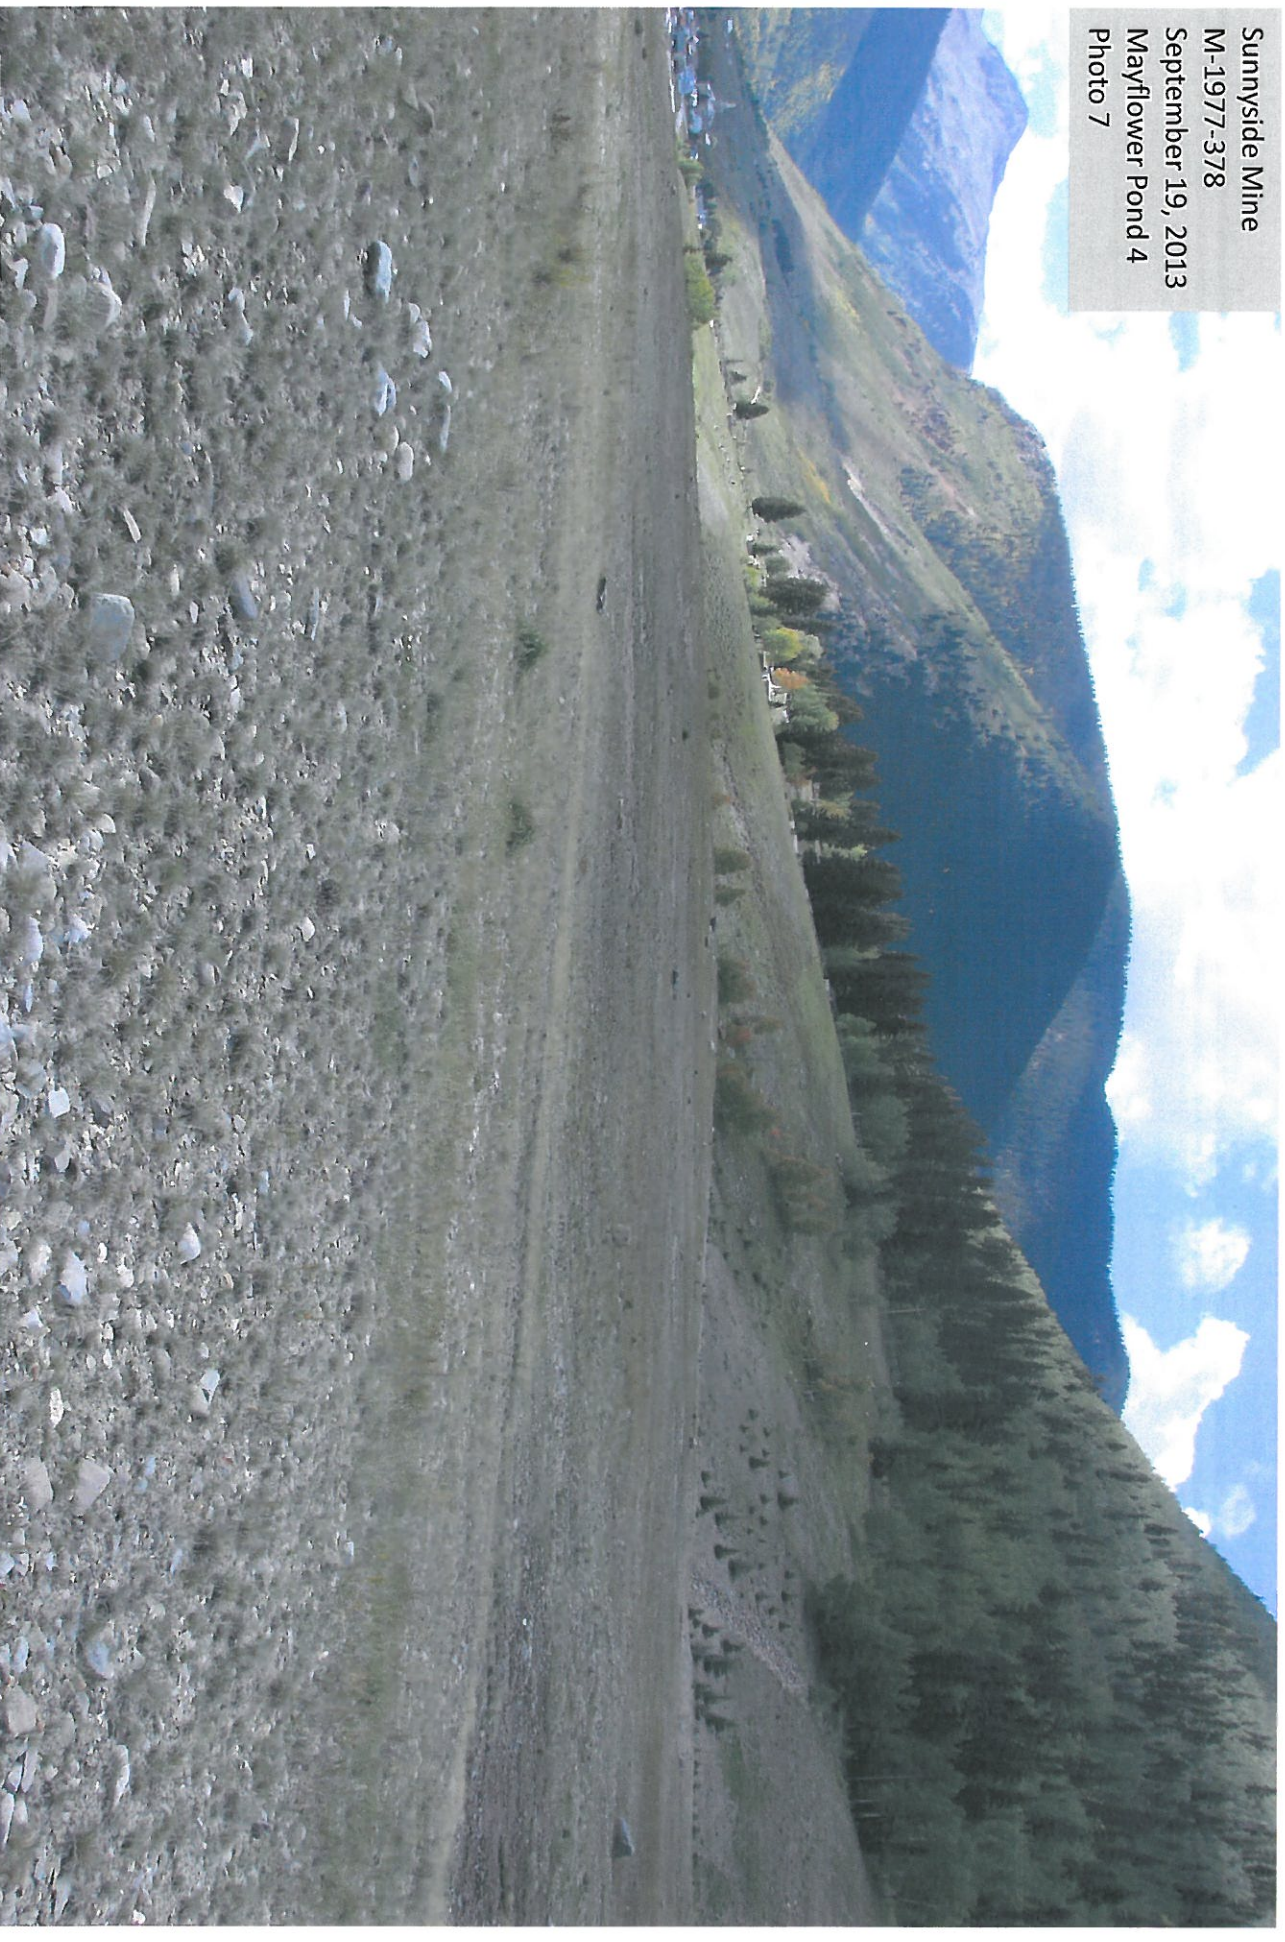
Sunnyside Mine
M-1977-378
September 19, 2013
Mayflower Pond 4
Photo 7

View west, showing portions of the reclaimed top of Mayflower Tailings Pond 4, located at 9,600 feet elevation. Reclaimed lands appeared stable; evidence of settling, slumping or excessive erosion was not observed. Vegetative cover was well established and at least equal in extent of cover to the surrounding natural vegetation.

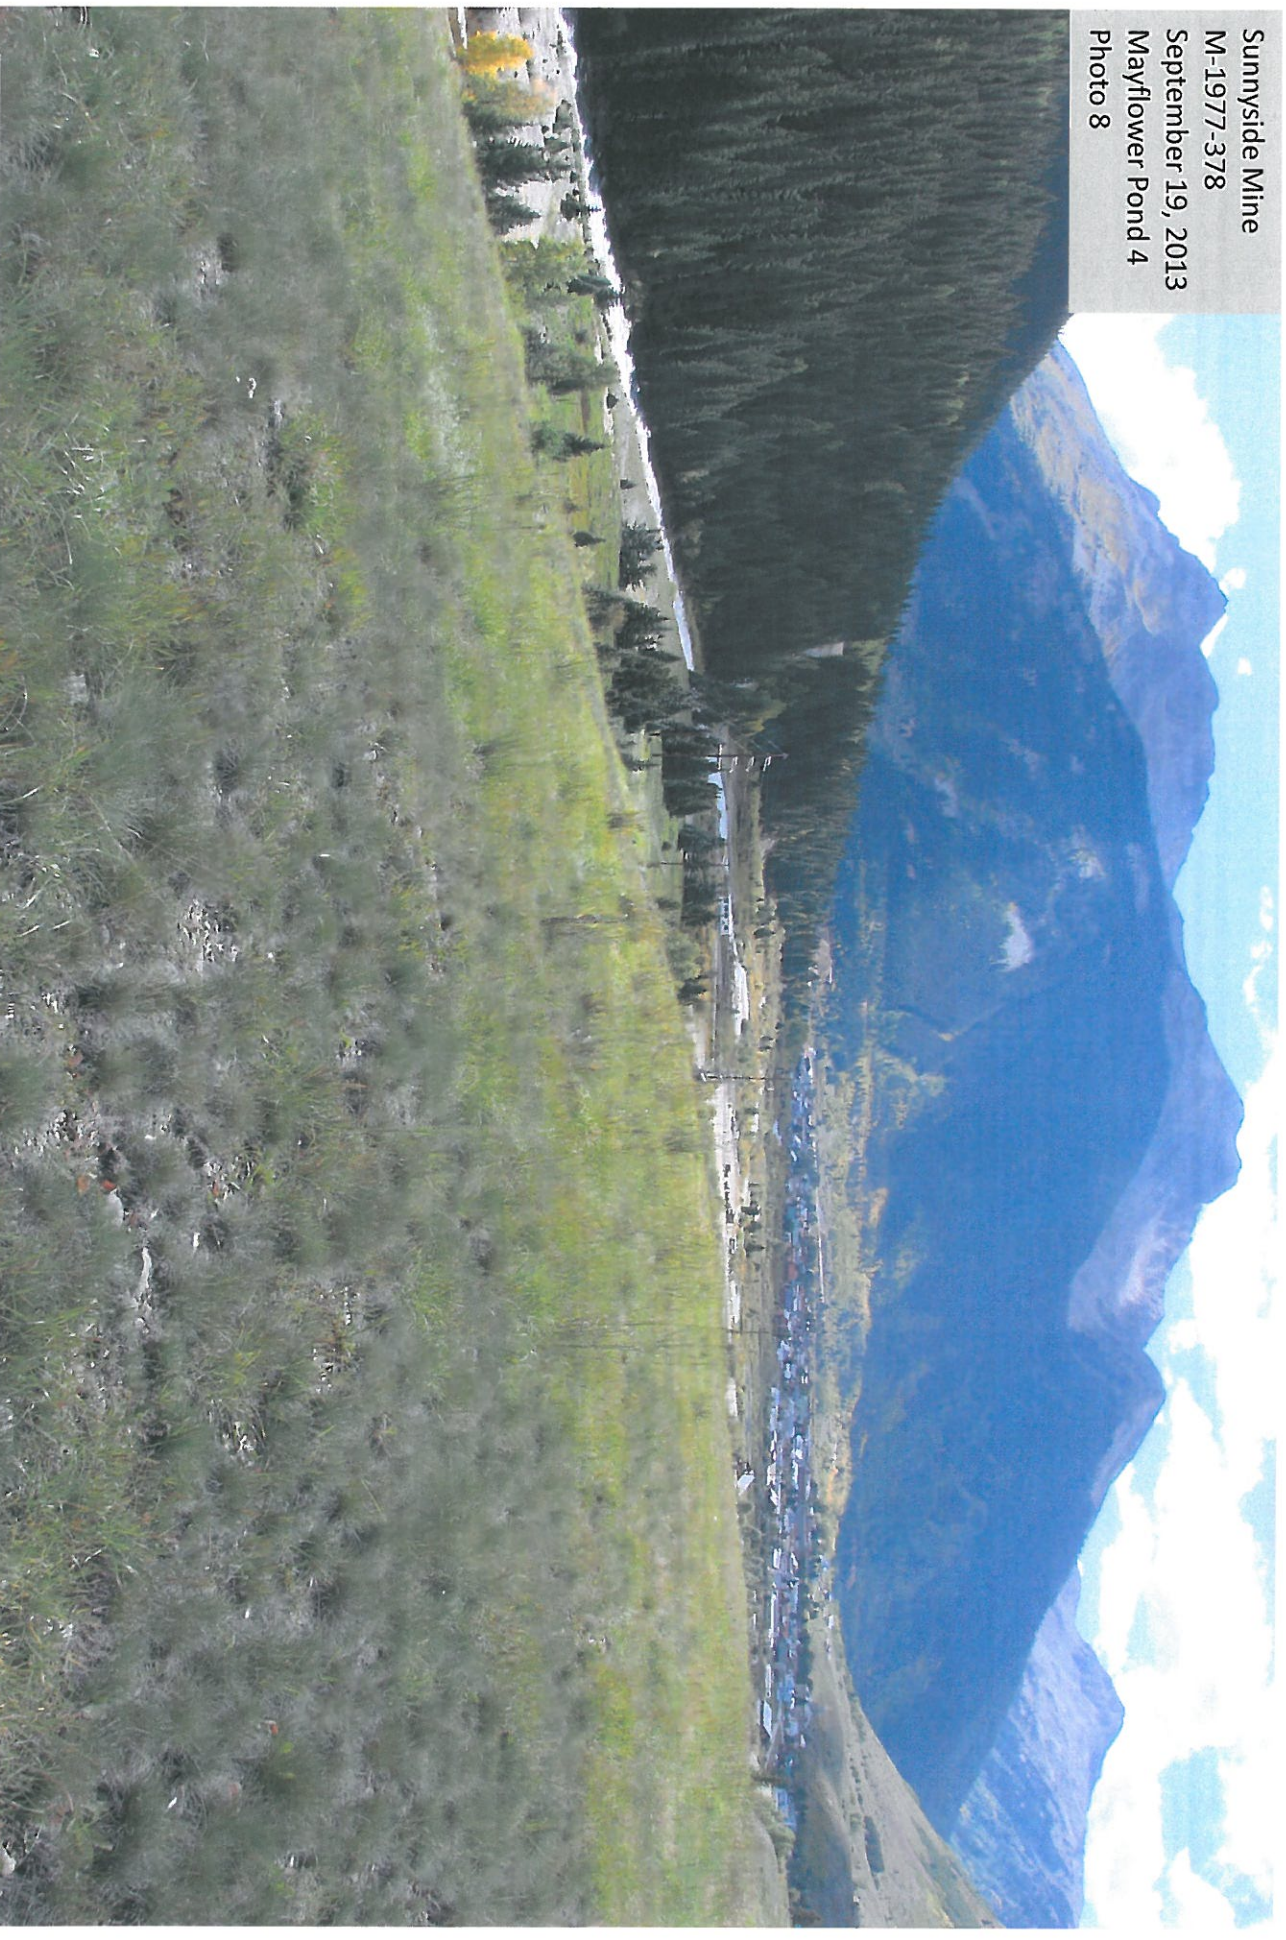
Sunnyside Mine
M-1977-378
September 19, 2013
Mayflower Pond 4
Photo 8

View west, showing portions of the reclaimed slopes of Mayflower Tailings Pond 4, located at 9,600 feet elevation. Reclaimed lands appeared stable; evidence of settling, slumping or excessive erosion was not observed. Vegetative cover was well established and at least equal in extent of cover to the surrounding natural vegetation.
