**COLORADO DIVISION OF RECLAMATION, MINING AND SAFETY**  
**MINERALS PROGRAM INSPECTION REPORT**  
**PHONE: (303) 866-3567**

<b>MINE NAME:</b> Bulldog Mine Operation	<b>MINE/PROSPECTING ID#:</b> M-1977-215	<b>MINERAL:</b> Lead and silver	<b>COUNTY:</b> Mineral
<b>INSPECTION TYPE:</b> Monitoring	<b>INSPECTOR(S):</b> Bob Oswald	<b>INSP. DATE:</b> September 4, 2013	<b>INSP. TIME:</b> 10:10
<b>OPERATOR:</b> Rio Grande Silver, Inc.	<b>OPERATOR REPRESENTATIVE:</b> Drew Marino, Tom Day	<b>TYPE OF OPERATION:</b> 112 - Hard Rock Regular Operation

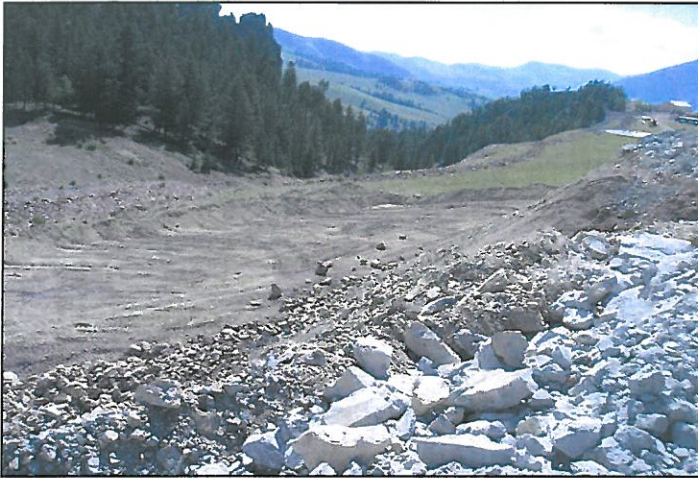
Expansion area below 9400 waste rock dump

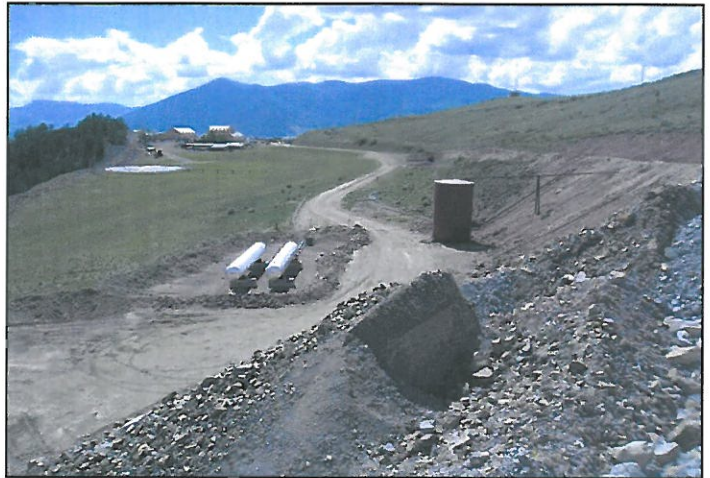
Below 9400 waste rock dump

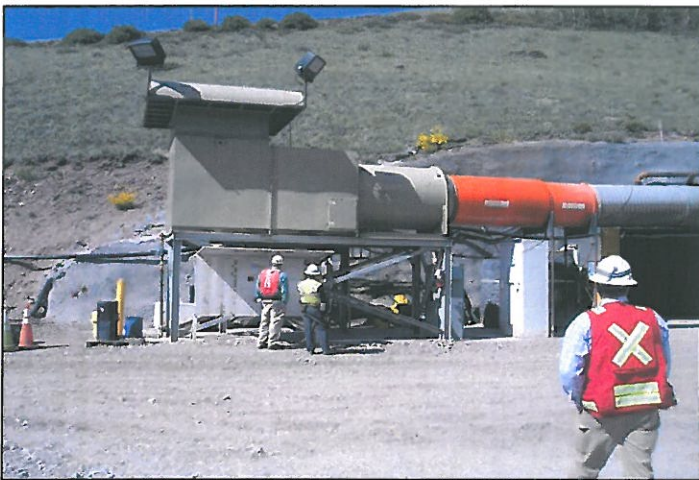
9400 Portal Area and Decline. The portal area includes a concrete face-up and wide bench area where the necessary electrical and ventilation equipment to support underground operations are located. Electric supply includes both overhead lines and onsite generators. The bench top is bermed for safety. The size of the bench area expands as waste rock from driving the 9400 decline proceeds. The decline has intercepted the old Bulldog workings of the 9360 level. The area below the 9400 waste rock dump has been stripped of topsoil in preparation for dump expansion, and topsoil is protected. All equipment and structures conform to the approved plan. A ventilation fan has been installed in the culvert entry at the 9700 portal, as approved.

Ventilation equipment at 9400 portal

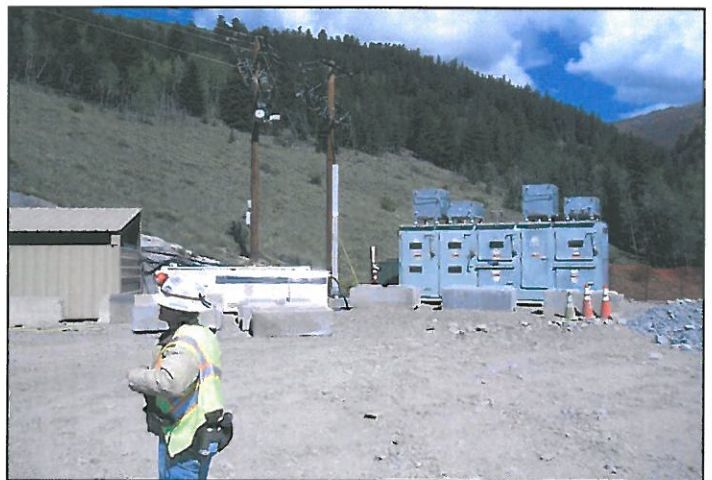
Electrical supply at 9400 portal

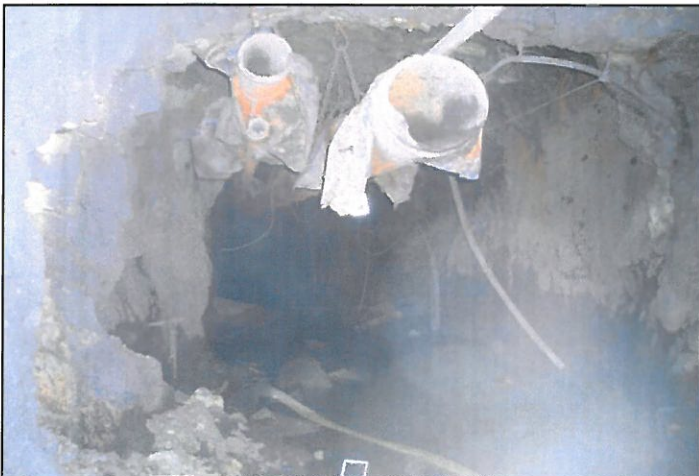
Vent duct and mine pool in old Bulldog 9360 workings

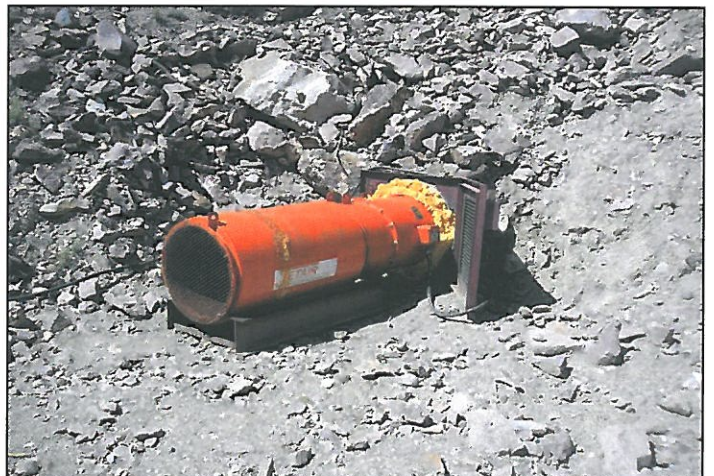
Vent fan installed in culvert at 9700 portal

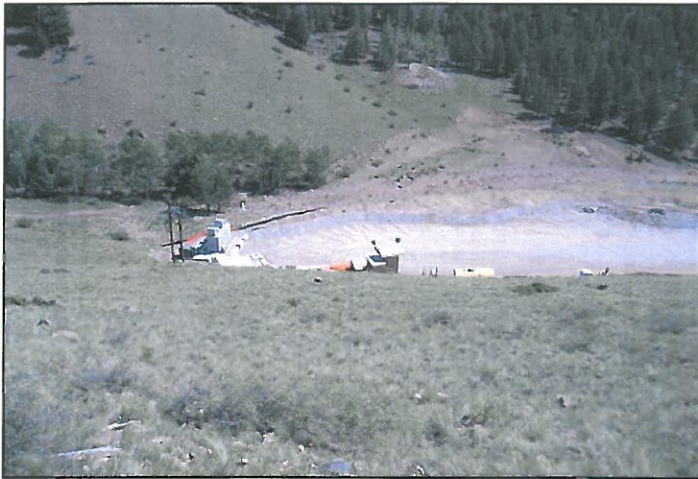
Looking down on 9400 level bench, northwest end

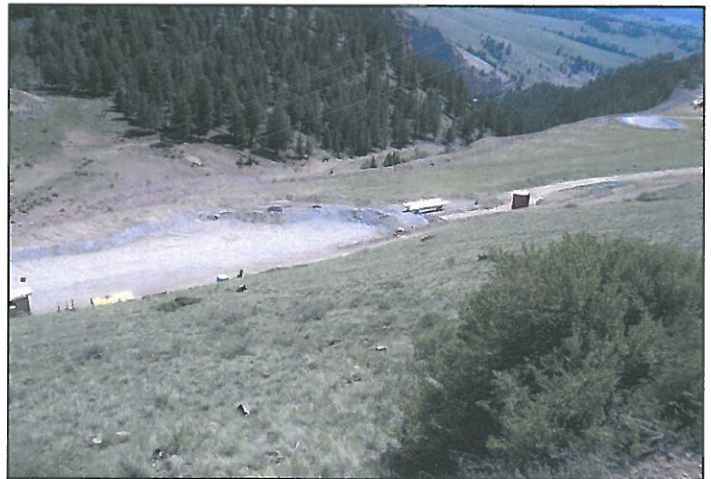
9400 level bench, southeast end

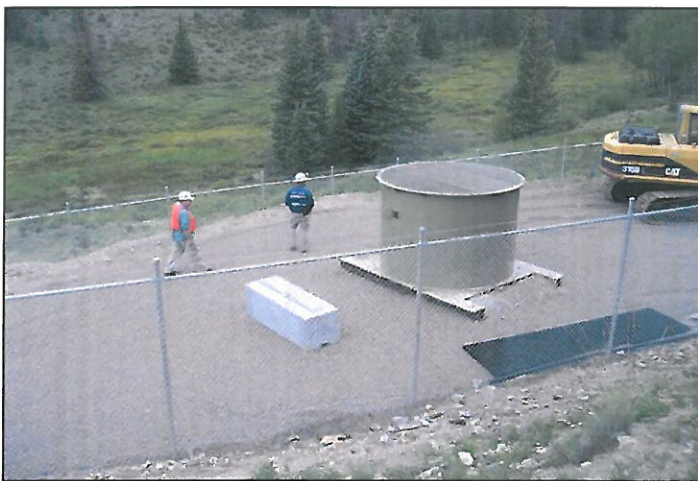
Area E Vent Raise. The operator uncovered the buried vent raise earlier in 2013 and found it to be intact and capped. A new extended safety collar has been installed on the top of the shaft. The entire footprint, except for the access road spur, are fenced and secured against unauthorized entry. Topsoil was stripped and stockpiled for later reclamation. The cut and fill slopes of the pad are a bit steeper than 2:1, but so dot exhibit erosion yet. The toe of the fill slope has a straw wattle installed to catch sediment. The operator has seeded these new slopes, and some vegetation has emerged. These slopes should be monitored for erosion and weeds, and remedial treatments should be used as needed.

New collar safeguard at Area E Vent Raise

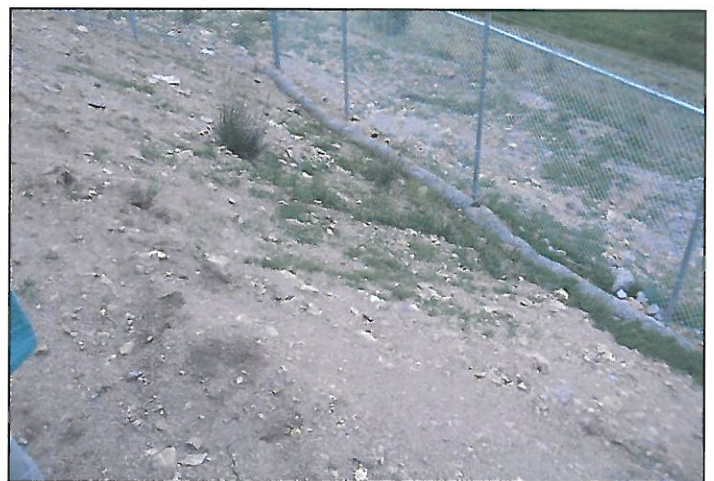
Seeded outslope at Area E

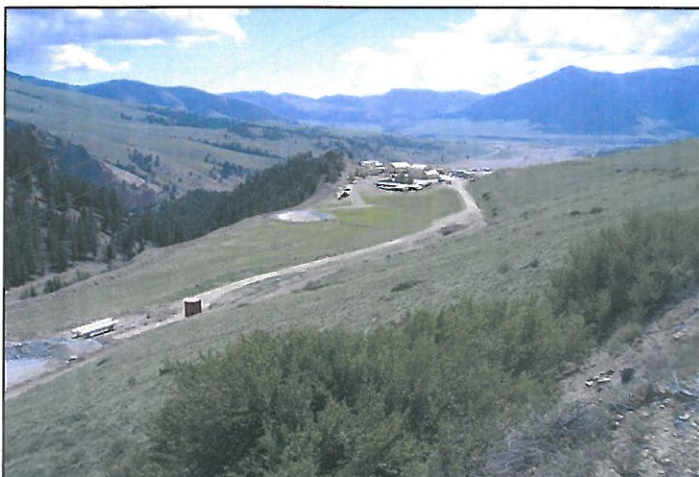
9360 Level Facilities Area. The main offices, new core building, shotcrete building, shop building, and materials and fuel storage areas were briefly inspected. All structures are as approved in the mining plan and are in compliance with the permit.

Looking SE at Bulldog 9360 facilities area

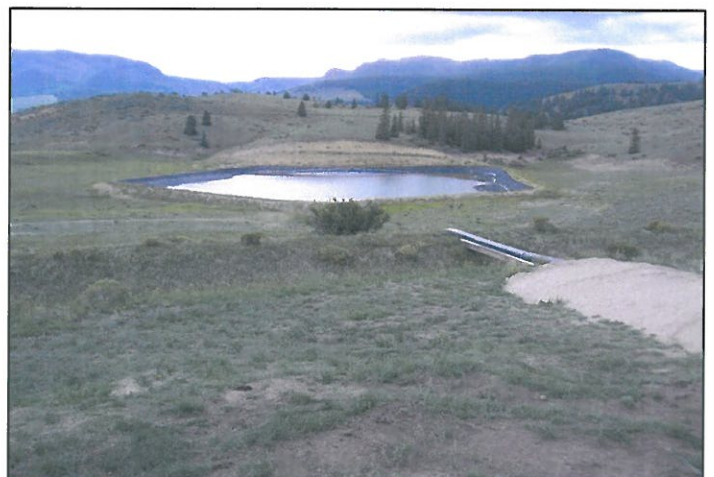
The operator has installed the necessary lines, pumps and instruments to facilitate the pumping and measurement of mine pool water. To-date nearly 2 million gallons have been pumped to the surface, where it is then trucked to the lined pond at TP2, as approved. There is no release, loss or discharge of water; all water in the pond evaporates. Existing vegetation around TP2 is well established and weed-free.

Lined pond and water delivery pipe at TP2 (Area D)
