COLORADO DIVISION OF RECLAMATION, MINING AND SAFETY
MINERALS PROGRAM INSPECTION REPORT
PHONE: (303) 866-3567

MINE NAME: Equity Exploration Project	MINE/PROSPECTING ID#: P-2011-010	MINERAL: Silver, gold, lead and	COUNTY: Mineral
INSPECTION TYPE: Mineral Prospect Inspection	INSPECTOR(S): Bob Oswald	INSP. DATE: September 4, 2013	INSP. TIME: 15:00
OPERATOR: Rio Grande Silver, Inc.	OPERATOR REPRESENTATIVE: Tom Day, Drew Marino, Bruce Norquist	TYPE OF OPERATION: MP - Mineral Prospecting

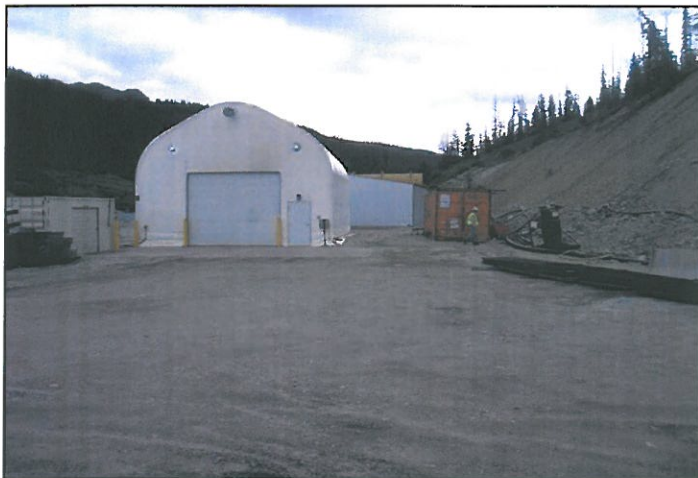
Much of the surface equipment and structures have been removed during the period of "care and standby" in 2013. Items no longer at the site include: portable electric power plant and switch gear, propane tank, modular office/dry, drilling equipment and supplies. Structures still onsite include: fabric-covered shop building, two large steel tanks, fuel storage building (currently containing minimal amount of diesel), plus two zircon storage containers (which are slated for removal soon). The removal of portable items from the site reduces the reclamation liability, since they will be required for eventual removal, but the removal does not reduce the bond by itself. There is no cause to revise the bond amount at this time since many of these items may be installed again upon commencement of renewed activity.

L-R: Storage, shop, fuel, and electrical-related structures.

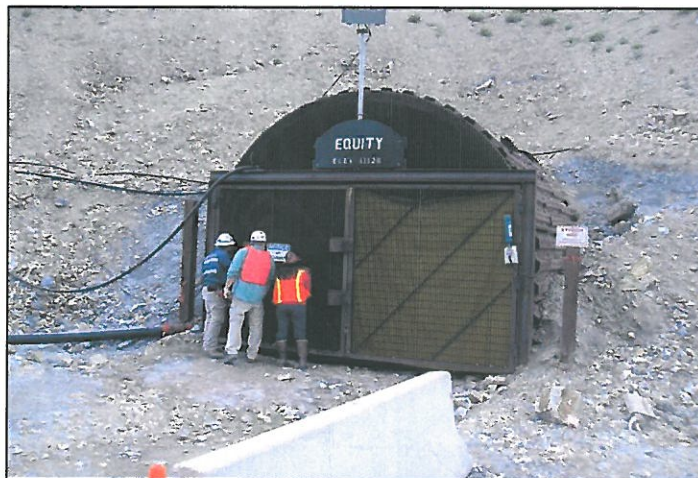
The main portal was locked and secured against unauthorized entry, and the vent portal was also locked and secured. These openings will not be closed or covered until final reclamation. No inspection of the underground workings was conducted at this time.

Main portal.

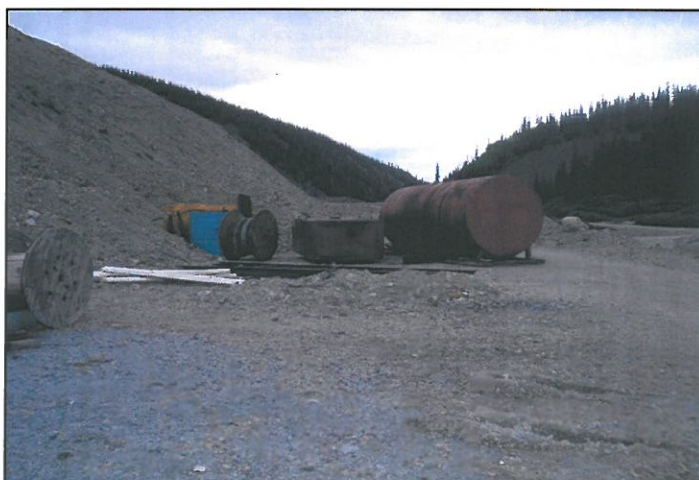
Vent portal, with cable and storage tank.

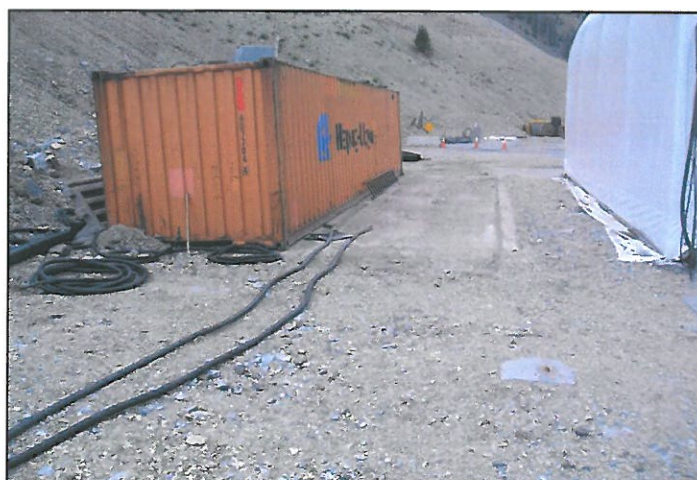
Electric storage zircon, concrete pad, cable.
