**COLORADO DIVISION OF RECLAMATION, MINING AND SAFETY
MINERALS PROGRAM INSPECTION REPORT
PHONE: (303) 866-3567**

MINE NAME: CME Mineral Prospecting Project	MINE/PROSPECTING ID#: P-2011-002	MINERAL: Silver, gold, lead and	COUNTY: Mineral
INSPECTION TYPE: Mineral Prospect Inspection	INSPECTOR(S): Bob Oswald	INSP. DATE: September 4, 2013	INSP. TIME: 16:30
OPERATOR: Colorado Mining Enterprises, LLC	OPERATOR REPRESENTATIVE: None	TYPE OF OPERATION: MP - Mineral Prospecting

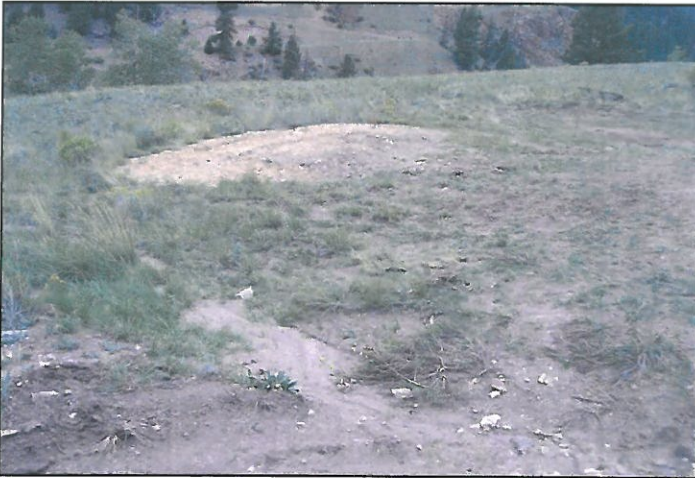
Drill pad 1. This is the lower drill pad, and it was not disturbed. No reclamation of pad 1 is needed. There was, however, a small footprint of disturbance a short distance north of approved pad 1, of approximately 100 sq ft adjacent to the lower road which exhibited some drilling muck, although no drilling occurred there. The grass around the muck was matted down, so the site may have been a parking or storage area for the project. The disturbance is minimal, but it is clearly related to the 2013 drilling, so the operator should monitor the site to ensure that it becomes revegetated soon. The muck may have to be removed to revegetate the site.

Muck in area adjacent to lower road, not at Pad 1.

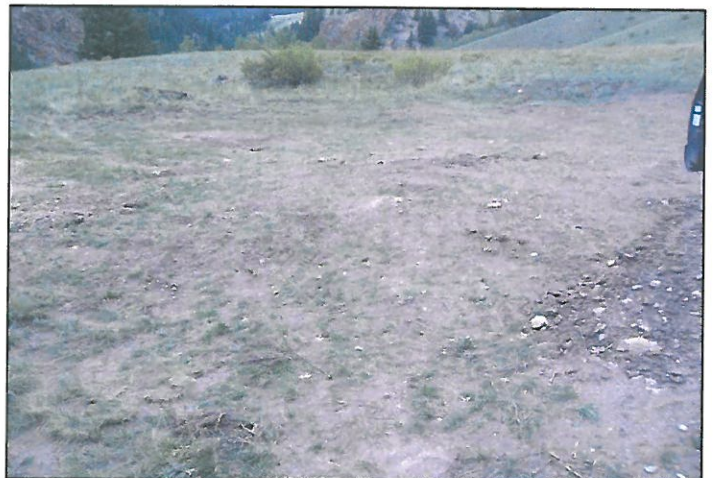
Matted grass adjacent to lower road.

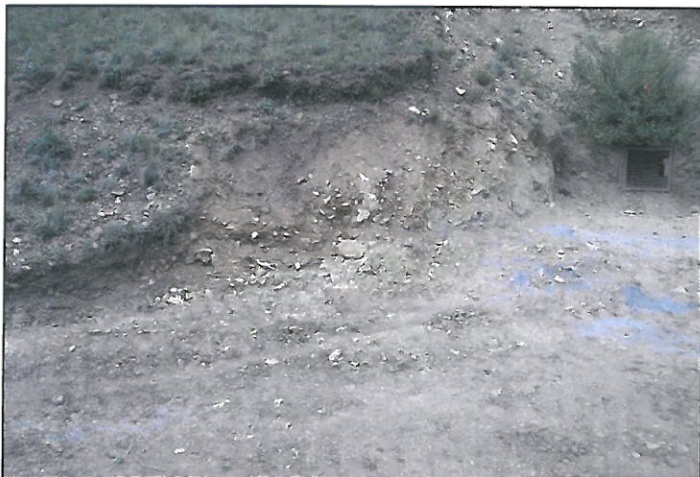
Drill pad 2. There were boreholes drilled here in 2013. The operator had prepared the pad by leveling it. The site was found to be clean and free of debris, and rough earthwork had been done. Final grading must still be carried out, as well as the revegetation seeding. In particular the edges of the pad (at its SW end) could be most prone to eroding. The cut walls on either side of the portal may also erode if not backfilled with available fill material from the pad. It may become necessary to do additional grading at this areas. Until the site is stabilized, the operator must monitor it for erosion, weed control and revegetation establishment.

Cut wall at Pad 2.

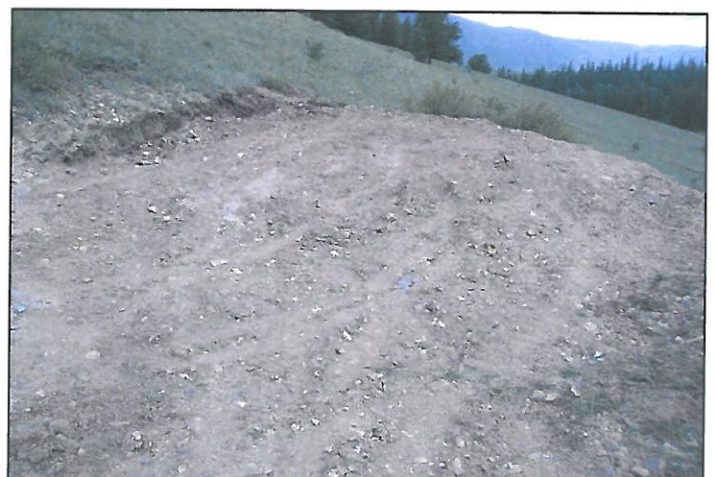
SW end of Pad 2.

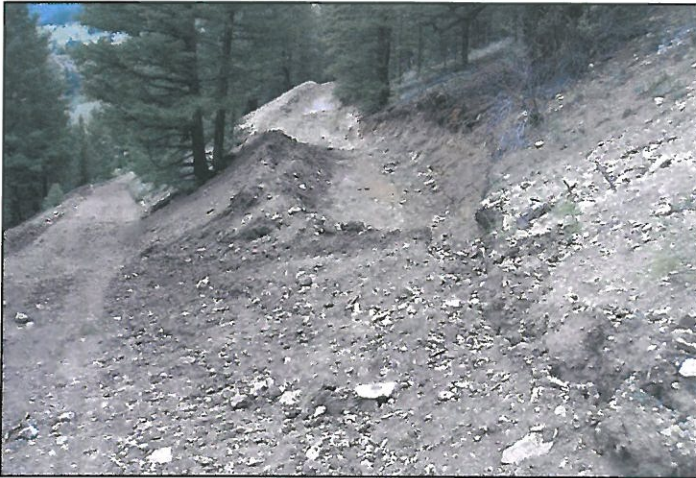
Drill pad 3. There were boreholes drilled here in 2013. The operator prepared the pad by light excavation to re-establish an old slot. The site was clean and free of debris, but little reclamation earthwork had been done yet. Final grading must still be carried out. The operator must be careful at this site, due to its hillside location, especially on the slope below the slot where sidecast materials have begun to ravel or slough down the slope. The upper cut wall of the slot may advance up the hill if adequate recontour grading is not performed in a timely fashion. Some time reclaiming with an excavator, pulling lower materials up the slope and pushing them against the cut to recontour the area will help immensely, and is required. Ultimately, the surface must be stabilized, and the drainage and erosion must be controlled. Further earthwork is felt to be needed and should be carried out. If not, this could be the drill site that will deteriorate the most, part of it possibly extending offsite. As it stands now, the site needs further work.

Looking up at Pad 3.

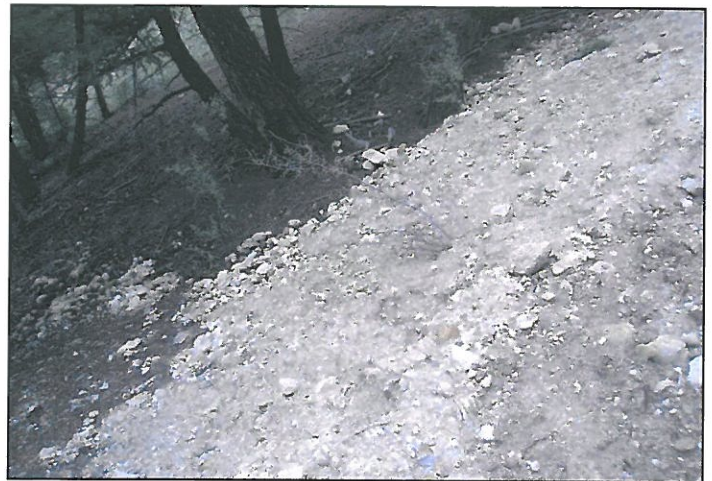
Material cast down the slope below Pad 3.

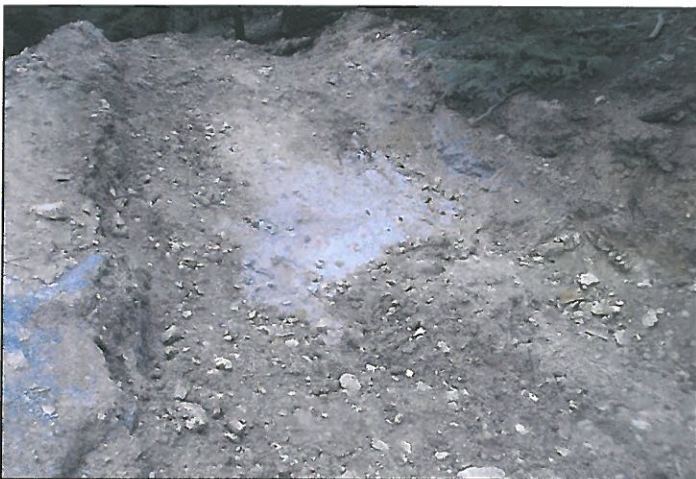
Drill site at Pad 3, showing recontouring needed.

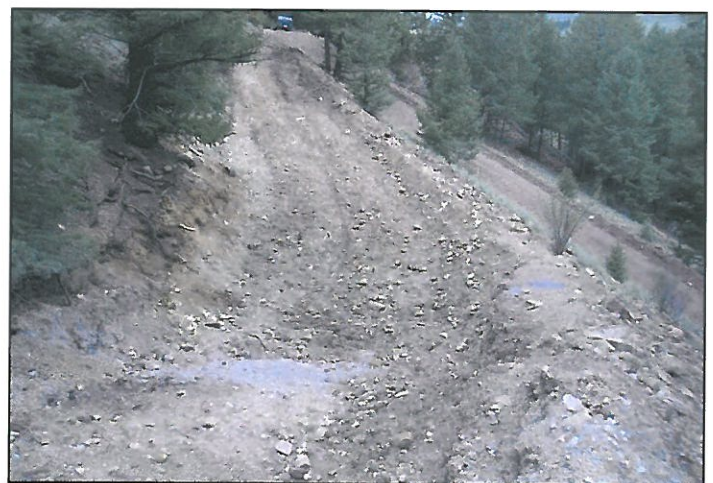
Looking down slot at Pad 3.

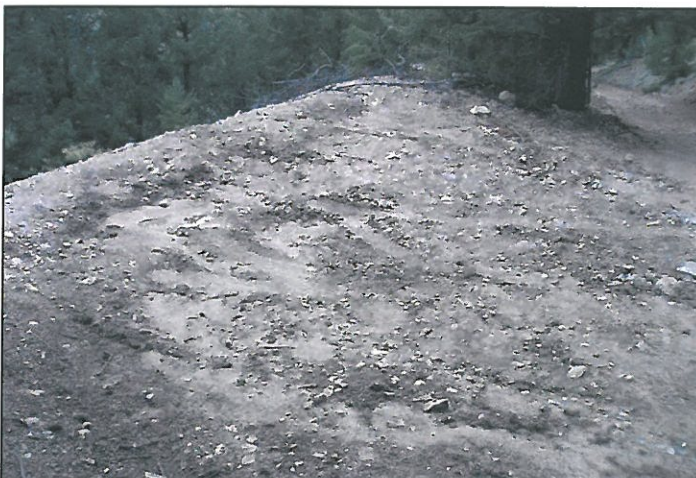
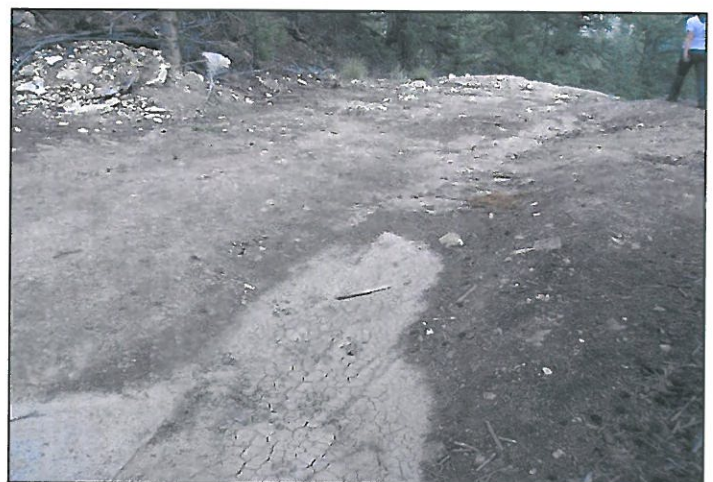
Drill pad 4. There was no drilling carried out here. This is a site at a level switchback on the existing road near the old caved portal. The site is near pad 3, and only tire tracks from equipment were evident here. No reclamation is needed.

Road at Pad 4.
