**COLORADO DIVISION OF RECLAMATION, MINING AND SAFETY**  
**MINERALS PROGRAM INSPECTION REPORT**  
**PHONE: (303) 866-3567**

<b>MINE NAME:</b> Camp Bird Mine	<b>MINE/PROSPECTING ID#:</b> M-1982-090	<b>MINERAL:</b> Gold, silver, lead, zinc	<b>COUNTY:</b> Ouray
<b>INSPECTION TYPE:</b> Monitoring	<b>INSPECTOR(S):</b> Wallace H. Erickson	<b>INSP. DATE:</b> September 20, 2013	<b>INSP. TIME:</b> 09:00
<b>OPERATOR:</b> Camp Bird Colorado, Inc.	<b>OPERATOR REPRESENTATIVE:</b> Mike Thompson	<b>TYPE OF OPERATION:</b> 112 - Hard Rock Regular Operation

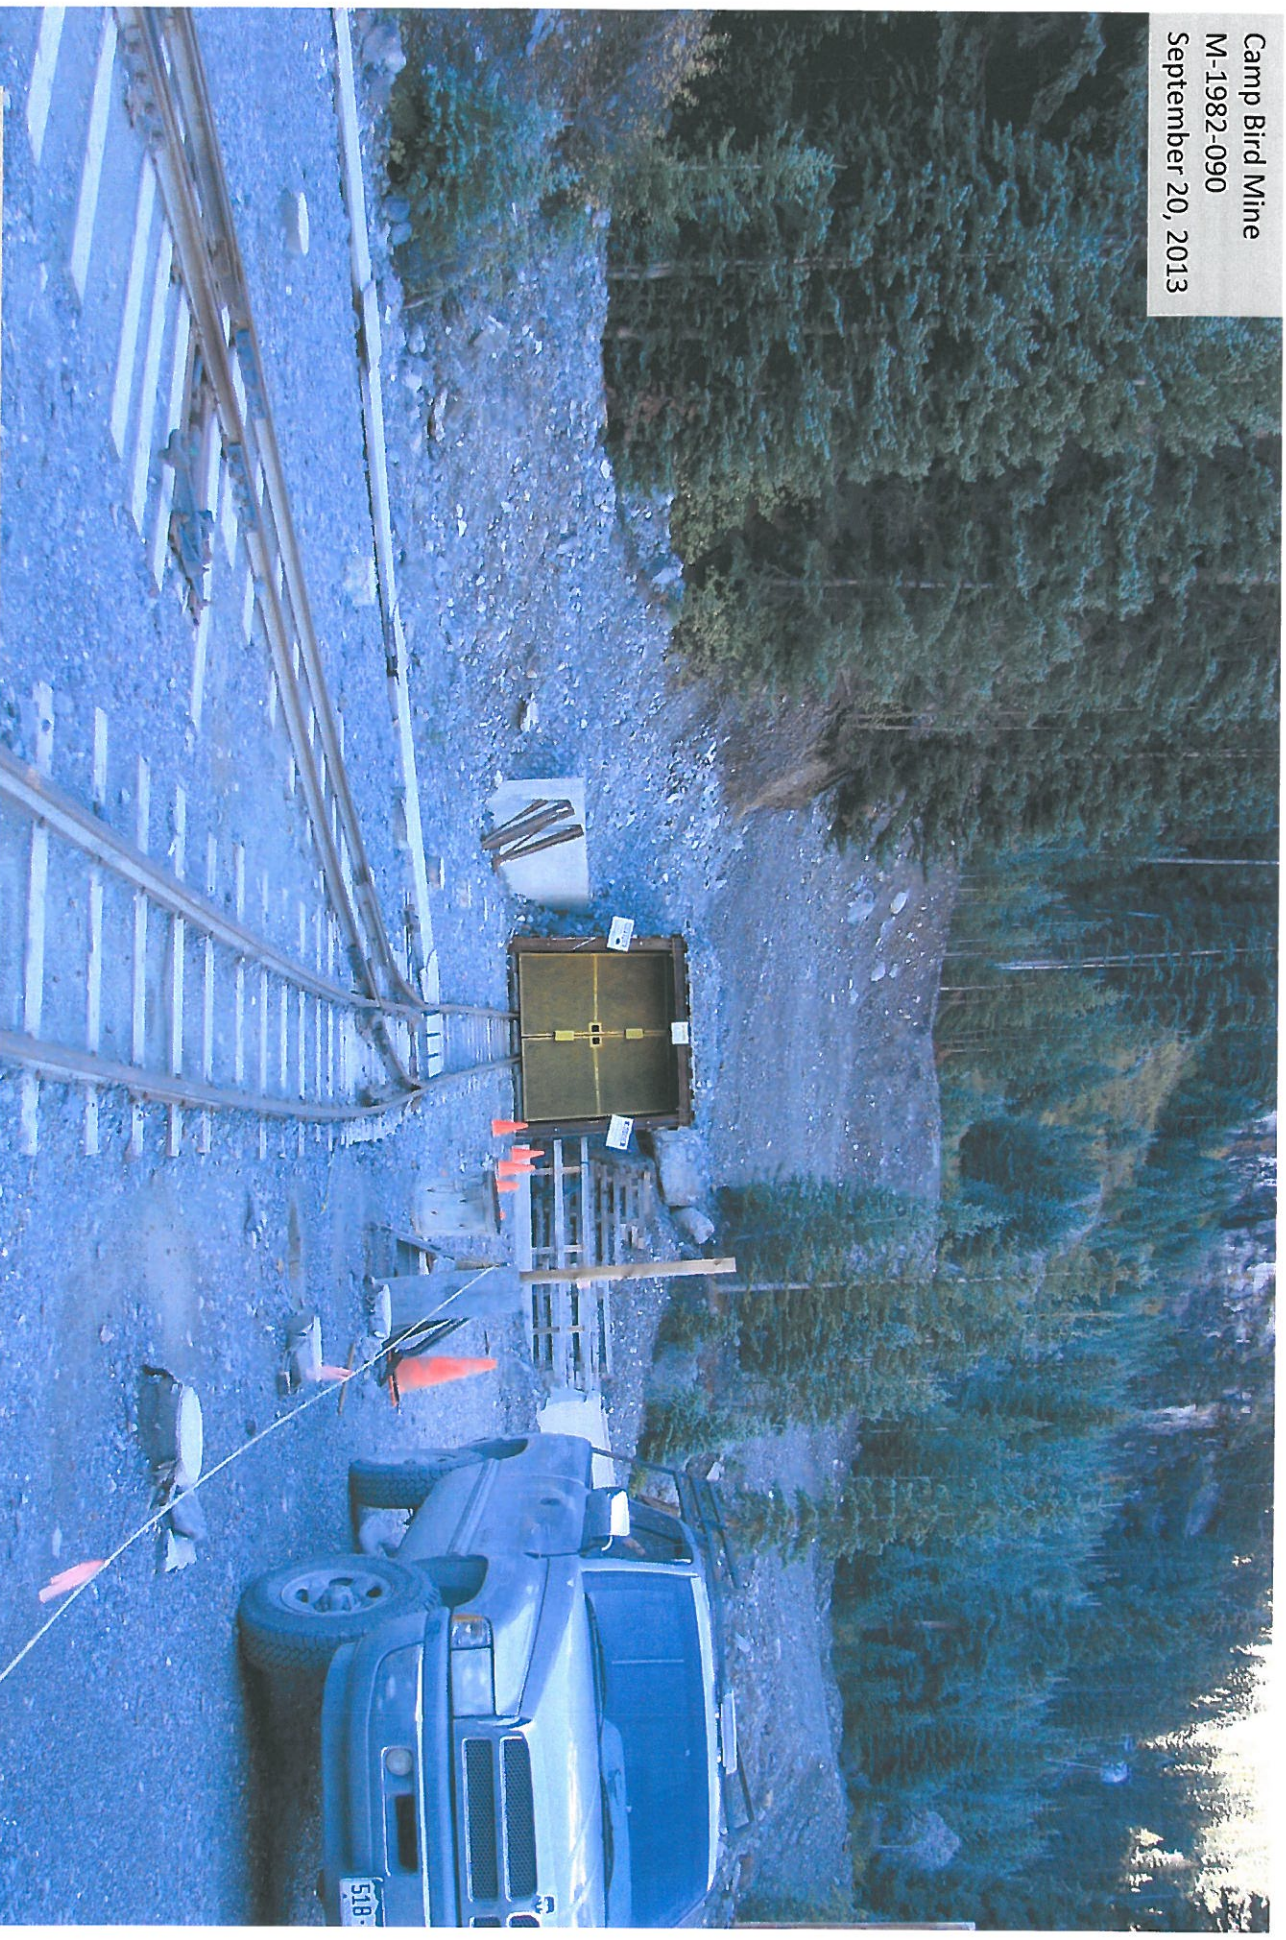
View south, showing recent upgrades to the 14L portal. Unauthorized entry is discouraged by the locked steel grate closure. Concrete footers appeared ready for construction of the snow shed, which will cover the rail line approach to the portal. Mine drainage is routed west, across Imogene Creek, and south to the sediment pond.

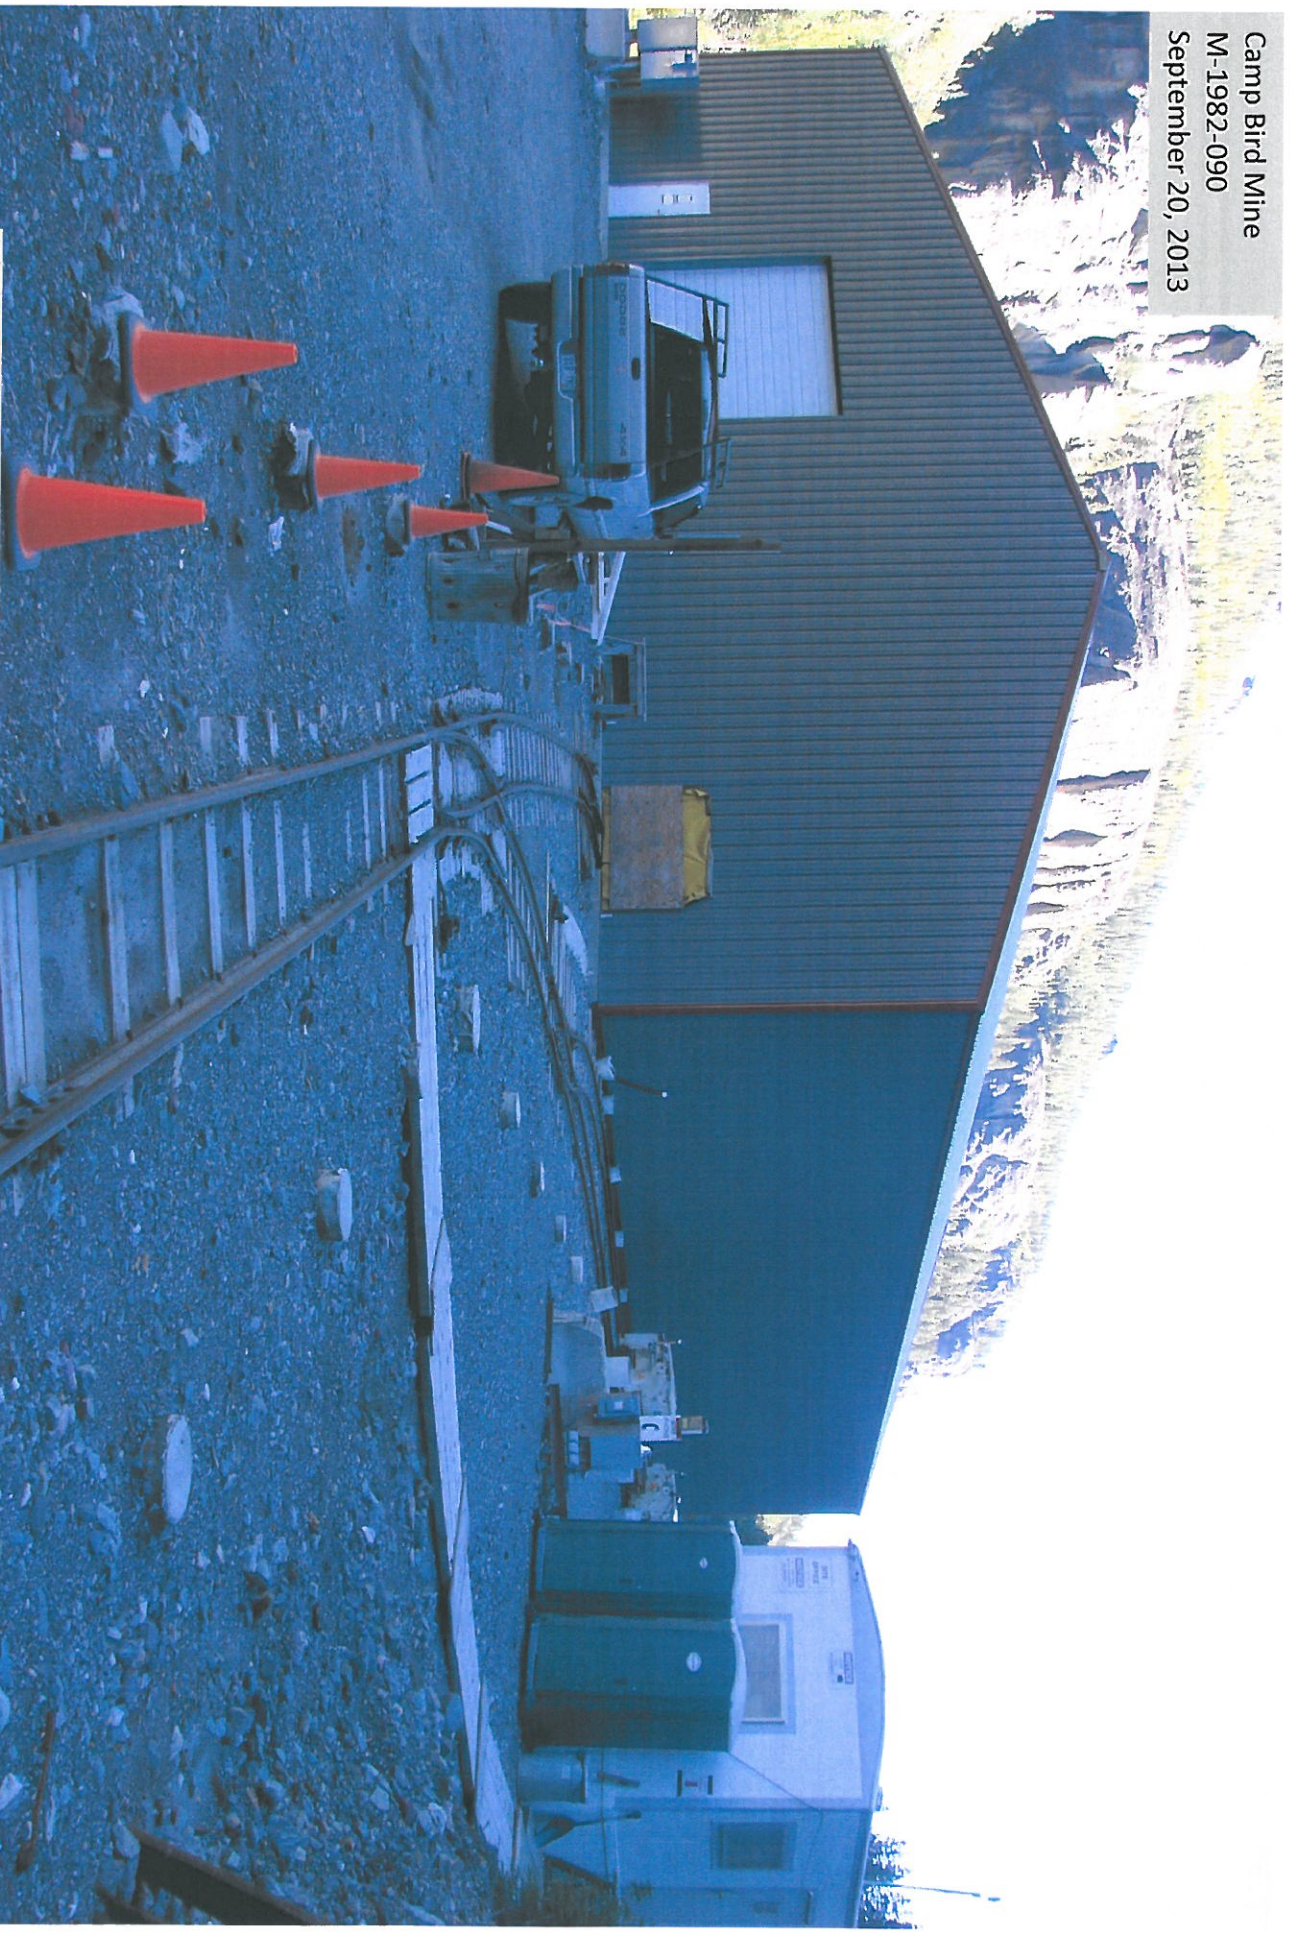
View north, taken from the 14L portal and showing the recently constructed 80 x 100 foot steel building. Concrete footers appeared ready for construction of the snow shed, which will cover the rail line from the steel building to the portal and beyond the steel building to the ore bin.

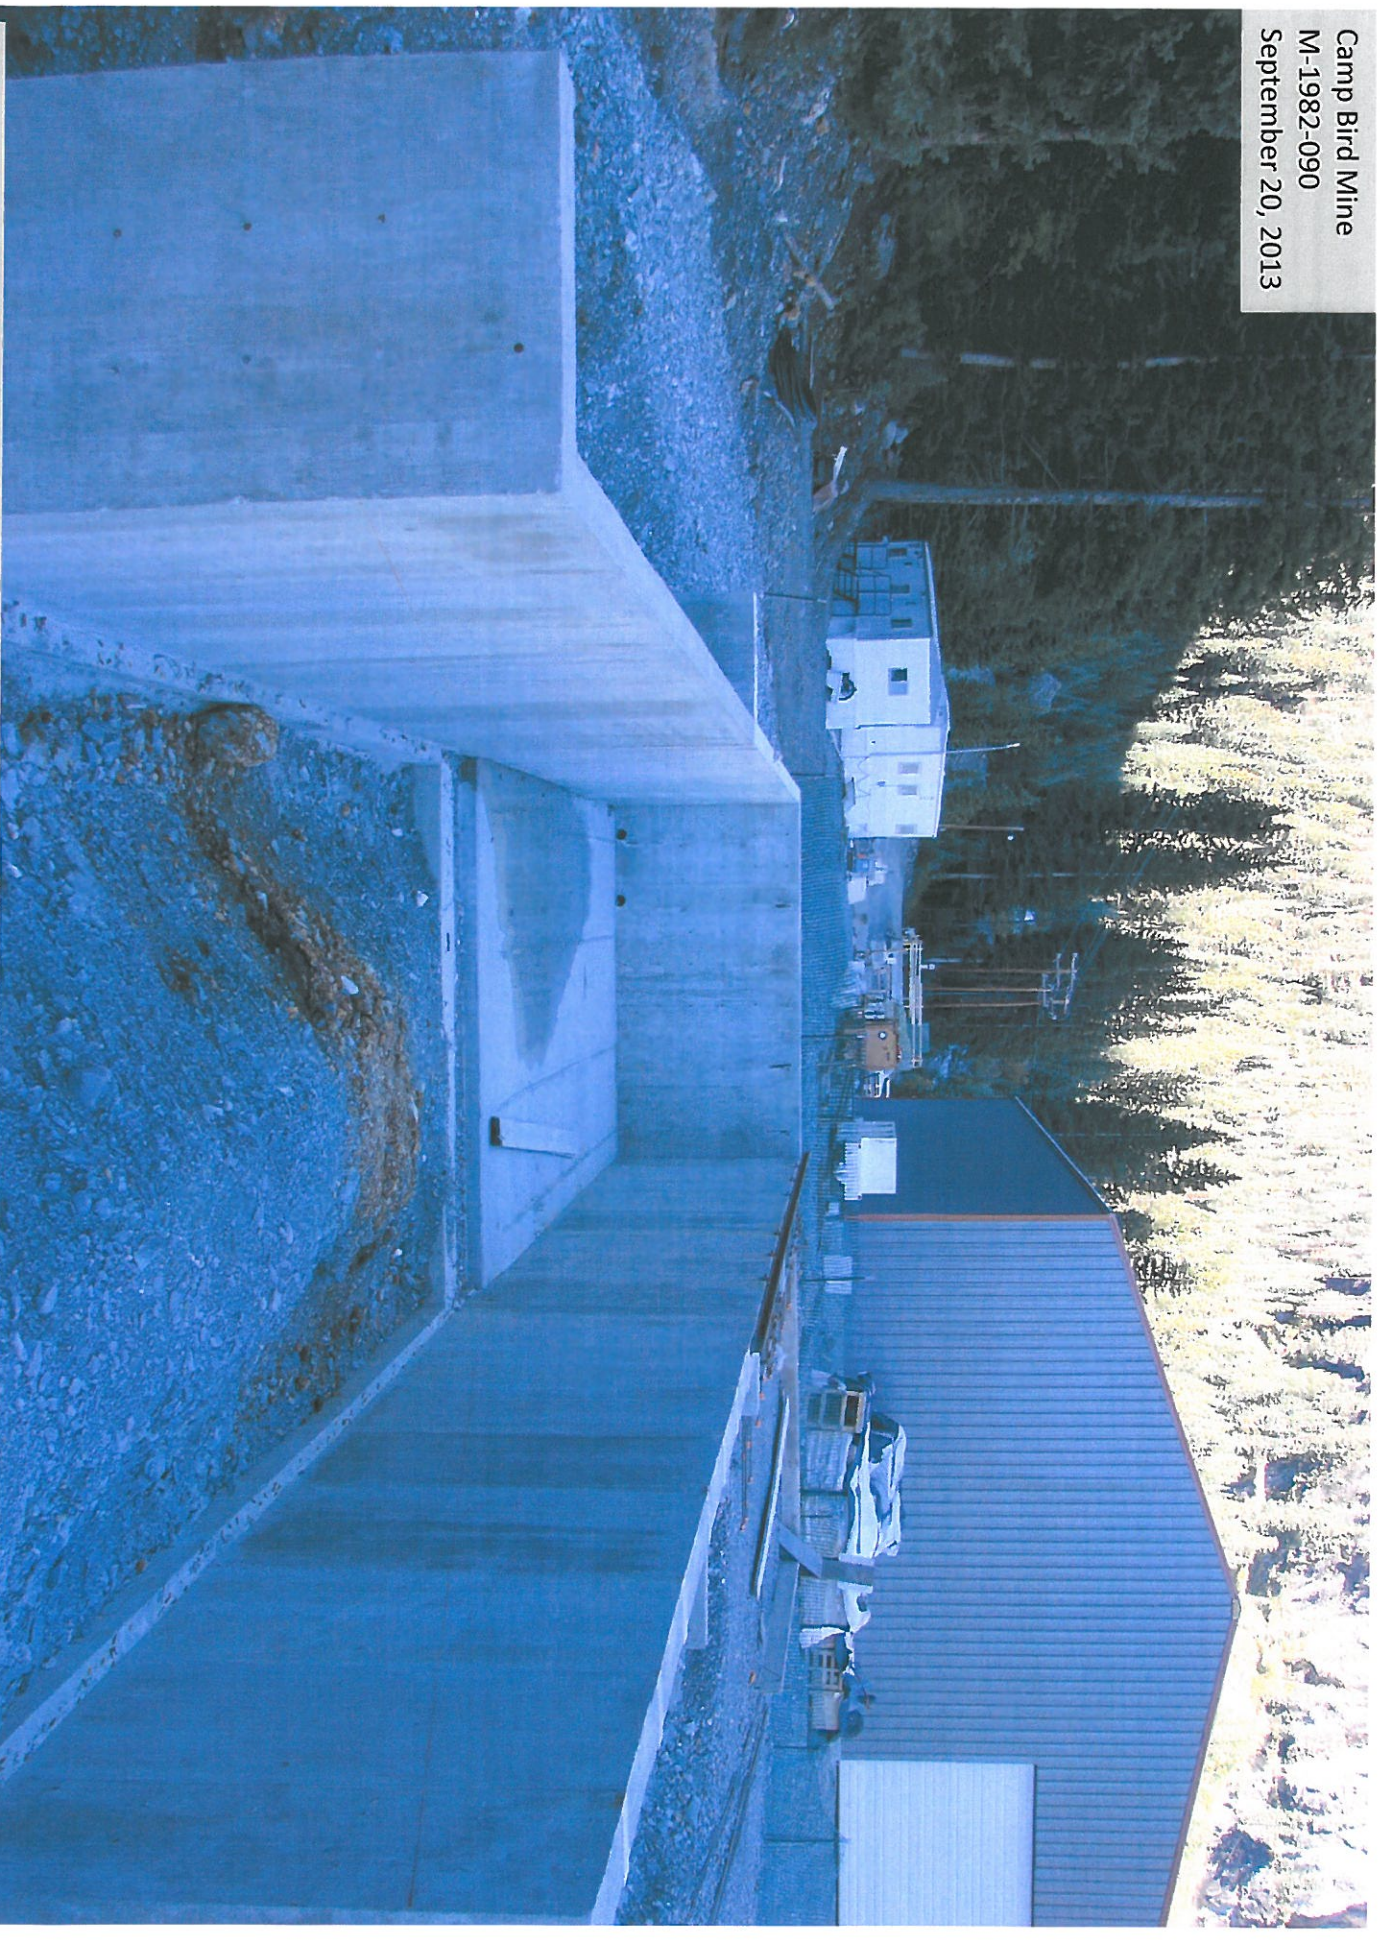
View southwest, showing the recently constructed 80 x 100 foot steel building and on-going construction of the ore bin.

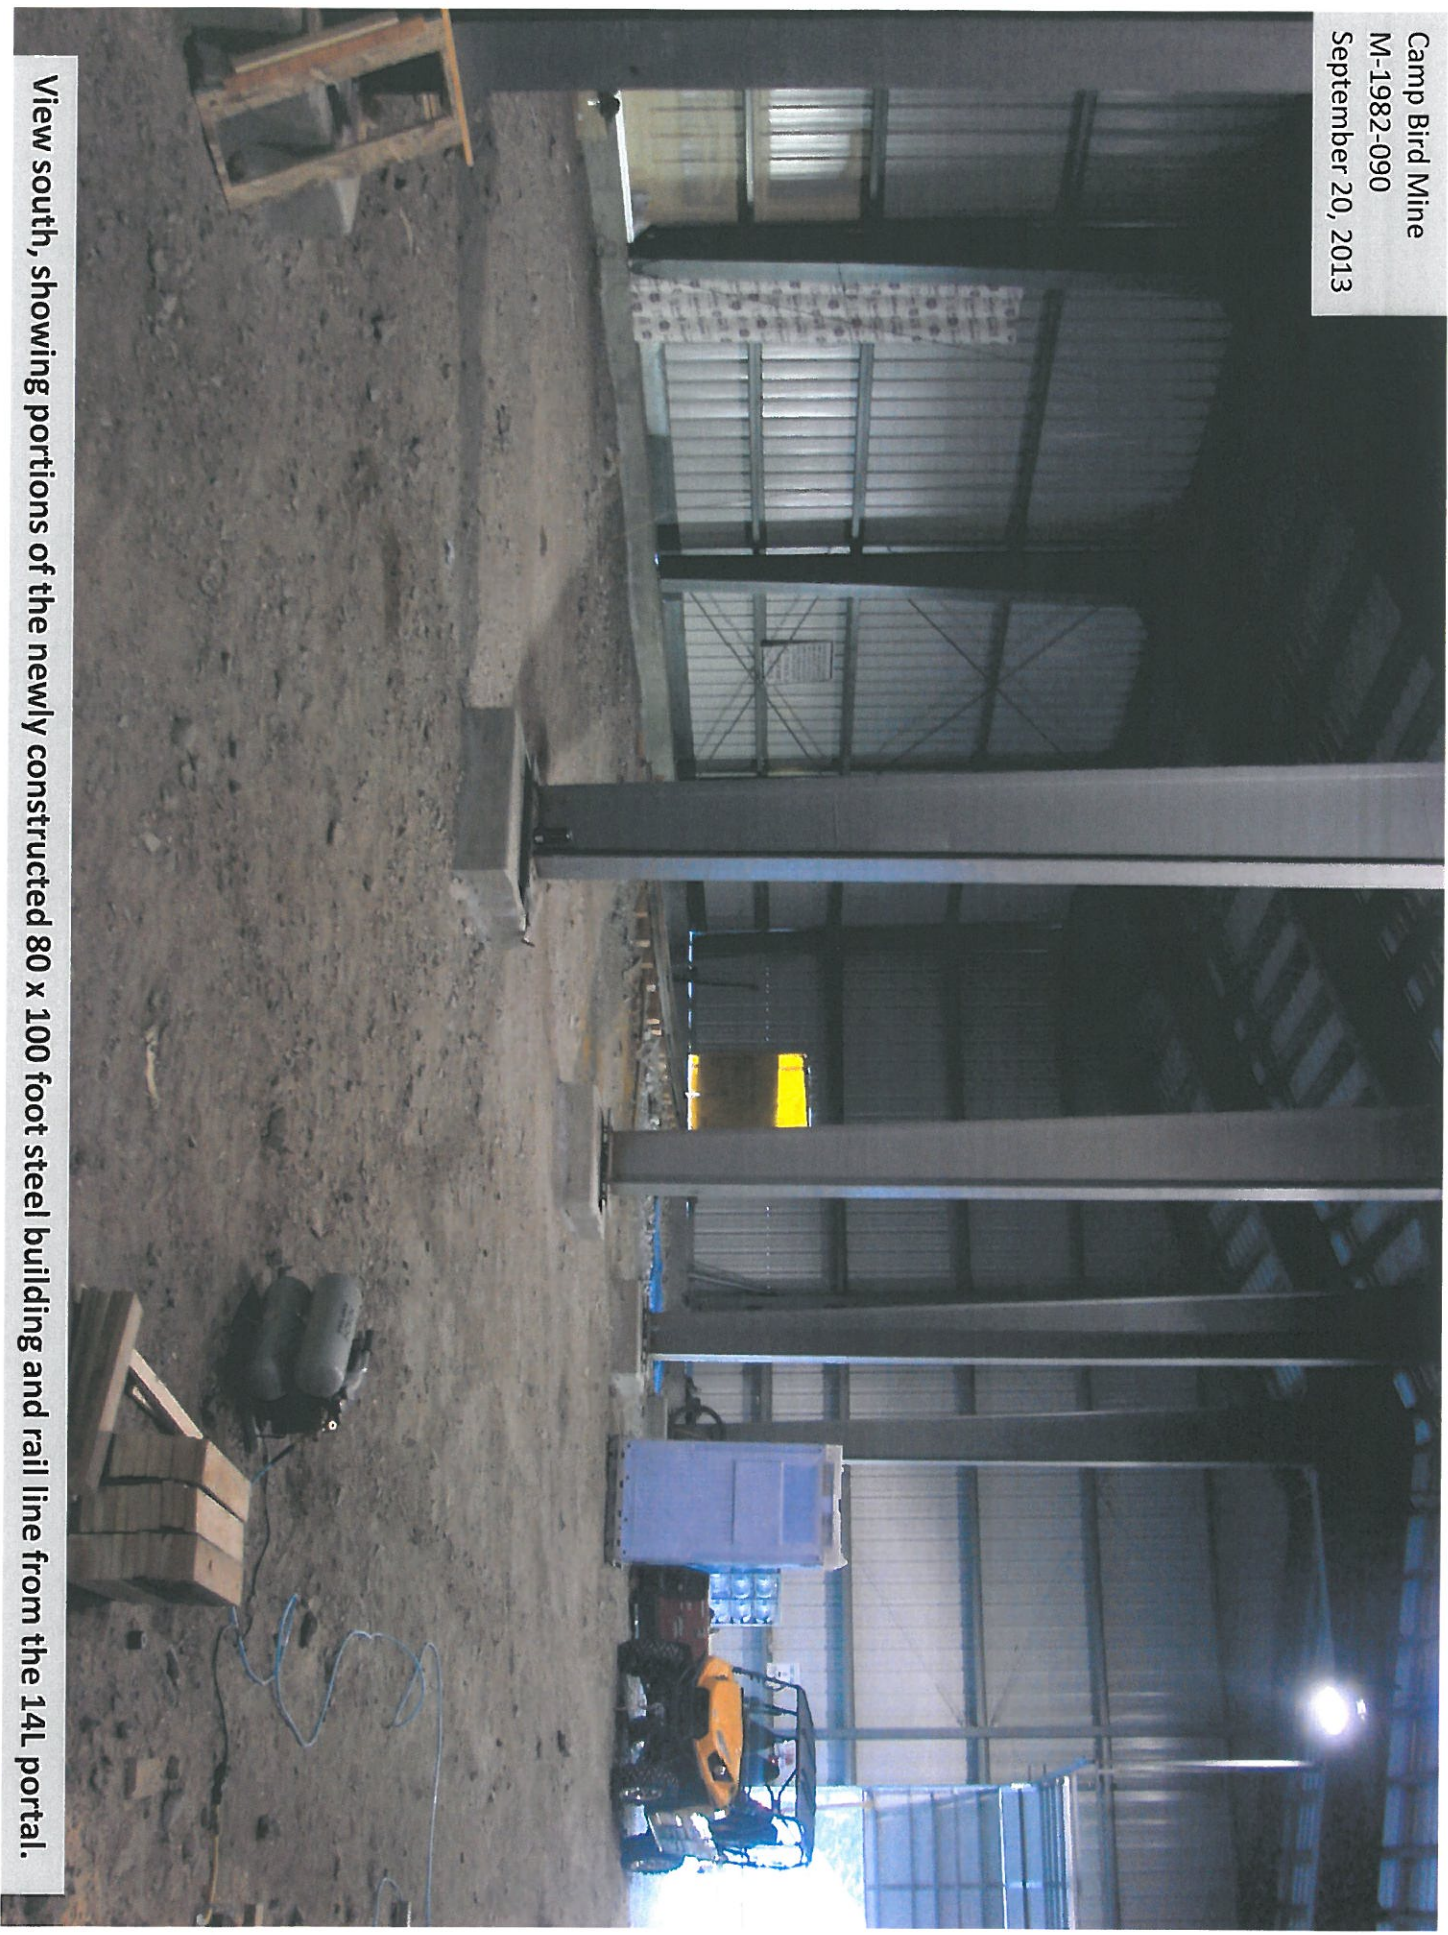
View south, showing portions of the newly constructed 80 x 100 foot steel building and rail line from the 14L portal.

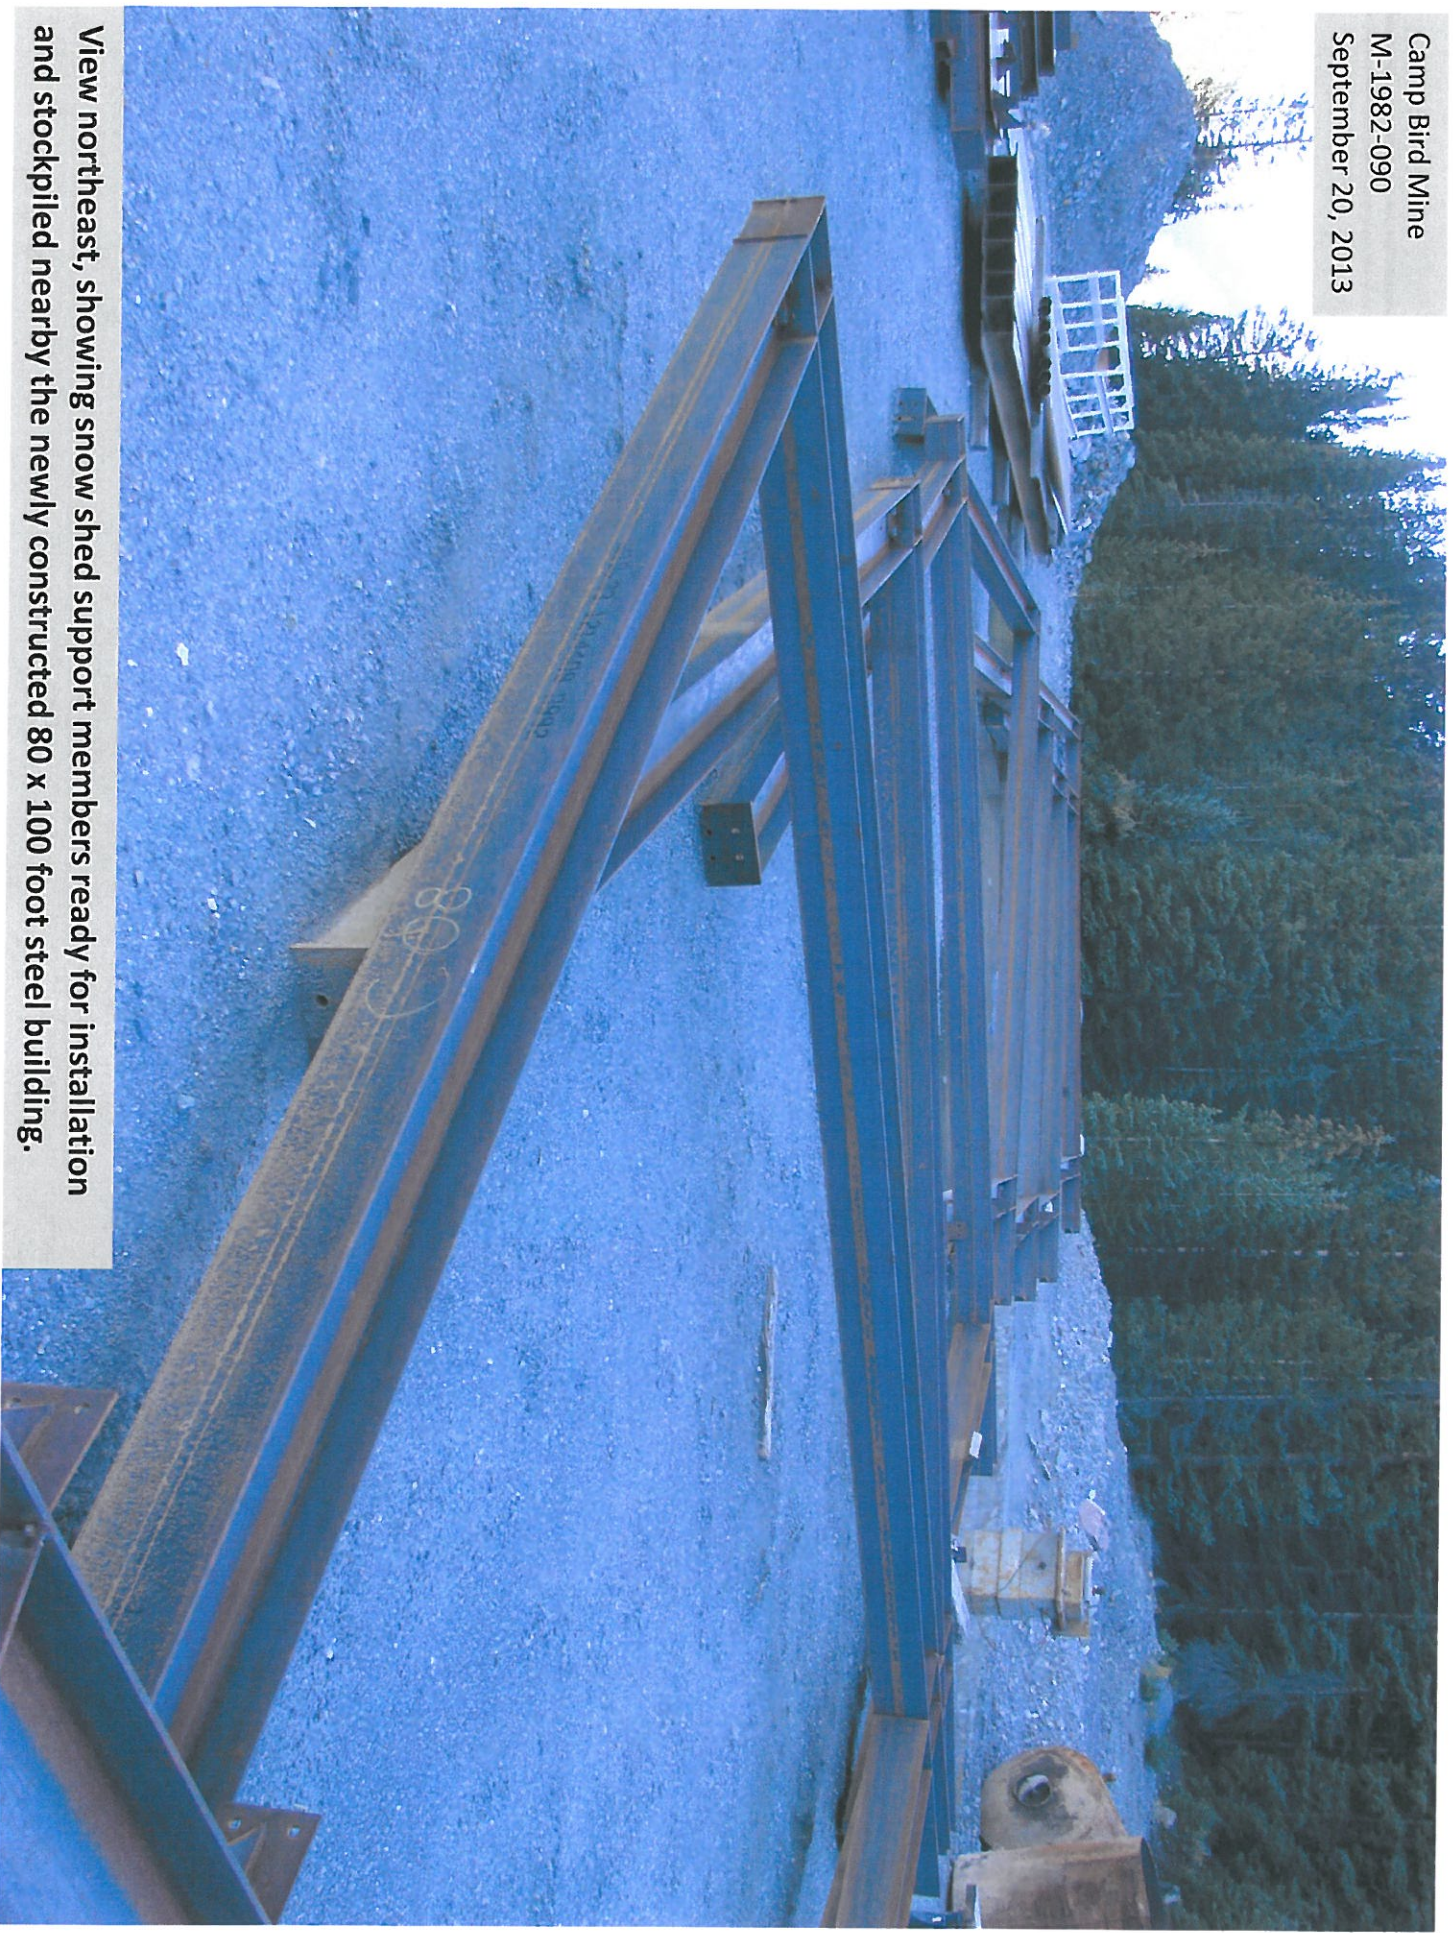
View northeast, showing snow shed support members ready for installation and stockpiled nearby the newly constructed 80 x 100 foot steel building.

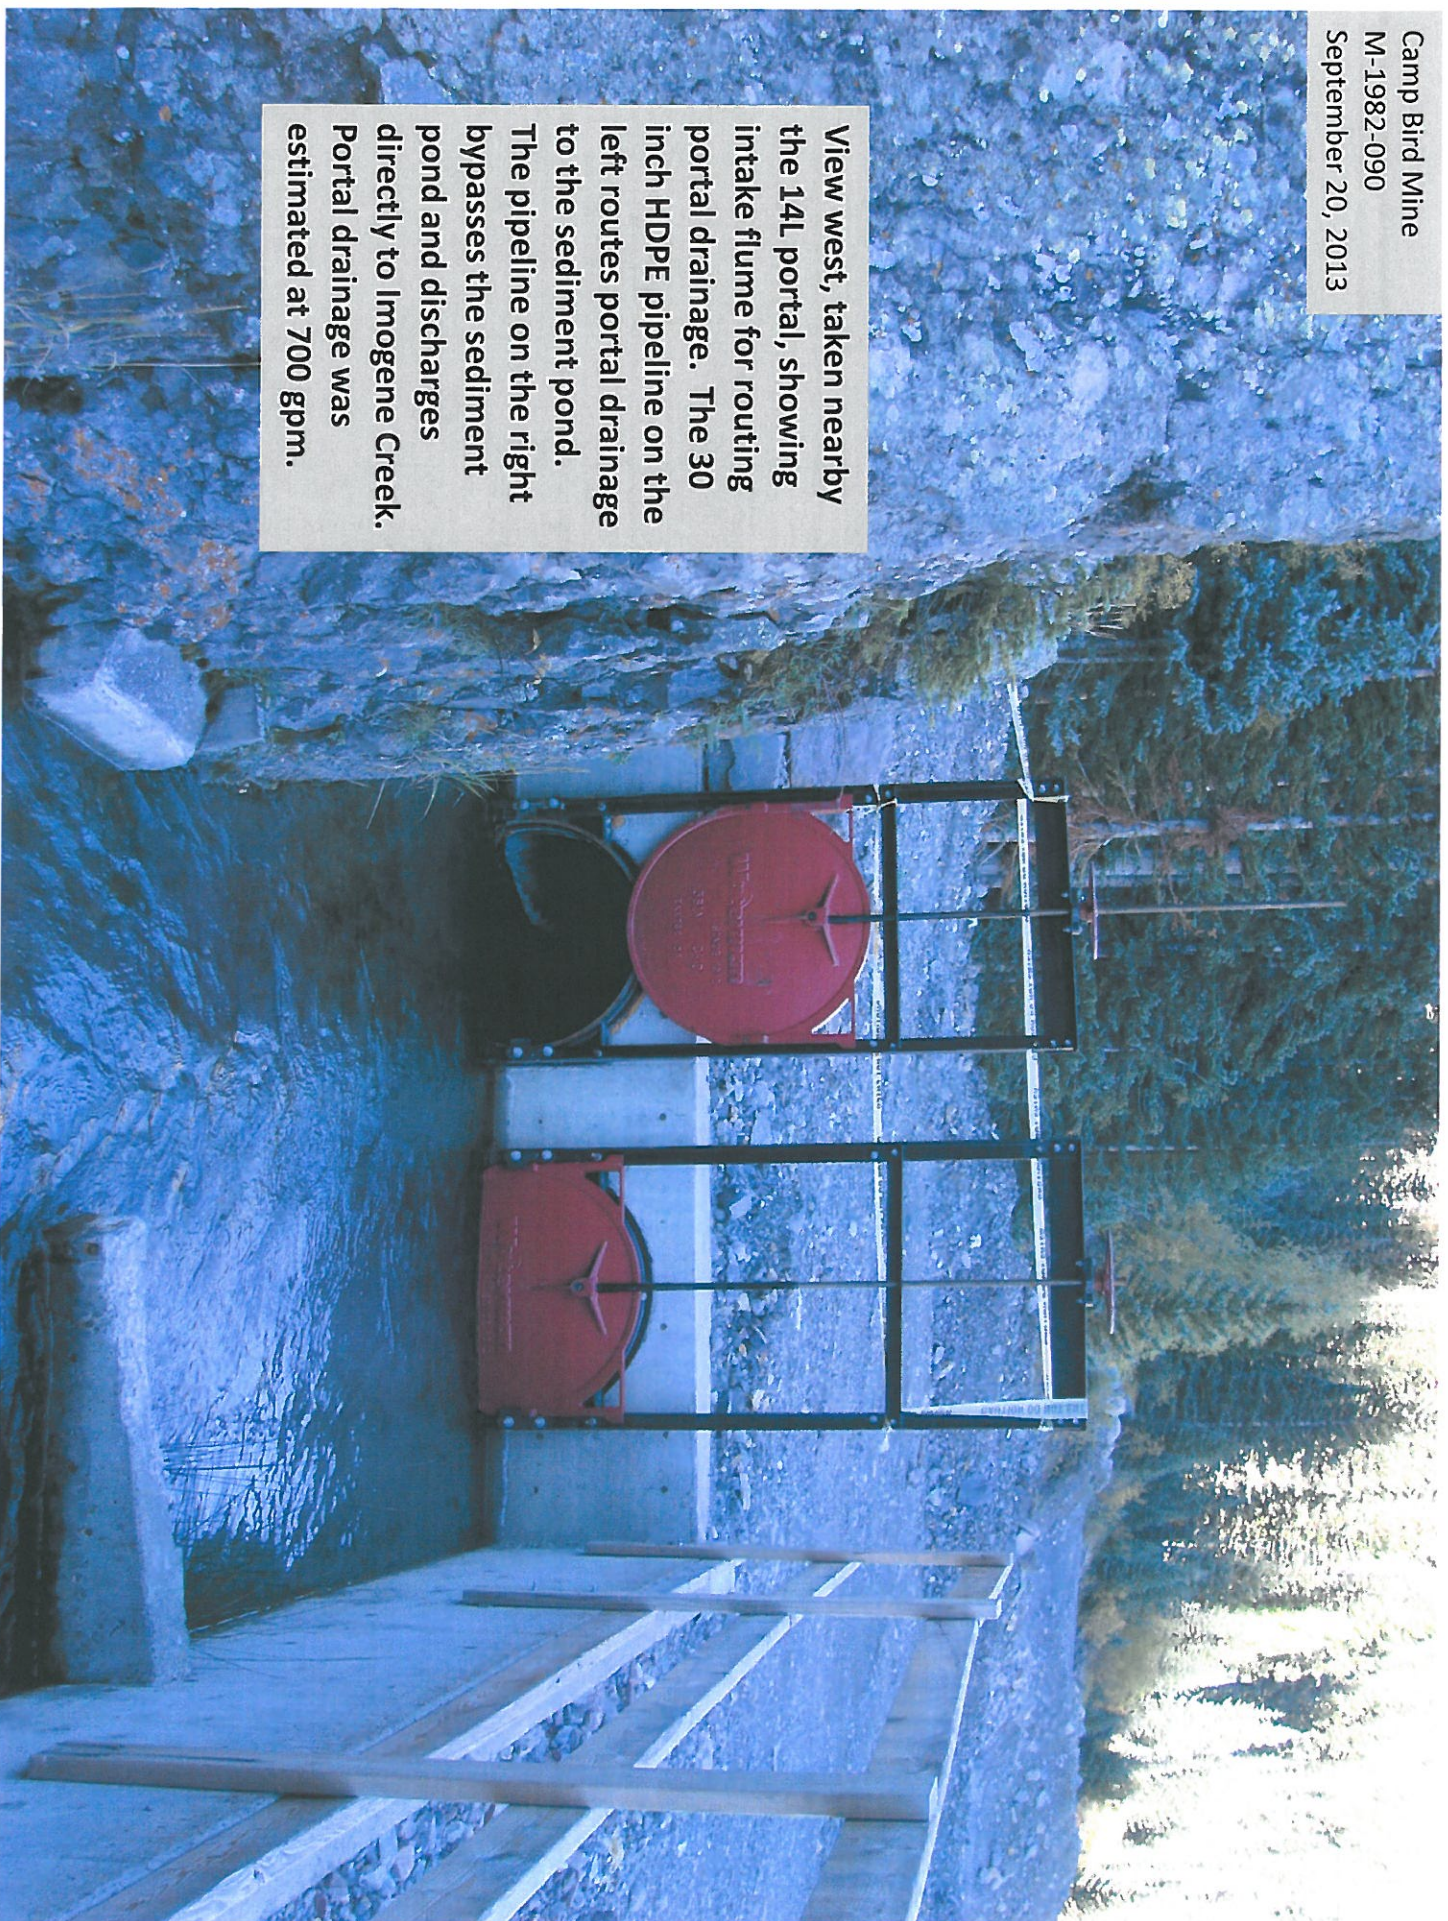
View west, taken nearby the 14L portal, showing intake flume for routing portal drainage. The 30 inch HDPE pipeline on the left routes portal drainage to the sediment pond. The pipeline on the right bypasses the sediment pond and discharges directly to Imogene Creek. Portal drainage was estimated at 700 gpm.
