COLORADO DIVISION OF RECLAMATION, MINING AND SAFETY
MINERALS PROGRAM INSPECTION REPORT
PHONE: (303) 866-3567

MINE NAME: Eldorado-Pilot	MINE/PROSPECTING ID#: M-1990-059	MINERAL: Gold and silver	COUNTY: Ouray
INSPECTION TYPE: Monitoring	INSPECTOR(S): Wallace H. Erickson	INSP. DATE: September 20, 2013	INSP. TIME: 10:30
OPERATOR: Gil Moser	OPERATOR REPRESENTATIVE: None present	TYPE OF OPERATION: 110(1) - Hard Rock Limited Impact

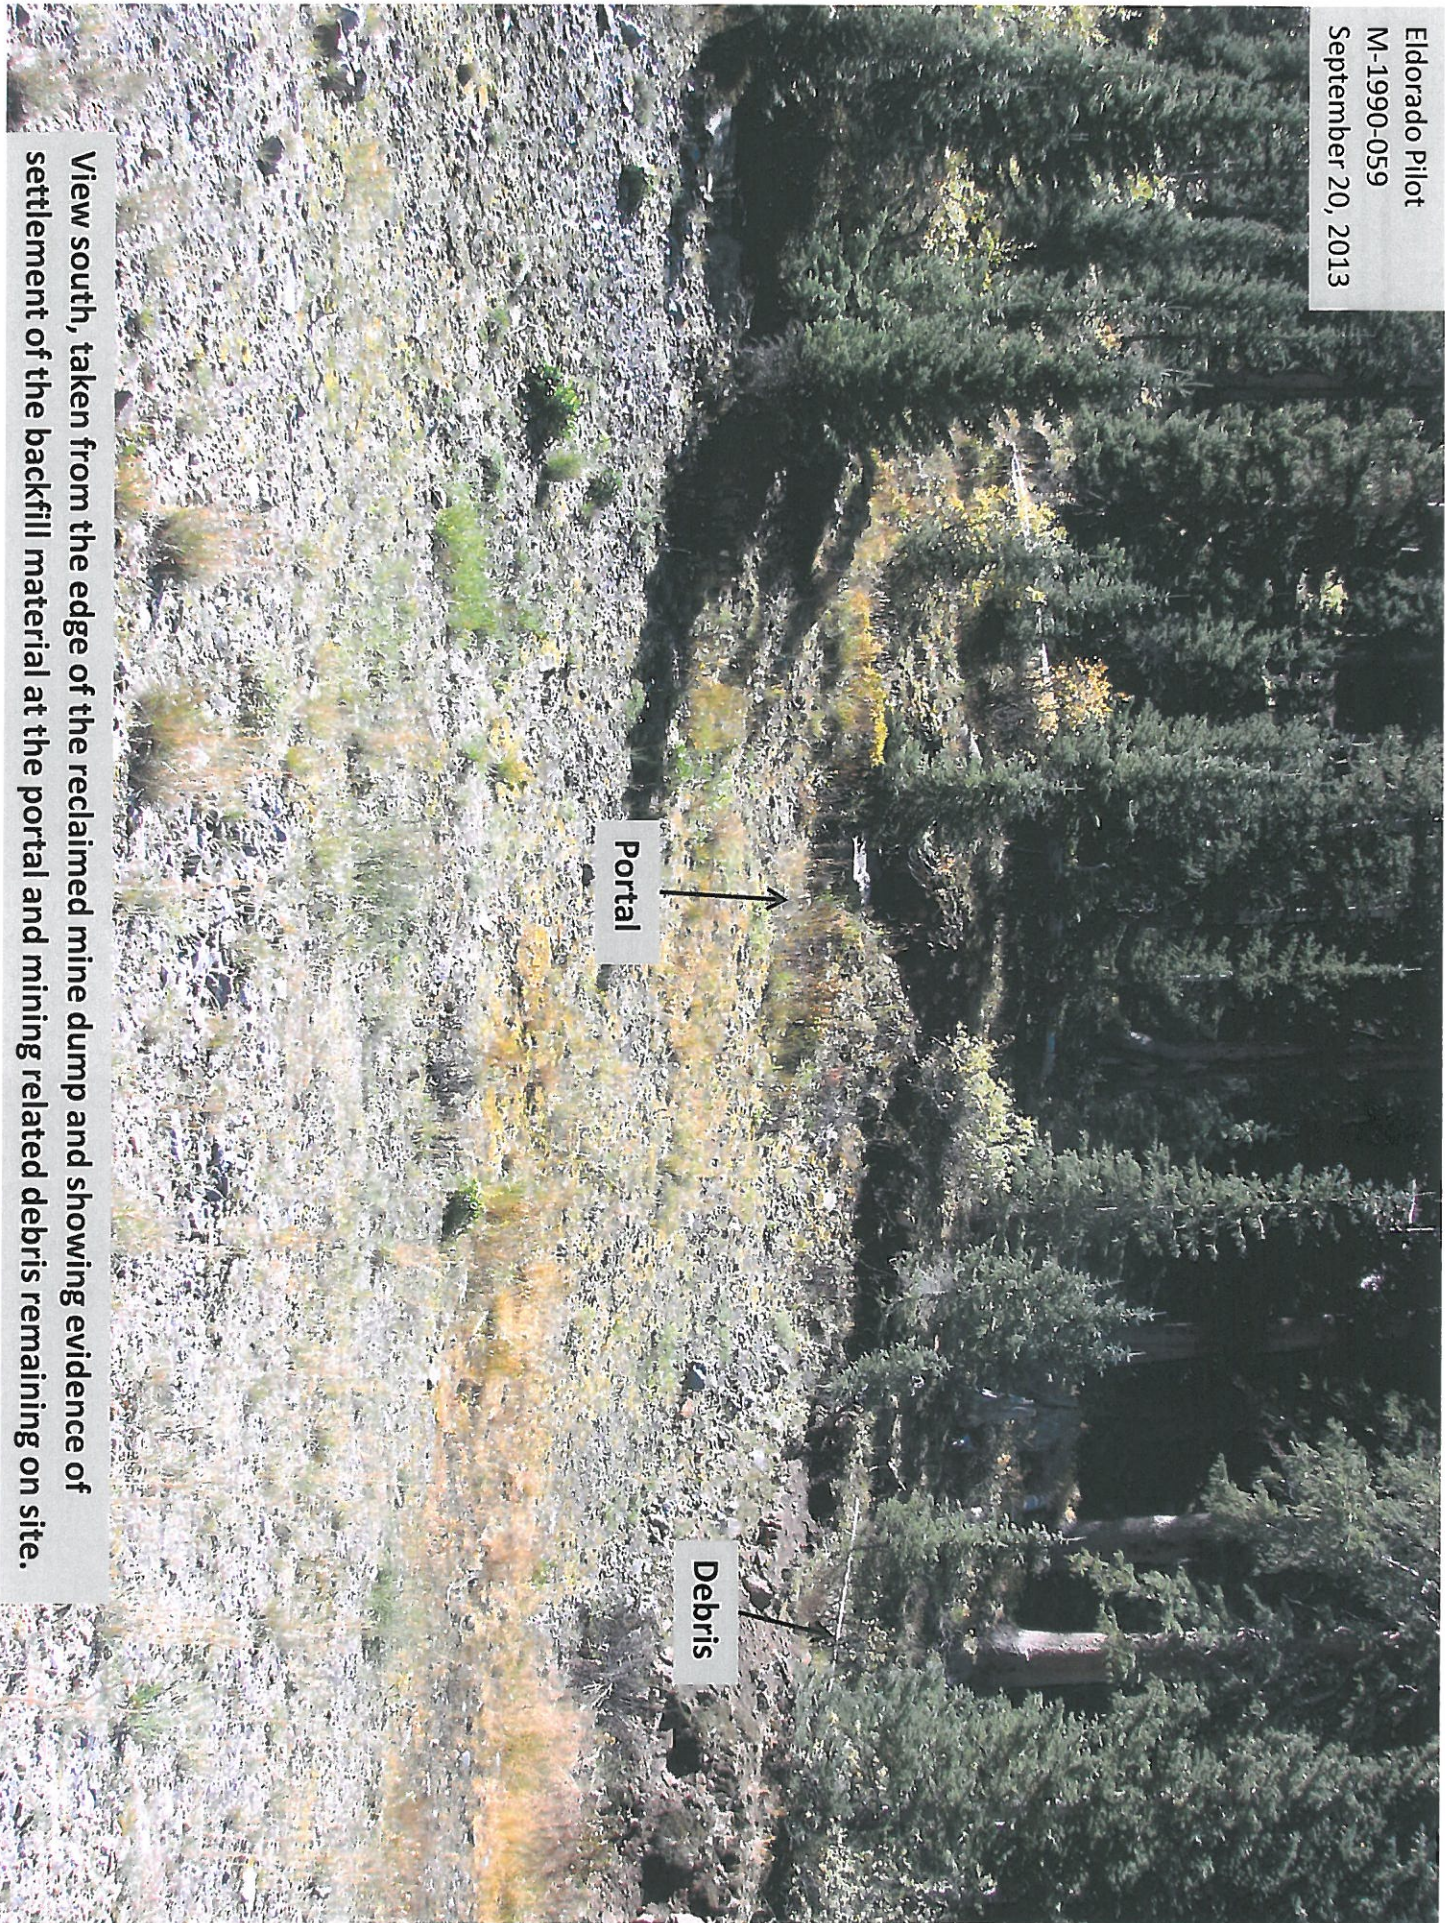
View south, taken from the edge of the reclaimed mine dump and showing evidence of settlement of the backfill material at the portal and mining related debris remaining on site.

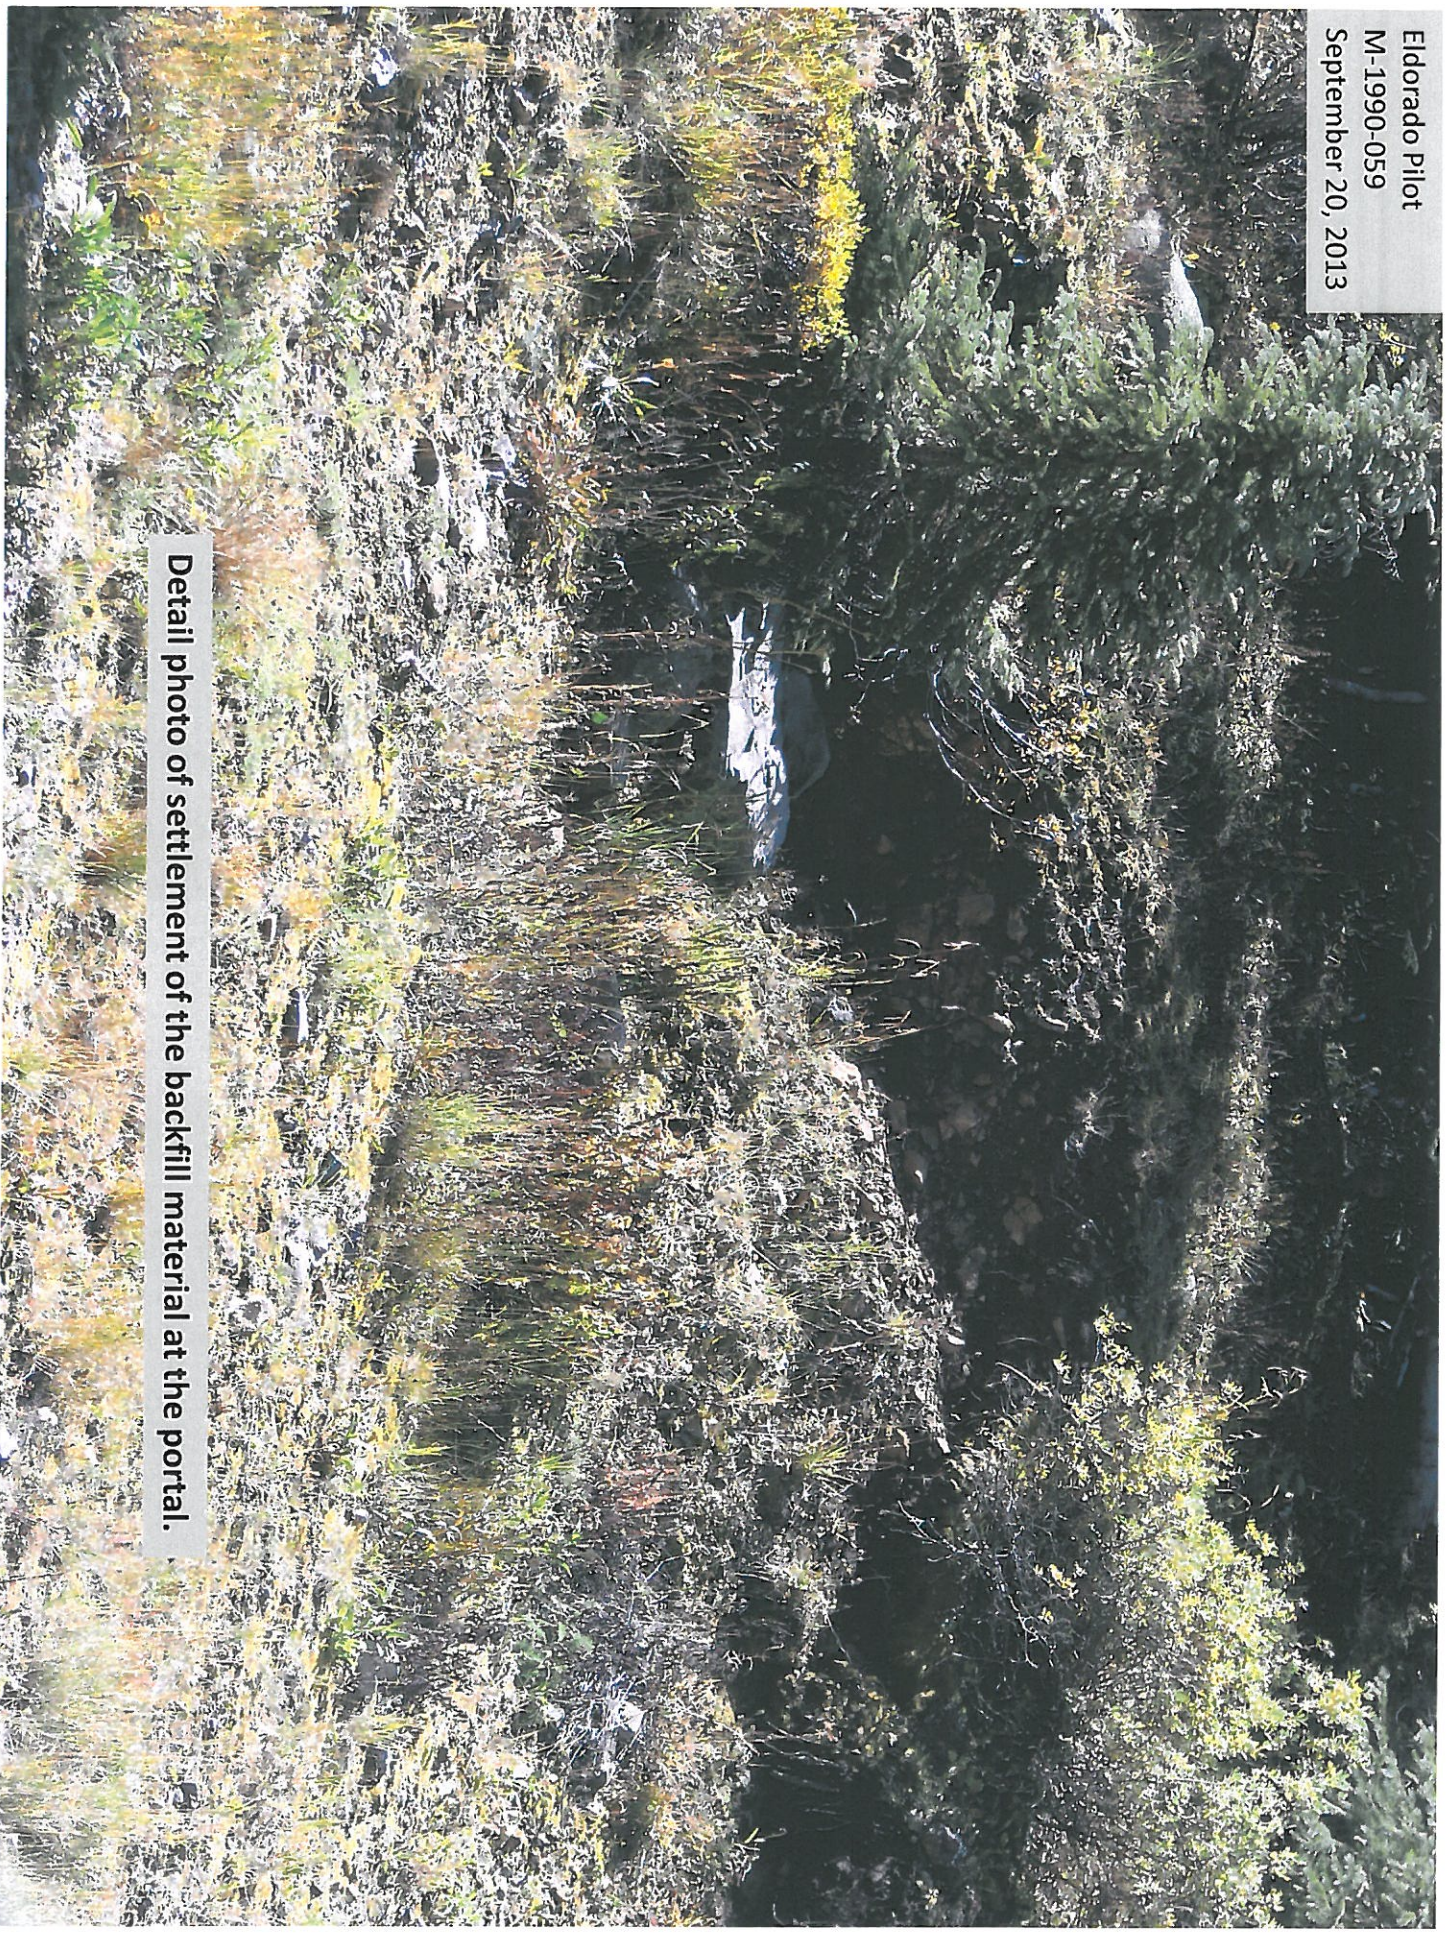
Opening Description	Dimensions	Closure Method	Quantity	Unit	Unit Cost	Total Cost
Portal has re-opened due to settling	3' x 3'	Adit closure - backfilling (per cu. yd.)	180.00	CY	\$1.61	\$289.80

Detail photo of settlement of the backfill material at the portal.

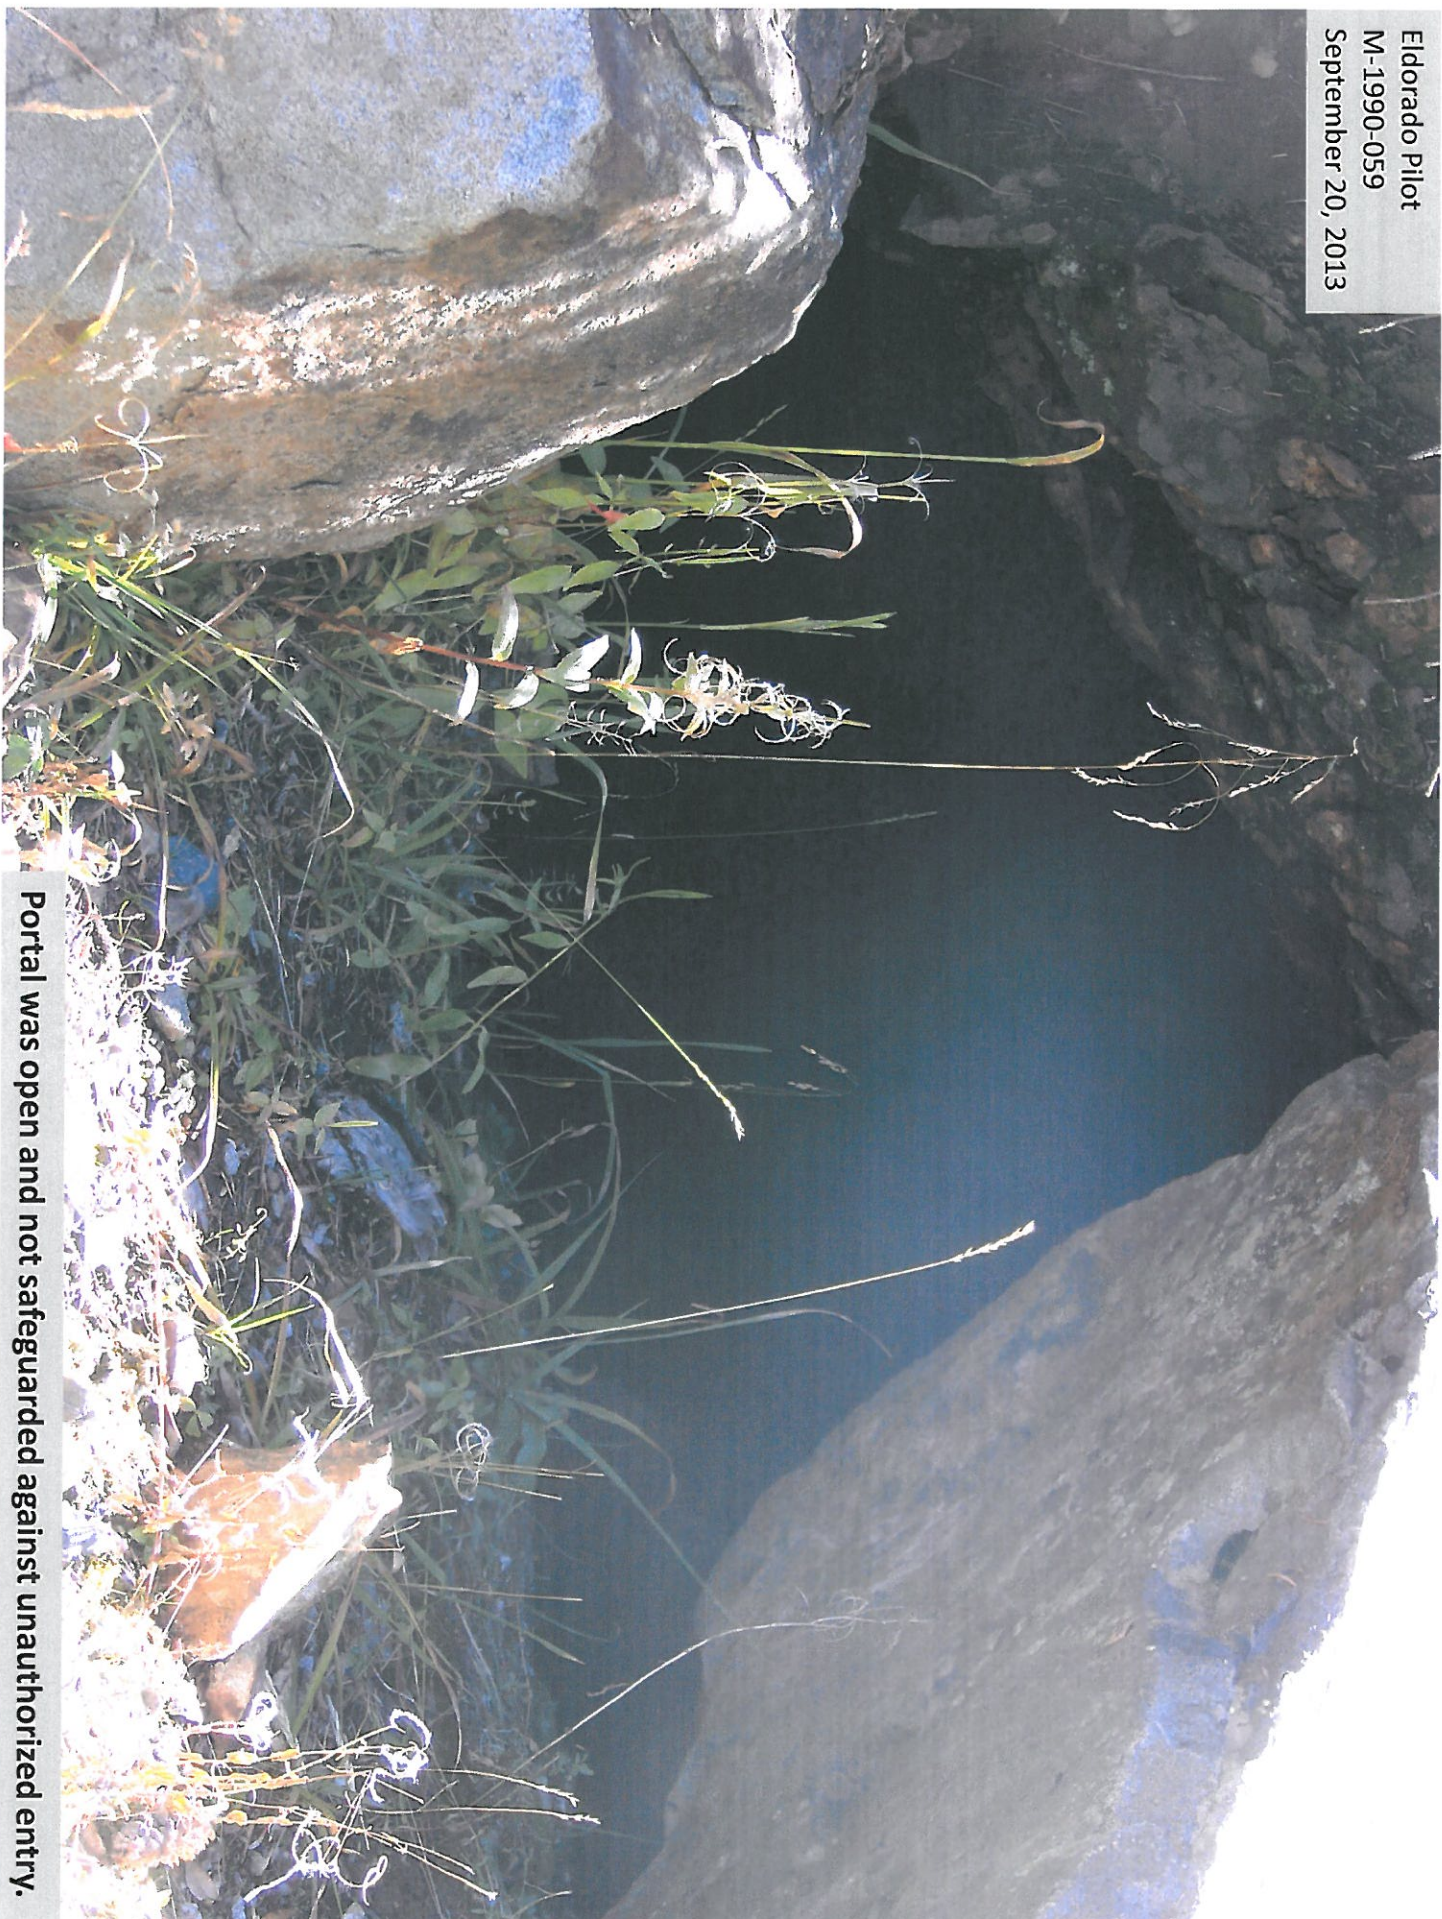
Portal was open and not safeguarded against unauthorized entry.

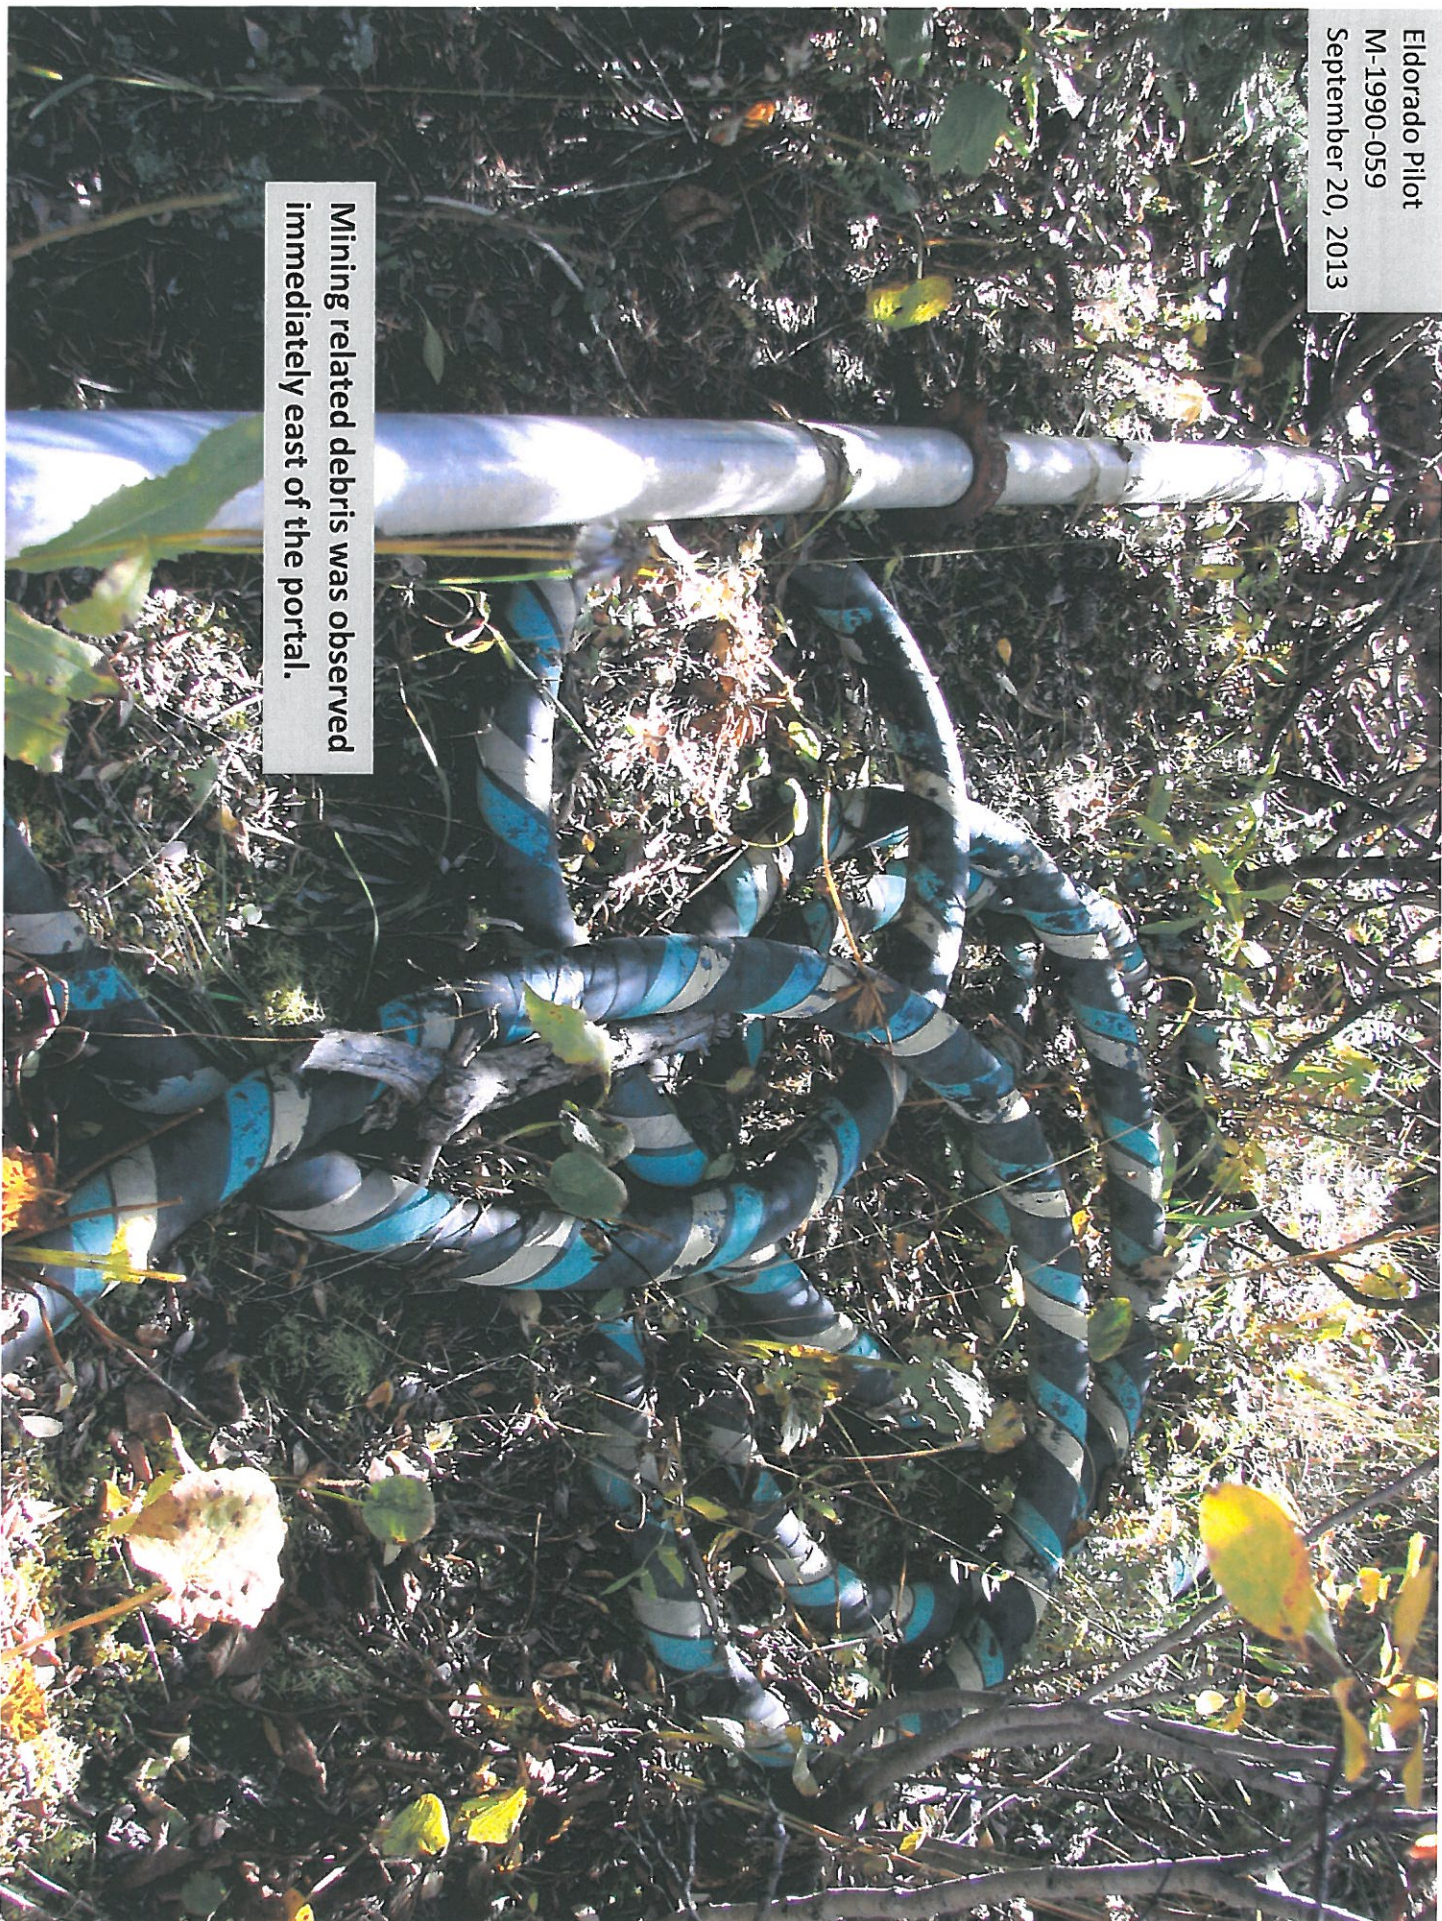
Mining related debris was observed
immediately east of the portal.
