**COLORADO DIVISION OF RECLAMATION, MINING AND SAFETY
COAL PROGRAM INSPECTION REPORT**

Permit Number: C-1981-028 Mine Name: Keenesburg Strip Mine Operator: Coors Energy Company Operator Address: Mr. Benjamin Moline P.O. Box 4030 Suite 400 Golden, CO 80401	County: Weld Operation Type: Surface Permit Status: Active Ownership: Private
	Operator Representative Present: Danny Kipp
Operator Representative Signature: (Field Issuance Only)

Inspection Start Date: October 17, 2013 Inspection Start Time: 08:45 Inspection End Date: October 17, 2013 Inspection End Time: 09:45	Inspection Type: Coal Partial Inspection Inspection Reason: Normal I&E Program Weather: Cloudy
Joint Inspection Agency: None	Joint Inspection Contacts:
Post Inspection Agency: None	Post Inspection Contacts:
Inspector(s): Jared L. Ebert	Inspector's Signature:

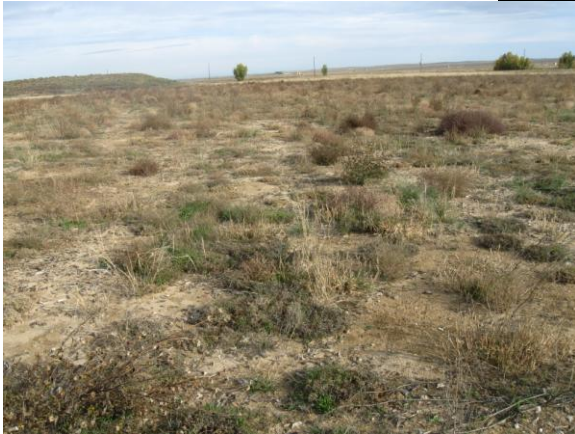
Area 25 was observed. Buffalo grass, Sand-dropseed, Indian Ricegrass, and sunflower have begun to establish throughout the area. Russian thistle was observed throughout this parcel.

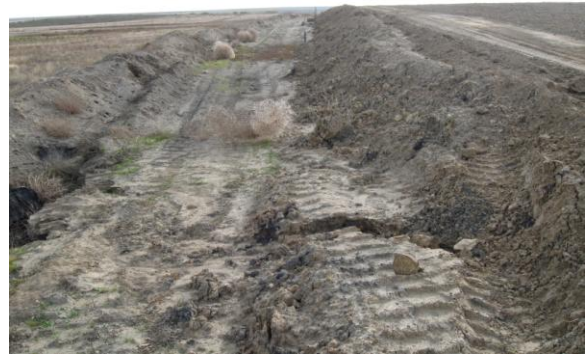
A relatively new area at the south end of the pit has been backfilled with a second bench of spoil material. Poles that are six feet in height have been placed in front of the backfilled area to insure the required depth of spoil has been placed in the pit. It appears the spoil has been backfilled to the required six foot depth in this area.

North end of recently placed spoil backfill.

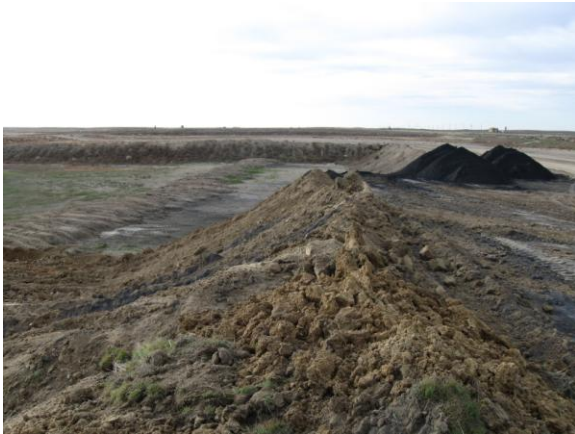
The Operator is actively backfilling the northwest corner of the B pit with fly ash. It appears two loads of Ash have been delivered to the site today.

From the northwest corner of B Pit looking south.

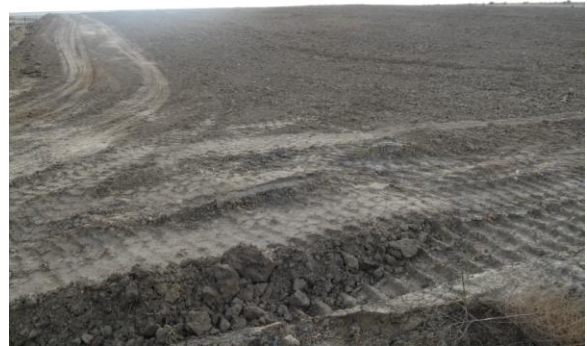
Two new areas are being prepared for topsand placement. According to Mr. Kipp, these areas will likely be labeled Area 33 and 32.

Area prepped for topsand placement.

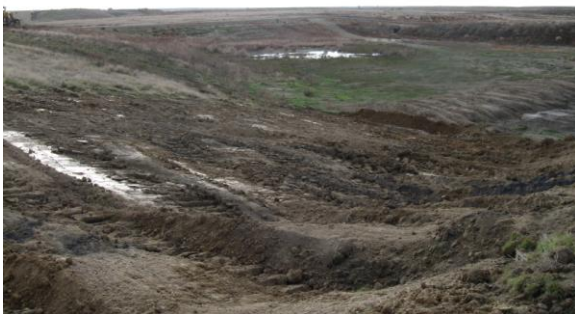
From the northwest corner of B Pit looking southeast.
