COLORADO DIVISION OF RECLAMATION, MINING AND SAFETY
MINERALS PROGRAM INSPECTION REPORT
PHONE: (303) 866-3567

MINE NAME: San Luis Project	MINE/PROSPECTING ID#: M-1988-112	MINERAL: Gold and silver	COUNTY: Costilla
INSPECTION TYPE: Multi Person Inspection	INSPECTOR(S): Wallace H. Erickson, G. Russell Means	INSP. DATE: May 13, 2013	INSP. TIME: 10:00
OPERATOR: Battle Mountain Resources, Inc.	OPERATOR REPRESENTATIVE: Julio Madrid, Steve Carino, Jim Witweir	TYPE OF OPERATION: 112d-3 - Designated Mining Operation	
REASON FOR INSPECTION: Citizen Complaint	BOND CALCULATION TYPE: Partial Bond	BOND AMOUNT: \$7,400,000.00	
DATE OF COMPLAINT: NA	POST INSP. CONTACTS: Complainant, OSE Dam Safety	JOINT INSP. AGENCY: OSE, DWR, Dam Safety, Mark Perry, PE	
WEATHER: Cloudy	INSPECTOR'S SIGNATURE: <i>Wallace H. Erickson</i>	SIGNATURE DATE: September 11, 2013

ENGINEER'S INSPECTION REPORT

DAM NAME: BATTLE MOUNTAIN SAN LUIS TAILINGS T: 0 R: 0 S: COUNTY: COSTILLA DATE OF INSPECTION: 5/13/2013
 DAM ID: 240109 YR Compl: 1991 DAM HEIGHT(FT): 140.0 SPILLWAY WIDTH(FT): 4.0 PREVIOUS INSPECTION:
 CLASS: N hazard DAM LENGTH(FT): 1640.0 SPILLWAY CAPACITY(CFS): 170.0 NORMAL STORAGE (AF): 750.0
 DIV: 3 WD: 24 CRESTW

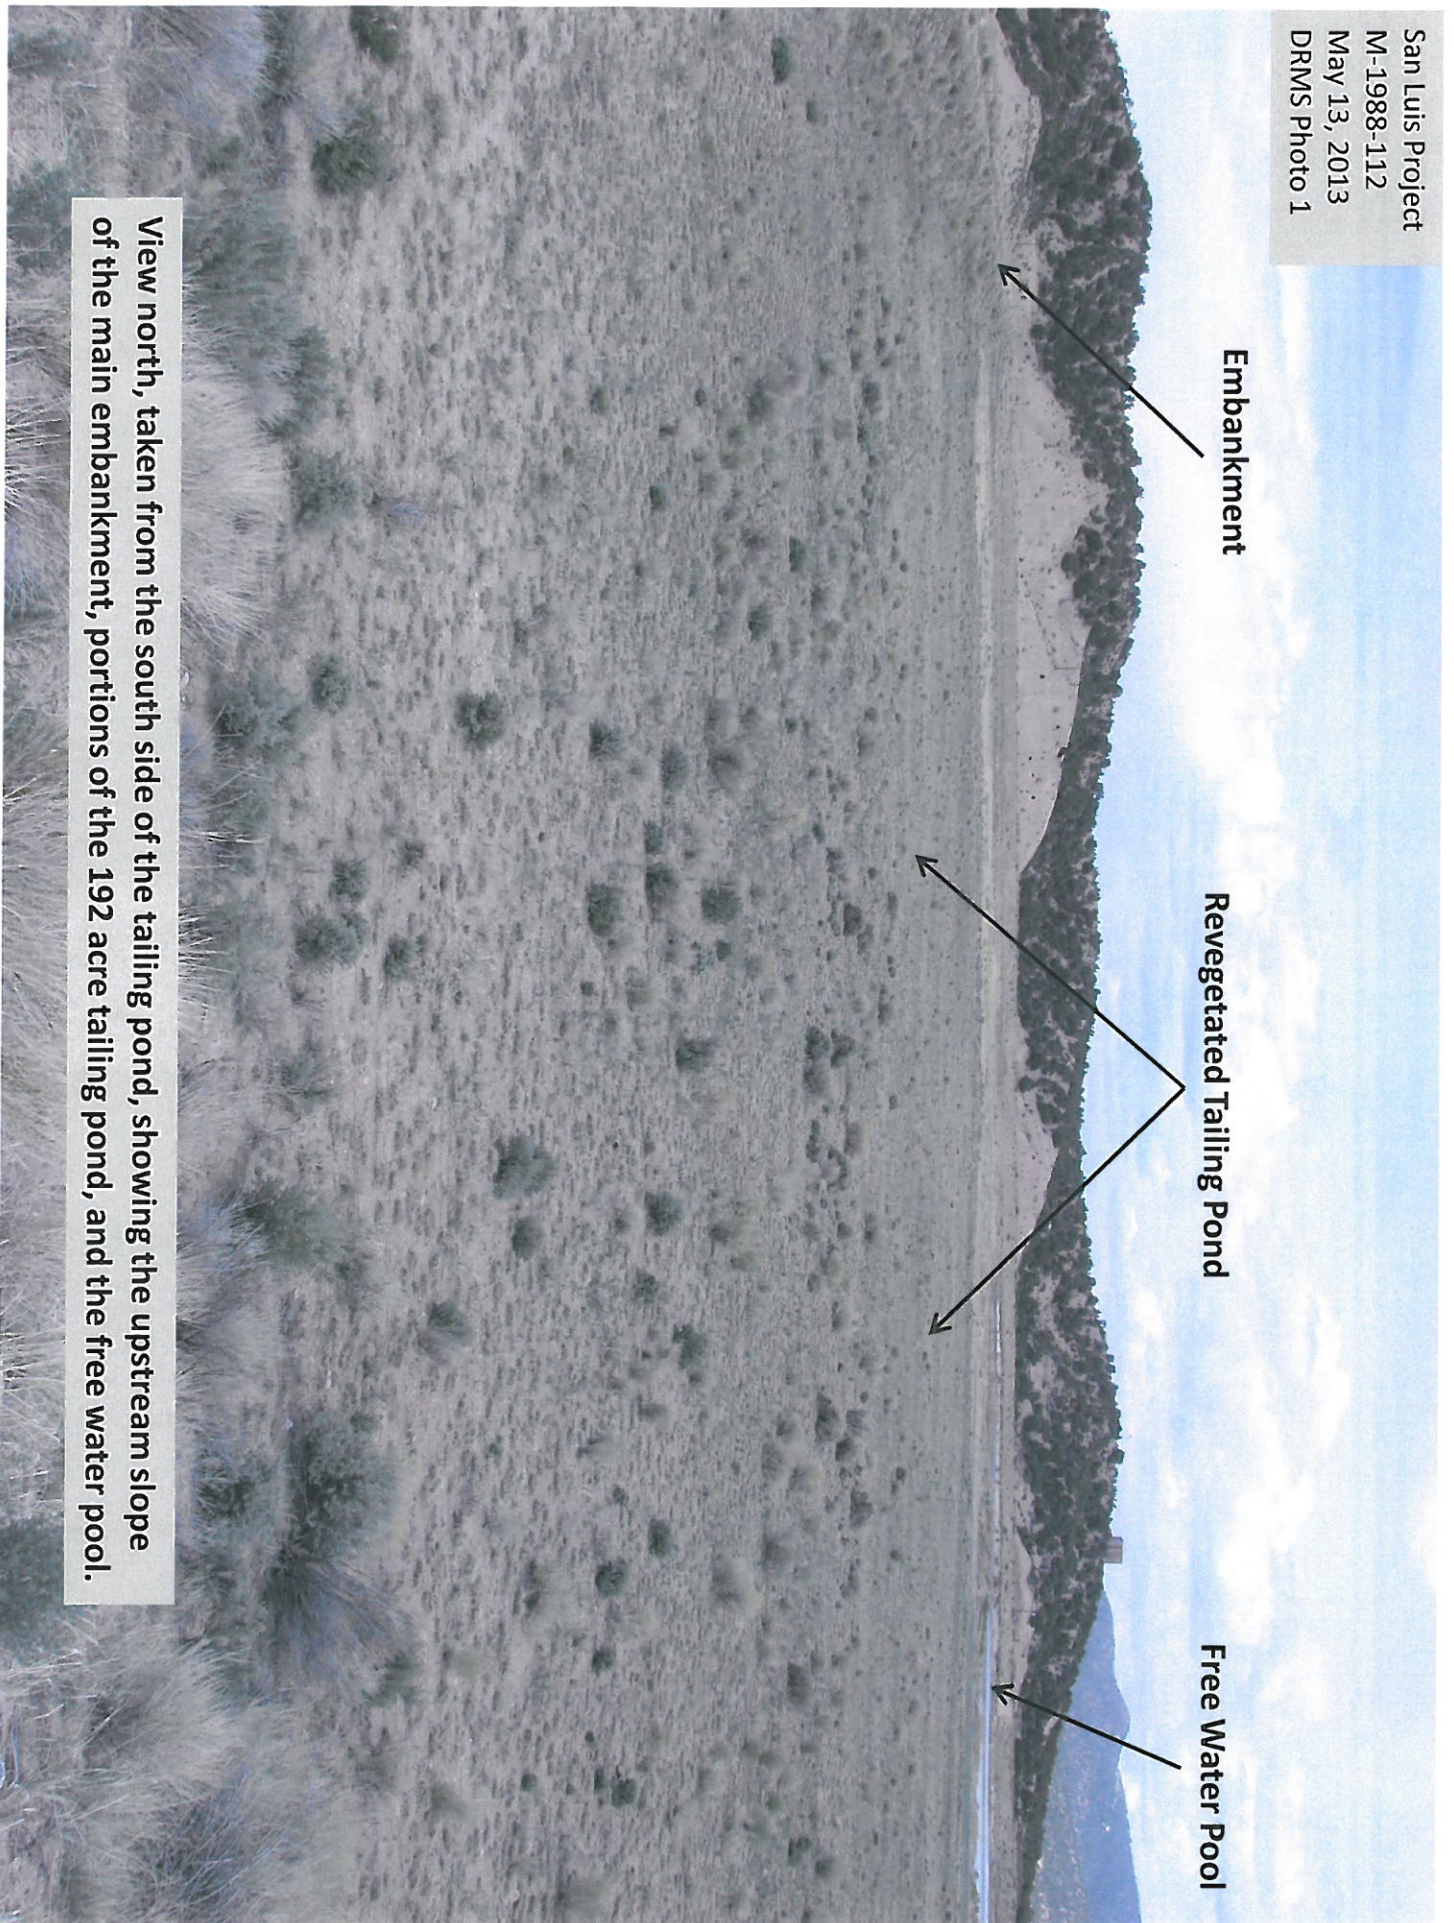
As shown in DRMS Photo 1, the upstream slope of the main embankment of the tailing pond was well vegetated and appeared stable; evidence of slumping, settling or excessive erosion was not observed. The surface area of the tailings is approximately 192 acres, which includes an approximate 20-acre area for the free water pool. The Operator identified markers at approximately 200 feet upstream from the embankment, which delineate the setback distance for the free water pool from the embankment. During the time of this inspection the free water pool was visually estimated at greater than 500 feet distance from the main embankment. The Operator indicated the current depth of the free water pool to be approximately 2 feet. The free water pool contains drainage from precipitation, fluids pumped from the collection pond, and brine and untreated West Pit water pumped from the water treatment plant.

View north, taken from the south side of the tailing pond, showing the upstream slope of the main embankment, portions of the 192 acre tailing pond, and the free water pool.

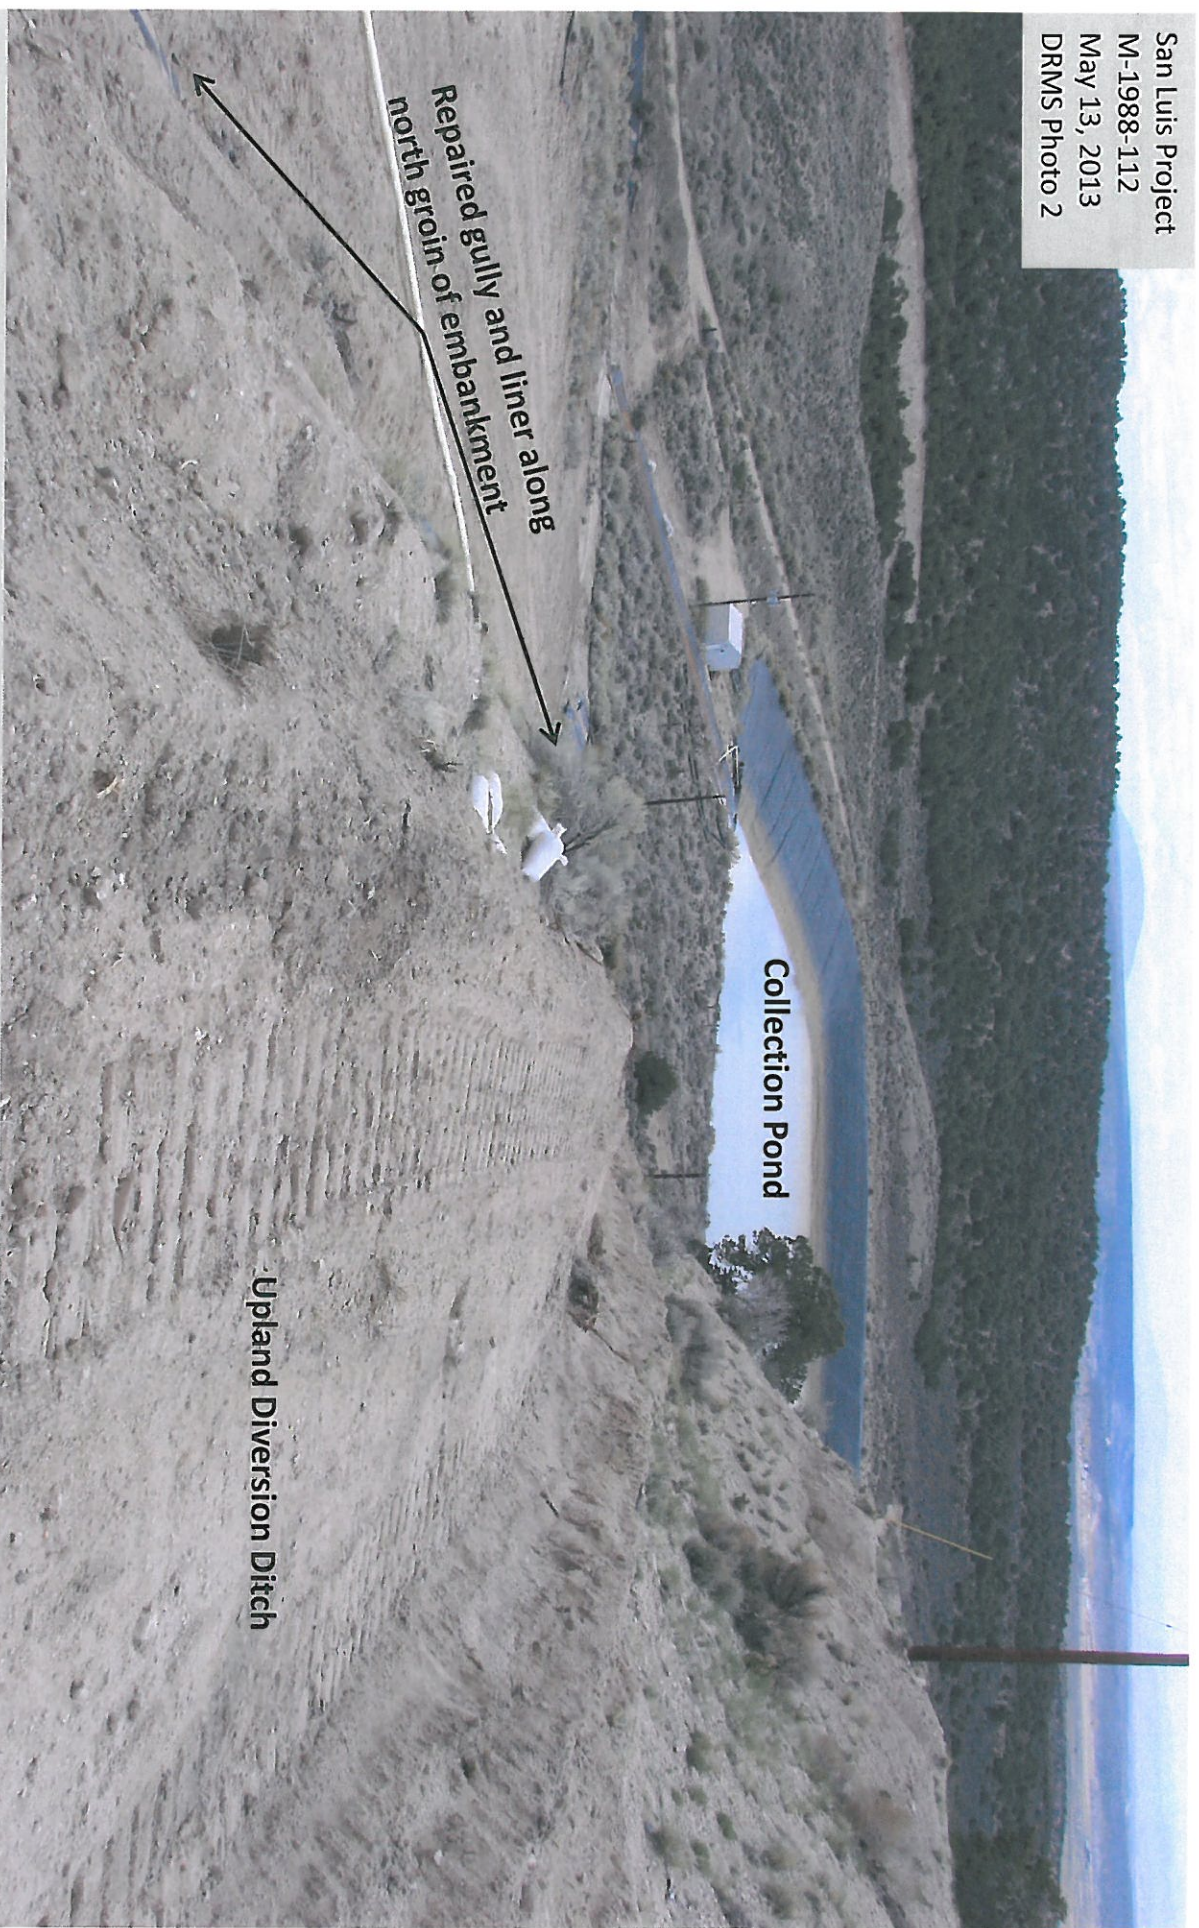
As shown in DRMS Photo 2, the Operator has recently completed routine maintenance and repair of minor erosion features on the downstream slope of the main embankment of the tailing pond. The area shown in photo 2 is located at the north end of the embankment, at the transition of the earthen embankment with the geosynthetic liner covering the native slope. The repairs included surface grading and reseeding, installation of new liner material to replace eroded liner, and excavation of a diversion ditch to intercept upland drainage

and thereby minimize potential for future erosion to the embankment. The recently disturbed area was visually estimated at 200 feet long by 50 feet wide, or approximately 0.23 acres. The downstream slope of the embankment was not steeper than 3H:1V, as indicated in the approved plans and as-built certifications for the embankment. The downstream slope of the embankment appeared well vegetated and stable; evidence of slumping, settling or excessive erosion was not observed.

View west, taken nearby the crest and north end of the main embankment of the tailing pond, showing portions of the downstream slope of the embankment and the collection pond of the tailings repository. The Operator had recently conducted routine maintenance to control erosion. Erosion control methods employed by the Operator included surface grading along the transition of the earthen embankment with the liner, replacement of eroded sections of the liner, and installed a diversion ditch to intercept upland drainage and minimize potential for future erosion to the embankment.

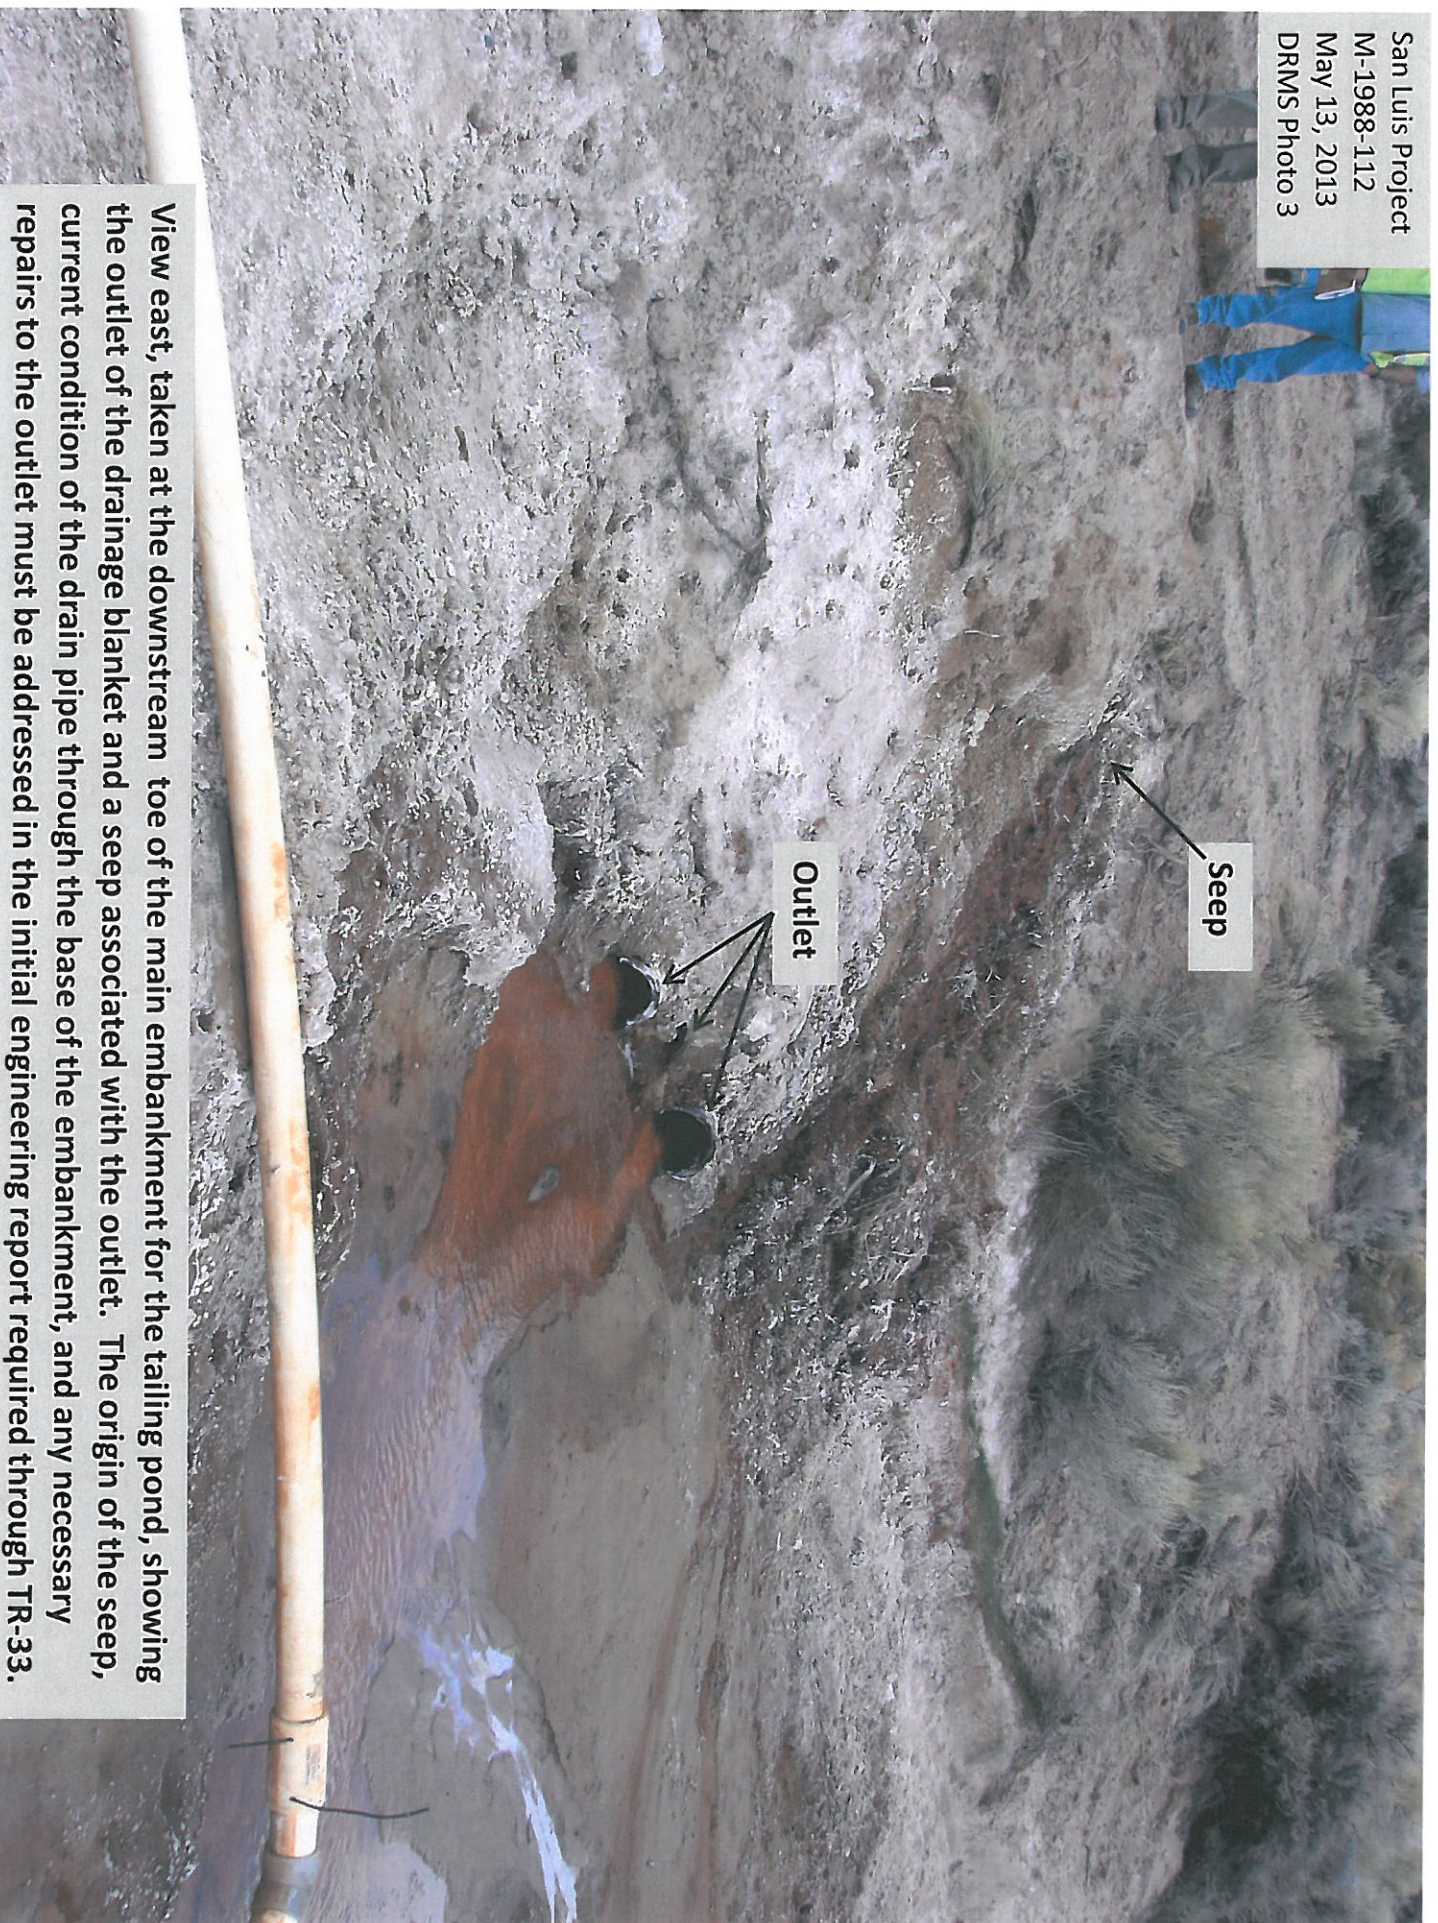
San Luis Project
M-1988-112
May 13, 2013
DRMS Photo 3

As shown in DRMS Photos 3 and 4, there is a seep associated with the outlet of the drainage blanket for the tailing pond. Flow rate from the outlet was estimated at 30 gpm and consistent with monthly flow reports recorded by the Operator. Although the outlet appeared to have sufficient capacity to function in accordance with the approved designs, routine maintenance to the outlet, to include sediment clean-out and stabilization of the slope immediately above the outlet, is required to ensure its continued function.

View east, taken at the downstream toe of the main embankment for the tailing pond, showing the outlet of the drainage blanket and a seep associated with the outlet. The origin of the seep, current condition of the drain pipe through the base of the embankment, and any necessary repairs to the outlet must be addressed in the initial engineering report required through TR-33.

The drainage blanket for the tailing pond and its associated outlet through the embankment are essential components of the tailings repository. As recommended in the enclosed Engineer's Inspection Report from Mr. Perry, the configuration of the existing drain-pipe upstream of the outlet, and the origin of the seep shown in photo 3, must be verified. Such investigations shall occur through the inspection and reporting program approved through TR-33. Any alteration to previously approved designs must be submitted for review and approval through the Technical Revision or Amendment process defined under Rules 1.9 and 1.10.

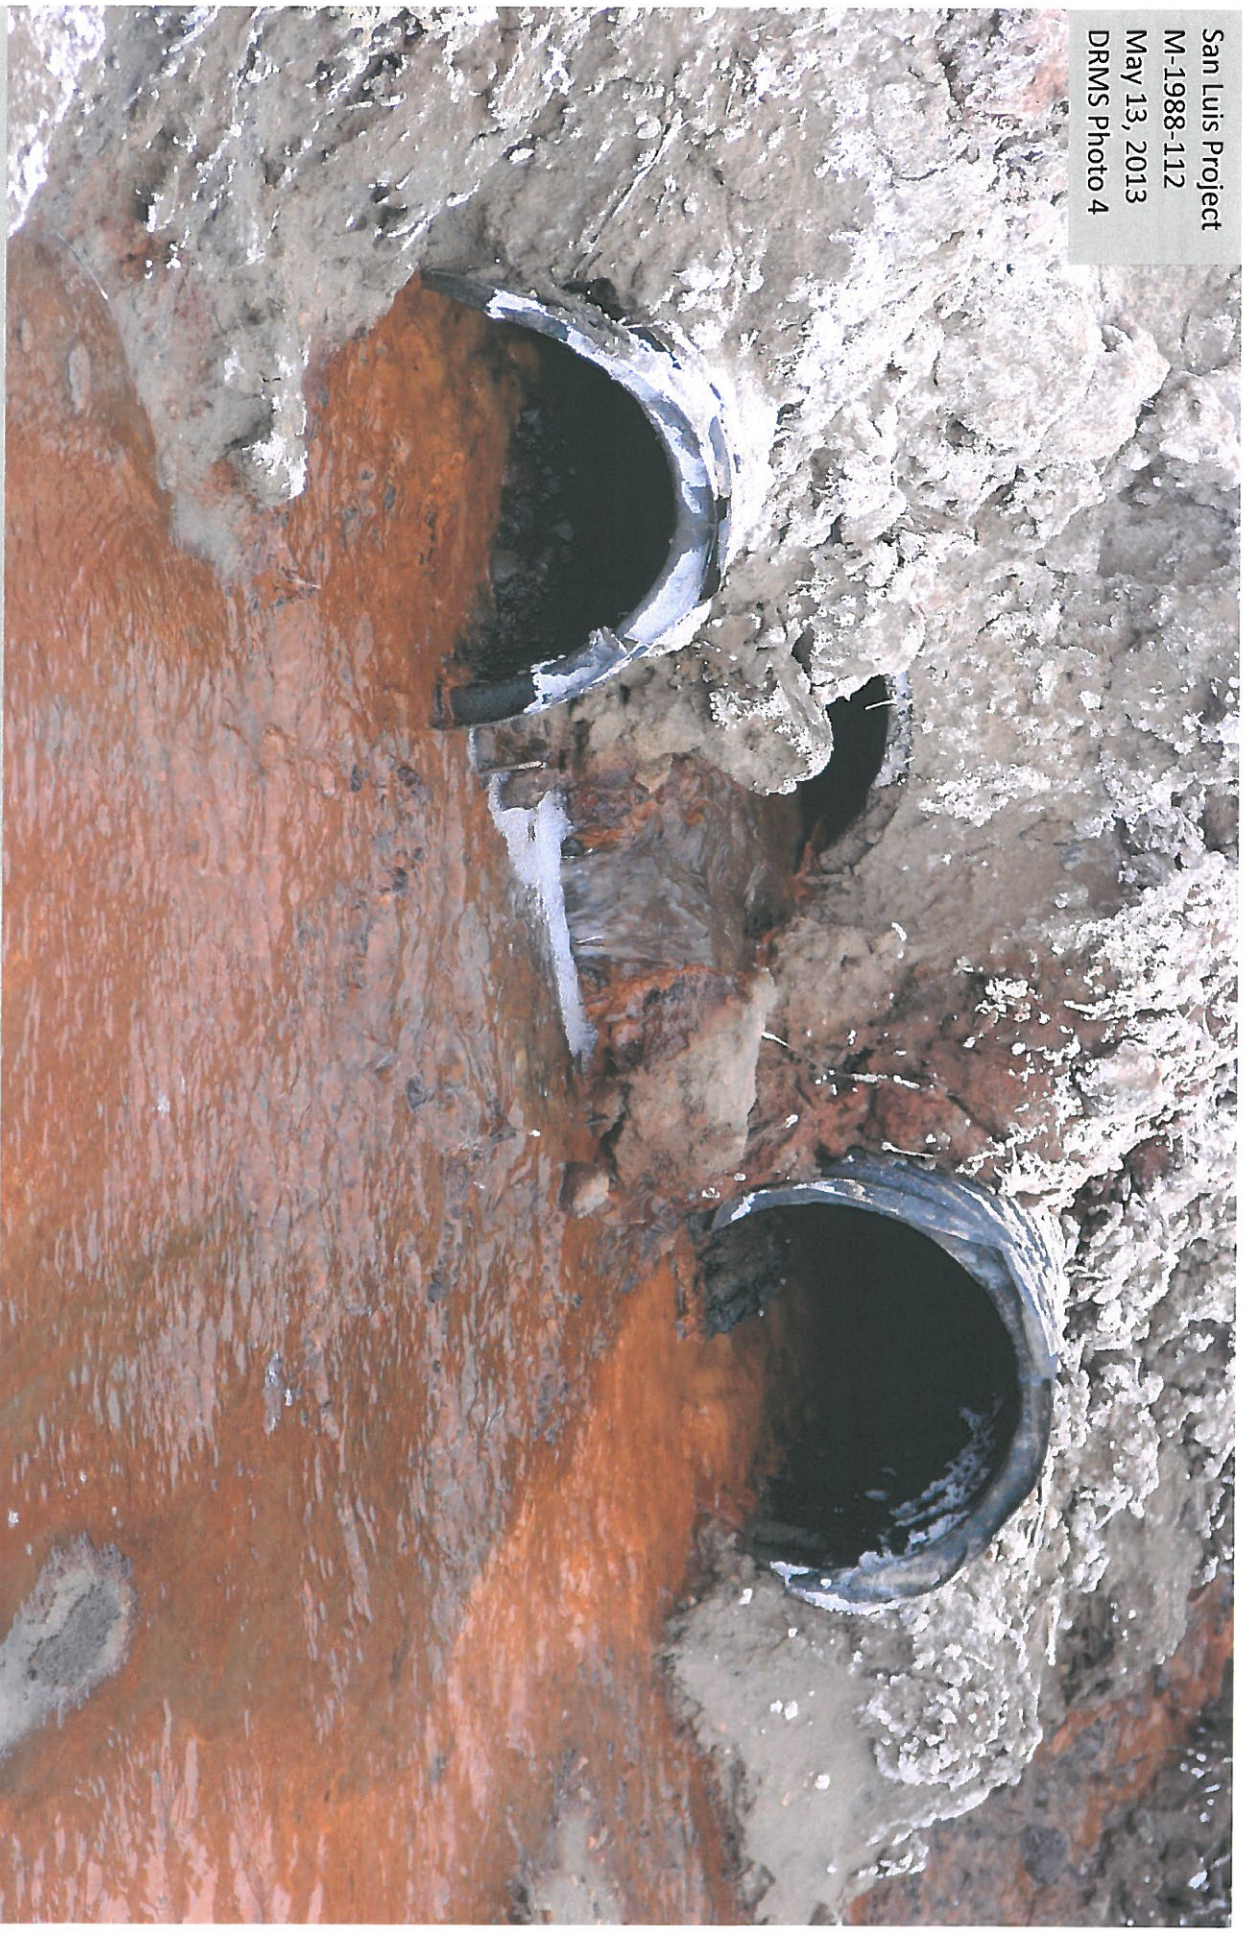
San Luis Project
M-1988-112
May 13, 2013
DRMS Photo 4

Detail photo of the drainage blanket outlet, shown in photo 3. Discharge from the outlet is contained at the collection pond and recycled to the free water pool for disposal by evaporation. Flow rate was estimated at 30 gpm. Routine maintenance to the outlet, to include sediment removal from the culverts and stabilization of the slope immediately above the culverts, appears necessary to ensure the outlet continues to function in accordance with approved designs.

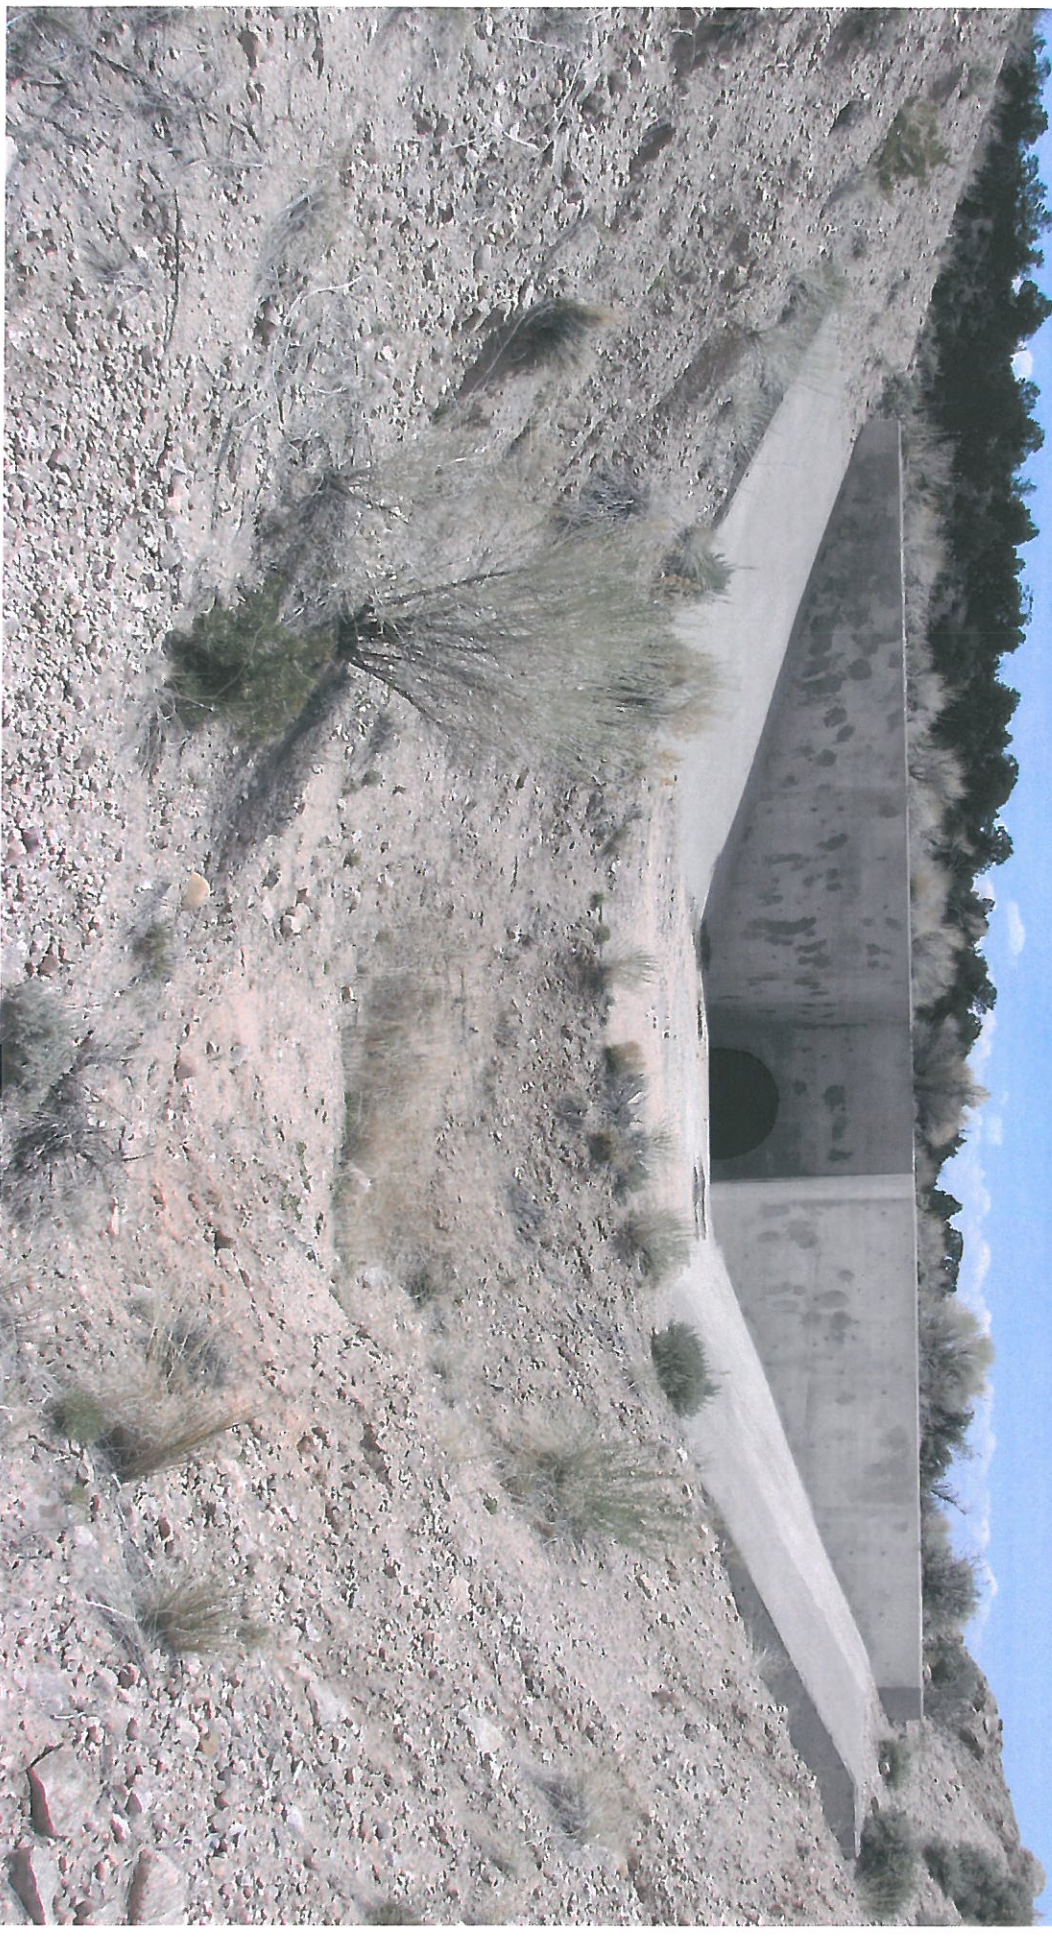
As shown in DRMS Photos 5 and 6, all portions of the south diversion ditch proximal to the embankment of the tailing pond appeared stable; evidence of erosion/sedimentation was not observed. However, as shown in photo 5, the inlet for the drop structure was not protected by a debris screen. As recommended by Mr. Perry, a properly designed debris screen appears essential to ensure the continued function of the drop structure. Please ensure the initial engineer inspection and report, required through TR-33, addresses the issue. If the engineer inspection and report recommends a debris screen, such plans must be submitted for review and approval through either the Technical Revision or Amendment process, described under Rules 1.9 and 1.10, prior to construction.

View west, showing portions of the upland diversion ditch for the south side of the tailings repository, and the inlet of its associated drop structure located at the crest of the embankment. The south upland diversion structure is designed to safely convey flows up to and including the 100 year, 24 hour storm event. Permit documents define the 100 year, 24 hour storm event at 2.9 inches precipitation and calculate storm runoff from the south drainage area at 292 cfs. As shown in this photo, the inlet of the drop structure did not include a debris screen.

•We observed that there is no trash rack on the drop structure intake. The SEO typically recommends a self-cleaning type trash rack for the intake of a closed conduit spillway in order to prevent clogging.

- ☒ (97) OTHER: **Consider installing a trash rack at the south diversion drop structure inlet.**
- ☒ (98) OTHER: **Perform an internal inspection of the south diversion drop structure conduit. ALSO we recommend evaluating how the Maximum Normal water level is controlled in both the main tailings dam and the seepage collection pond (See spillway sect. of this report).**

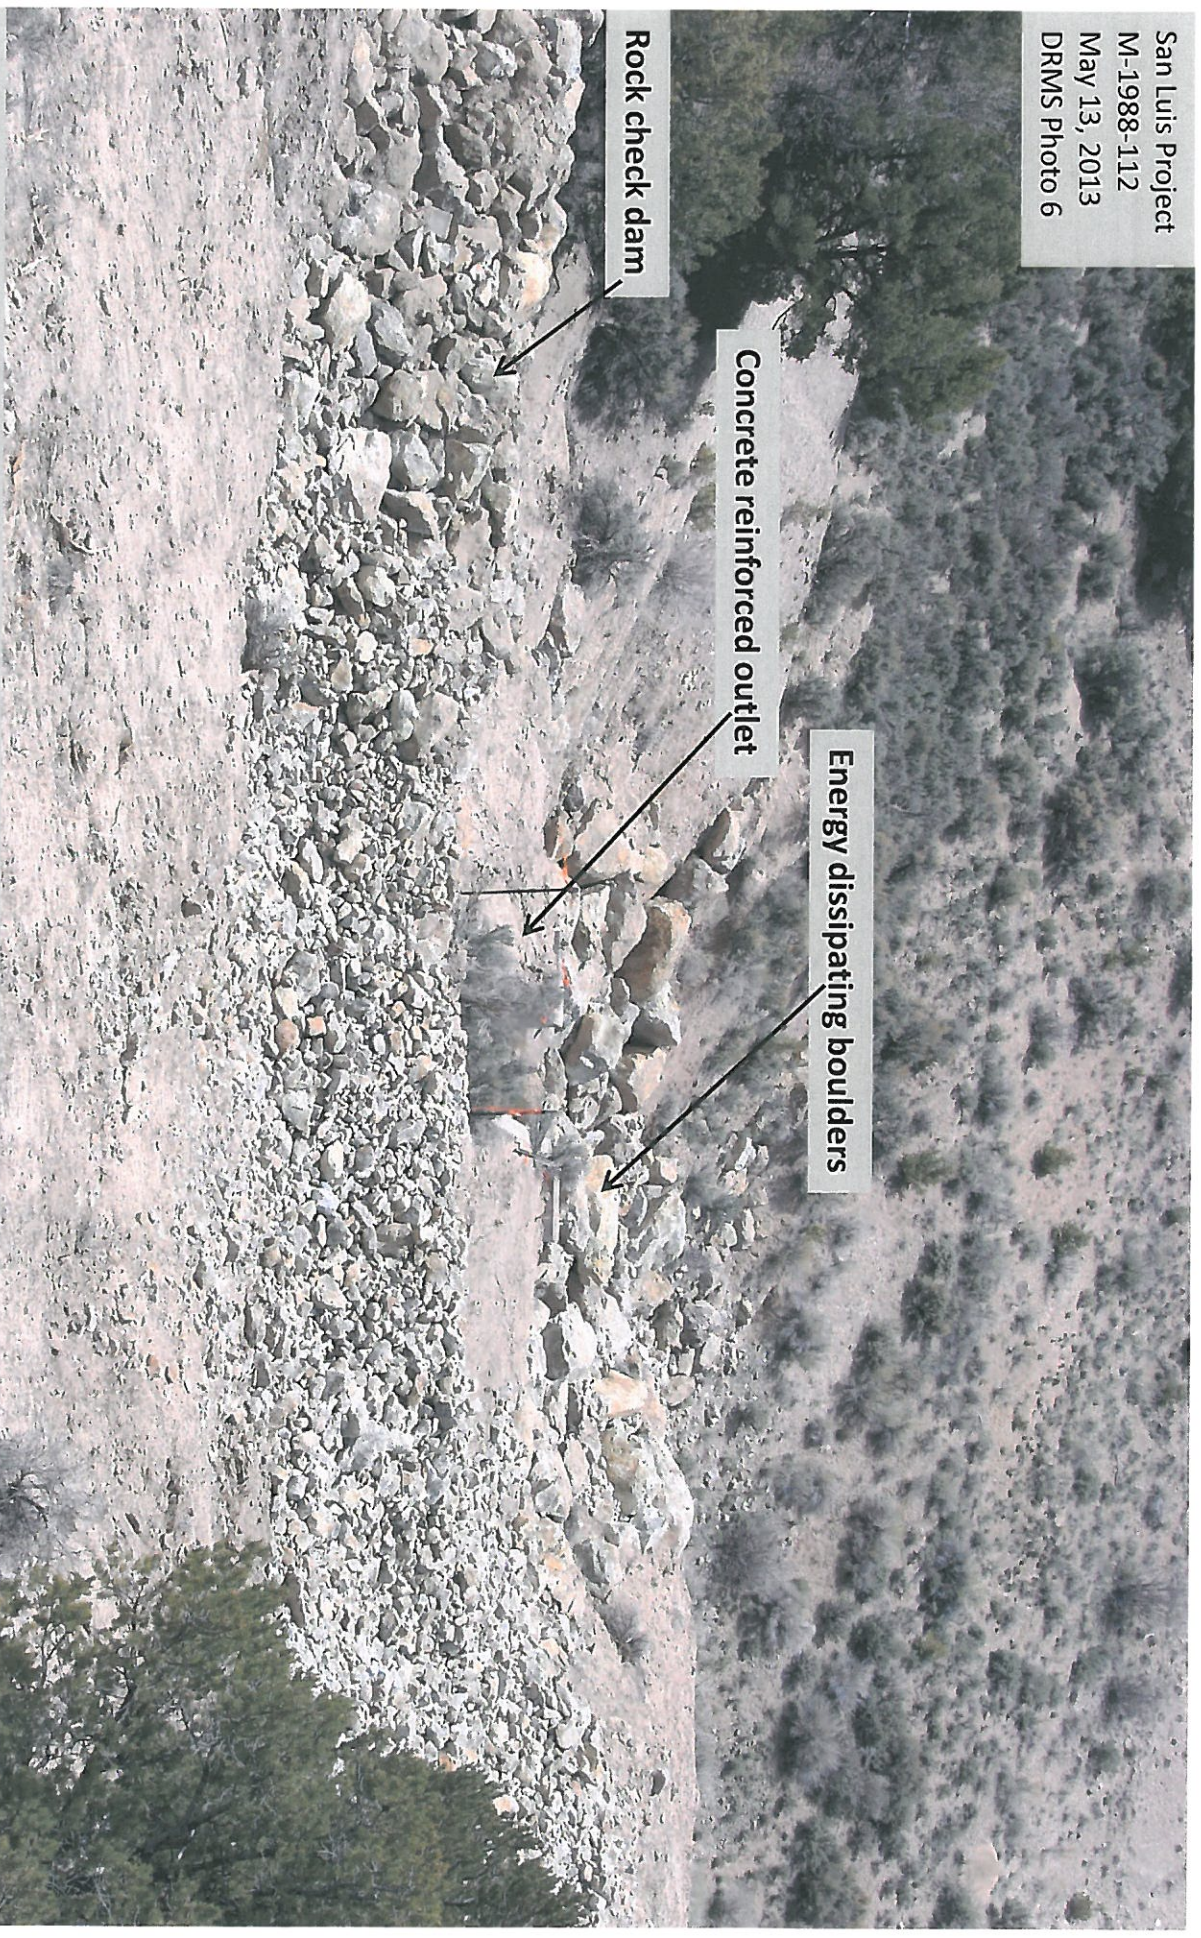
View west, taken nearby the crest and south end of the main embankment of the tailing pond, showing the drop structure outlet for the south diversion ditch. The Operator had recently conducted routine maintenance to control erosion. Erosion control methods employed by the Operator included surface grading, placement of riprap armoring, installation of rock check dam, and placement of energy dissipating boulders at the drop structure outlet. The outlet of the south diversion ditch appeared well maintained and stable; evidence of excessive erosion was not observed.

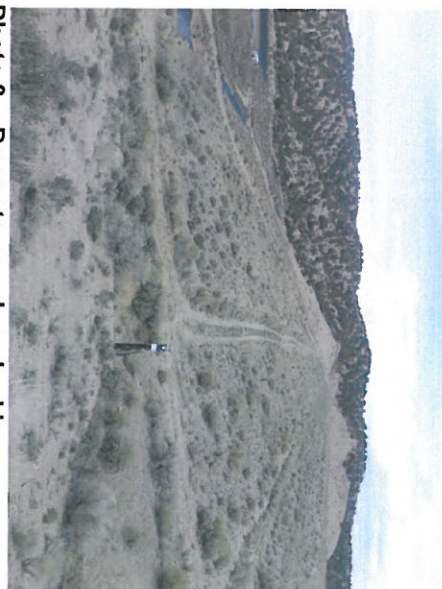
•The Phase I as-built plans show a 3H:1V downstream slope. The existing slope appears to be that or flatter. There are also 2 benches (~10-ft wide each) on top half of the slope.
 •Vegetation cover is typically sage brush, which is typical for the San Luis Valley climate. No significant surface erosion was observed on the slope. Spot repairs of erosion damage have been made at the right and left groins (see below).
 •Recent repairs to erosion damage and the liner were made at the right groin on the downstream slope (surface area of repair ~200' x 50'). A small diversion ditch was added on the right abutment to attempt to keep surface water off of the groin and liner. A similar repair was made at the left groin.

Photo 3 – Downstream slope looking right from the left abutment.

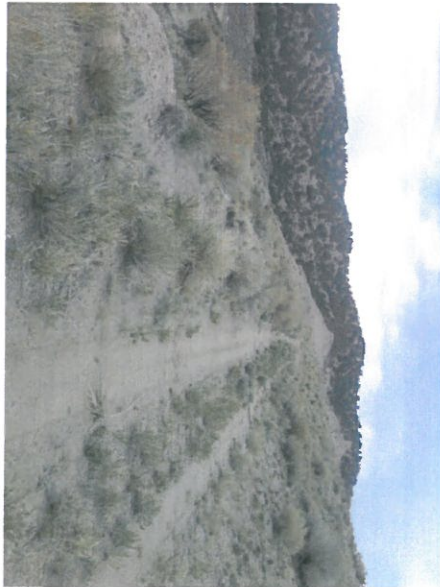
Photo 4 – Looking across one of two benches on the downstream slope.

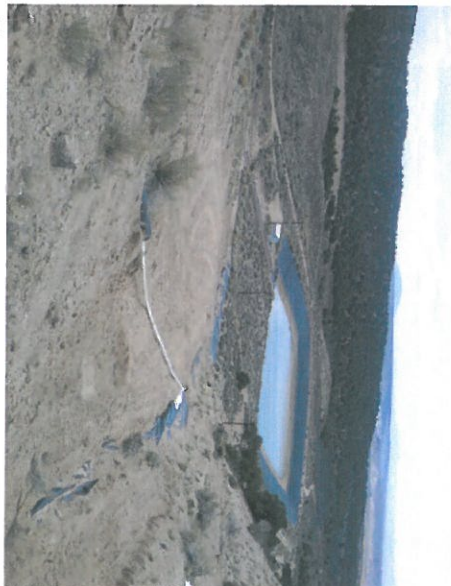
•The dam owner performs routine maintenance. We observed where they completed recent repairs of erosion damage along the right and left groins of the downstream slope and at the south diversion drop structure outfall.

Photo 5 – Foreground shows right groin where liner and erosion damage was recently repaired. Background: seepage collection pond at the downstream toe of the main dam.

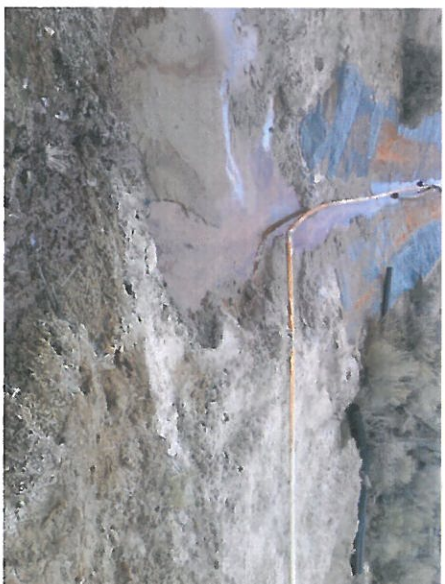
•Uncontrolled seepage was observed exiting ~6-ft above the 12" HDPE drain outfalls on the downstream slope of the main embankment.

Photo 8 – Seepage at toe of the main dam. Majority of seepage comes through collection drain, but some seepage appears to be uncontrolled (see Photo 9).

•Based on the above observations, we recommend:

(1) research to determine the design of the seepage collection pipe system under the embankment, and (2) after determining the design of the pipe collection system, determine if it is feasible to video inspect the pipes. The SEO recommends that internal outlet conduit video inspections be performed at least every 10 years for SEO-regulated High and Significant Hazard dams.

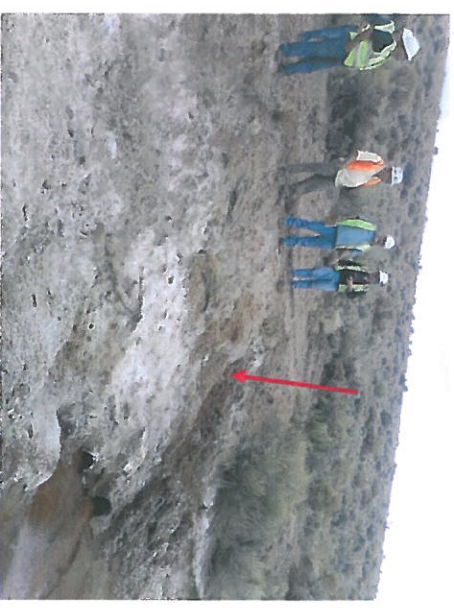
•Three 12" diameter HDPE pipes outfall at the downstream toe of the main embankment into an open channel to the seepage collection pond. The owner reports that the three pipes may be short extensions of what they believe is a larger (36"-48" dia.) HDPE seepage collection pipe under the main embankment. Again, no details of the collection pipe system were found by us on the Phase I as-built plans.

Photo 9 – Seepage drain outfall at the downstream toe (3x12" HDPE pipes). There is reportedly a large seepage collection pipe under the dam. NOTE: Uncontrolled seepage exiting higher on the slope above the drain outfalls (red arrow).
