**COLORADO DIVISION OF RECLAMATION, MINING AND SAFETY  
COAL PROGRAM INSPECTION REPORT**

<b>Permit Number:</b> C-1981-015 <b>Mine Name:</b> Fruita No 1 & 2 <b>Operator:</b> Dorchester Coal Company <b>Operator Address:</b> Greg Lewicki 9054 South Forrest Drive Highlands Ranch, CO 80126	<b>County:</b> Mesa <b>Operation Type:</b> Underground <b>Permit Status:</b> Revoked <b>Ownership:</b> Private
	<b>Operator Representative Present:</b>  None
<b>Operator Representative Signature: (Field Issuance Only)</b>

<b>Inspection Start Date:</b> October 16, 2013 <b>Inspection Start Time:</b> 09:00 <b>Inspection End Date:</b> October 16, 2013 <b>Inspection End Time:</b> 11:00	<b>Inspection Type:</b> Coal Complete Inspection <b>Inspection Reason:</b> Normal I&E Program <b>Weather:</b> Clear
<b>Joint Inspection Agency:</b>  None	<b>Joint Inspection Contacts:</b>  None
<b>Post Inspection Agency:</b>  None	<b>Post Inspection Contacts:</b>  None
<b>Inspector(s):</b>  Zach T. Trujillo	<b>Inspector's Signature:</b>

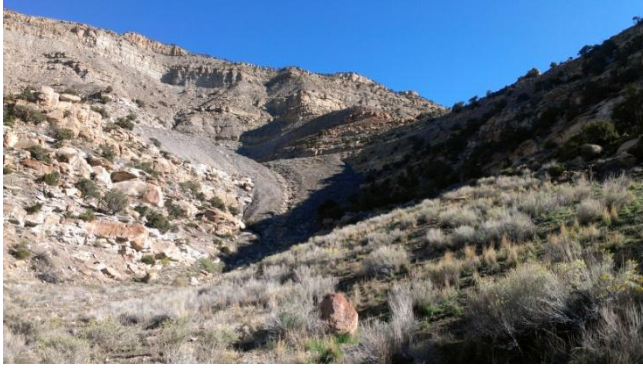
The steep drainage slope also remains stable.

Steep drainage slope.

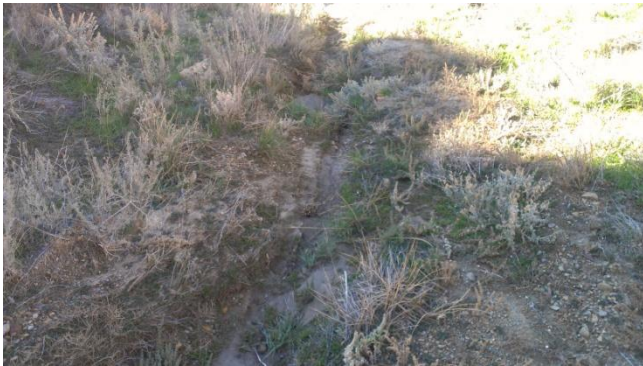
Overall the mine site was dry during the inspection. Sections were moist due to a recent precipitation event. The main drainage channel down the face of the slope is well armored with rip rap. No erosion or cutting was noted in this channel. Small rills were forming along the face area of the slope. The remaining sediment pond's floor was partially saturated near the ditch inlet to the pond during the inspection. Embankments were well vegetated. The spillway was covered with rip rap and vegetation and erosion or cutting was observed.

Rill forming on drainage slope.

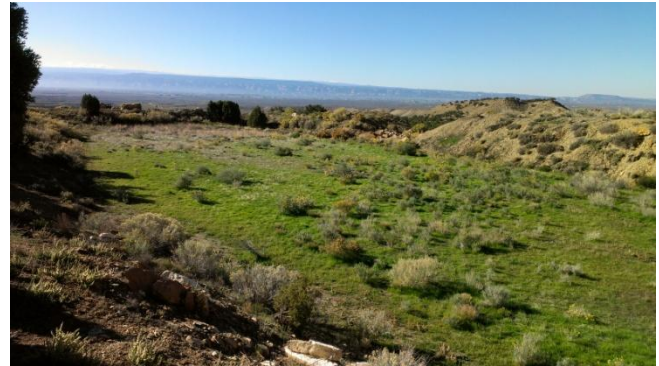
Sediment pond.

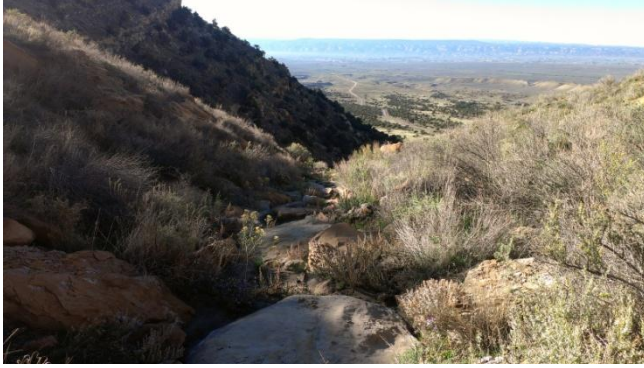
Constructed drainage channel.
