**COLORADO DIVISION OF RECLAMATION, MINING AND SAFETY
COAL PROGRAM INSPECTION REPORT**

Permit Number: C-1981-020 Mine Name: Munger Canyon Mine Operator: CAM Mining, LLC Operator Address: Mr Gary Isaac P.O. Box 98 Loma, CO 81524	County: Garfield, Mesa Operation Type: Underground Permit Status: Permanent Cessation Ownership: Federal
	Operator Representative Present: None
Operator Representative Signature: (Field Issuance Only)

Inspection Start Date: October 15, 2013 Inspection Start Time: 13:00 Inspection End Date: October 16, 2013 Inspection End Time: 14:00	Inspection Type: Coal Complete Inspection Inspection Reason: Normal I&E Program Weather: Clear
Joint Inspection Agency: None	Joint Inspection Contacts: None
Post Inspection Agency: None	Post Inspection Contacts: None
Inspector(s): Zach T. Trujillo Michael P. Boulay	Inspector's Signature:

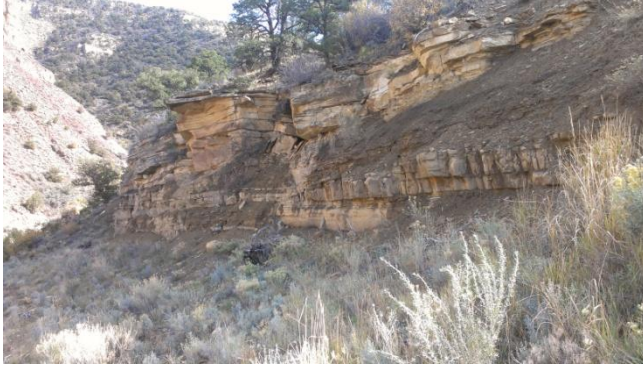
The backfilled and regraded portals and associated access road remains stable. No signs of slumping or sloughing were observed. Roughening of the reclaimed slopes appears to be successful with erosion control and contributing to vegetation success. No issues were noted.

Reclaimed portals.

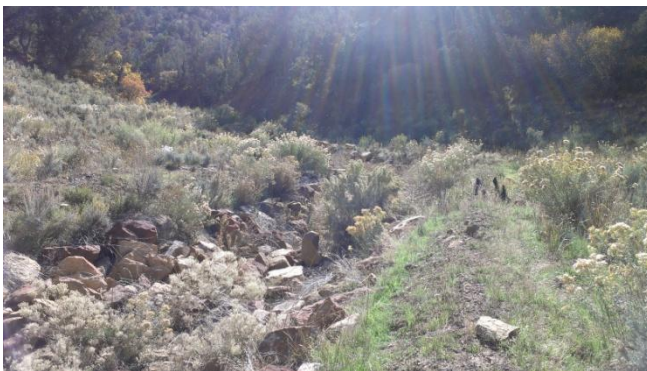
The ten permanent channels A through H were inspected. All channels were stable and well armored with rip rap. No cutting or erosion was observed in any of the channels.

Permanent channel along the reclaimed access road.

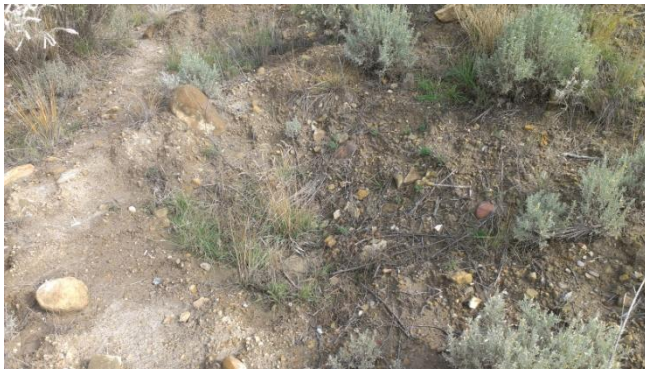
Vegetation along the reclaimed access road was diverse and well established.

Successful roughening with vegetation.

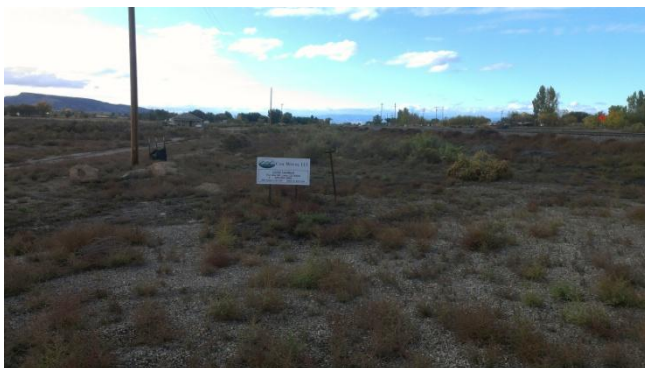
The Loma Loadout was inspected on October 16, 2013. The identification sign was located before the site with all the required information necessary for compliance. The site was surrounded by berms leading to a silt fence for erosion control. The silt fence was keyed in and was functioning as designed.

Loma Loadout with sign.
