COLORADO DIVISION OF RECLAMATION, MINING AND SAFETY COAL PROGRAM INSPECTION REPORT

Permit Number: C-1980-004 Mine Name: McClane Canyon Mine Operator: McClane Canyon Mining, LLC Operator Address: Mr Gary Isaac P.O. Box 98 Loma, CO 81524	County: Garfield Operation Type: Underground Permit Status: Temporary Cessation Ownership: Federal
	Operator Representative Present: None
Operator Representative Signature: (Field Issuance Only)

Inspection Start Date: October 15, 2013 Inspection Start Time: 15:00 Inspection End Date: October 16, 2013 Inspection End Time: 14:00	Inspection Type: Coal Complete Inspection Inspection Reason: Normal I&E Program Weather: Clear
Joint Inspection Agency: None	Joint Inspection Contacts: None
Post Inspection Agency: None	Post Inspection Contacts: None
Inspector(s): Zach T. Trujillo Michael P. Boulay	Inspector's Signature:

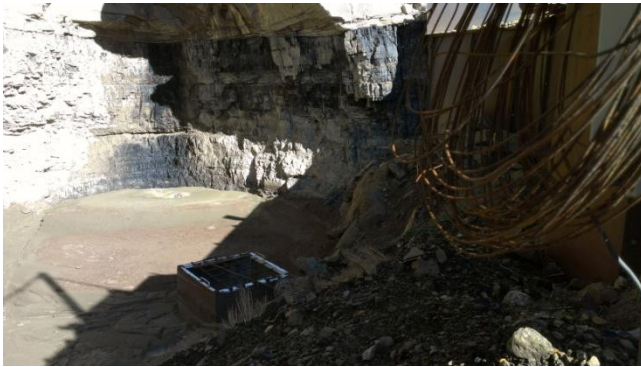
The upland clean water raised box culvert was inspected. No water was being conveyed by the culvert and the collection area around the culvert was dry. The inlet to the culvert was clear of all debris.

Clean water raised box culvert.

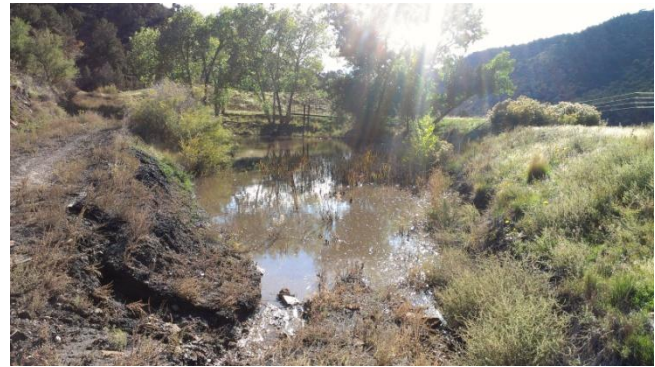
The majority of the surface disturbance along the facility area of the McClane Canyon Mine is directed to the one sediment pond by a series of ditches. Ditches along the facility area were in good shape with no cutting observed. The lone sediment pond held water above the principle spillway. The principle spillway of the sediment pond has a controlled inlet and was not discharging at the time of the inspection. The remaining area of surface disturbance has surface runoff report to two separate silt fences near the entrance to the mine site. Both silt fences were working as designed and were properly installed. Sediment has built up along the silt fences and may need cleaned in the future.

Sediment pond.

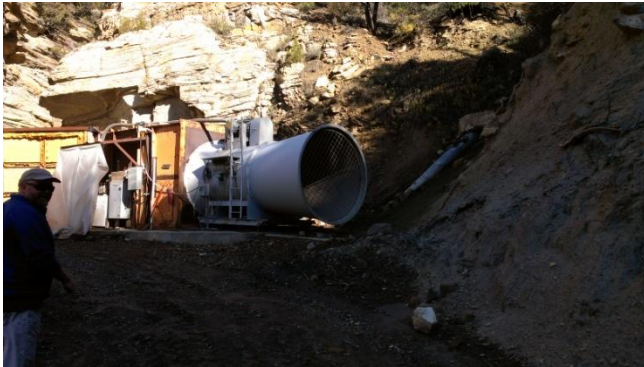
The mine ventilation fan was running at the time of the inspection. The fan is to continue running while the portal entrances to the mine are open.

Mine ventilation fan.
