**COLORADO DIVISION OF RECLAMATION, MINING AND SAFETY
COAL PROGRAM INSPECTION REPORT**

Permit Number: C-1981-018 Mine Name: Deserado Mine Operator: Blue Mountain Energy, Inc Operator Address: Mr Scott Wanstedt 3607 County Road 65 Rangely, CO 81648	County: Rio Blanco Operation Type: Underground Permit Status: Active Ownership: Federal
Operator Representative Present: Scott Wanstedt	
Operator Representative Signature: (Field Issuance Only)

Inspection Start Date: October 17, 2013 Inspection Start Time: 11:30 Inspection End Date: October 17, 2013 Inspection End Time: 14:30	Inspection Type: Coal Partial Inspection Inspection Reason: Normal I&E Program Weather: Clear
Joint Inspection Agency: None	Joint Inspection Contacts: None
Post Inspection Agency: None	Post Inspection Contacts: None
Inspector(s): Zach T. Trujillo	Inspector's Signature:

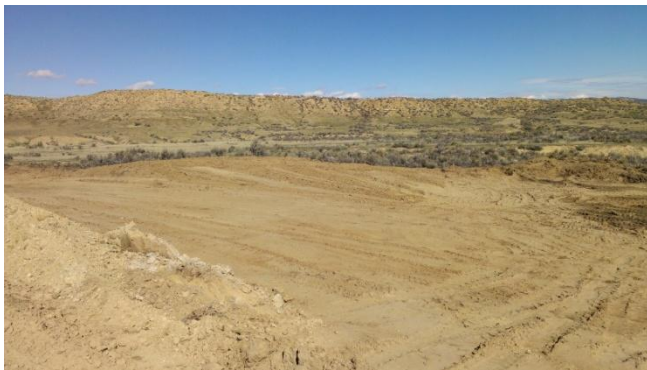
Drill pad was constructed and graded for construction of rock dust tank and blower. Two levels of pads were constructed. The east pad for the rock dust tank and the west pad for the blower. The site was fresh and still being constructed. Erosion control measures will be included as construction continues.

Constructed pad for rock dust tank and blower.

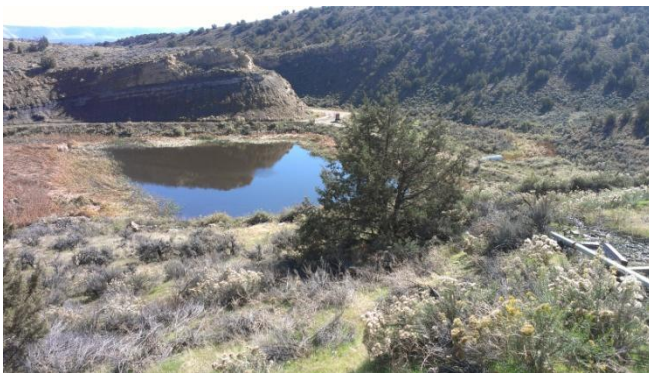
The facility pond DP-1 held water with no discharge. Water levels in the pond have been reduced for future cattail management around the embankments. Pond and associated spillways were stable with no issues noted. The two channels from the facility benches were stable. The main channel was well armored with rip rap and the secondary channel was showed no signs of erosion or cutting.

Pond DP-1.

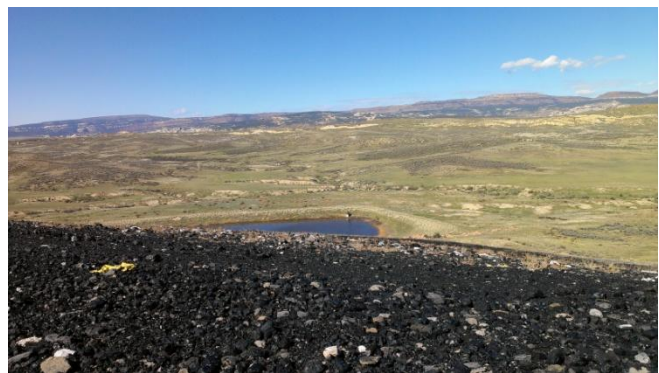
Pond RP-1 was dry and stable. Refuse pile ponds RP-2/3, RP-4 and PR-5 all held water. None of the ponds were discharging. No issues were observed with the refuse pile ponds.

Refuse pile pond PR-4.
