COLORADO DIVISION OF RECLAMATION, MINING AND SAFETY
MINERALS PROGRAM INSPECTION REPORT
PHONE: (303) 866-3567

MINE NAME: Sooner Lucky Strike Mine Ltd	MINE/PROSPECTING ID#: M-1982-020	MINERAL: Gold and silver	COUNTY: Gunnison
INSPECTION TYPE: Monitoring	INSPECTOR(S): Bob Oswald	INSP. DATE: October 10, 2013	INSP. TIME: 16:00
OPERATOR: Aspen Mineral Resources, Inc.	OPERATOR REPRESENTATIVE: John McGrath	TYPE OF OPERATION: 110(2) - Hard Rock Limited Impact

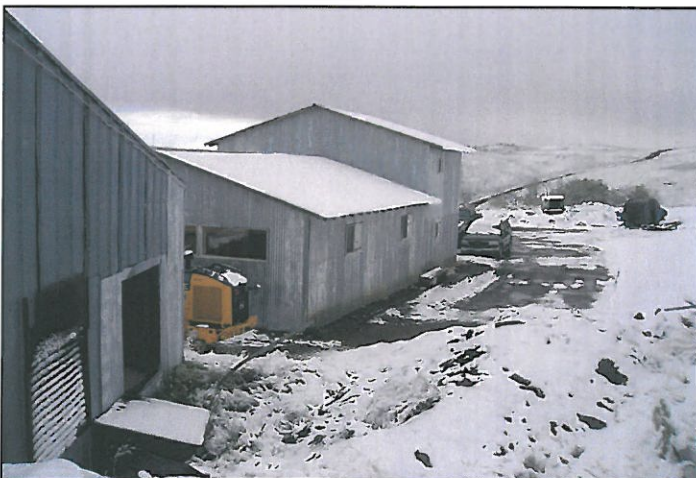
Generator bldg on left, office/dry in center

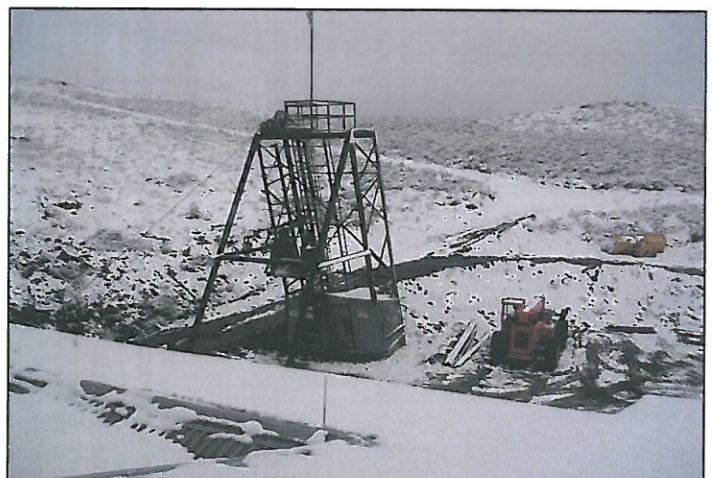
Headframe, looking south from mill bldg

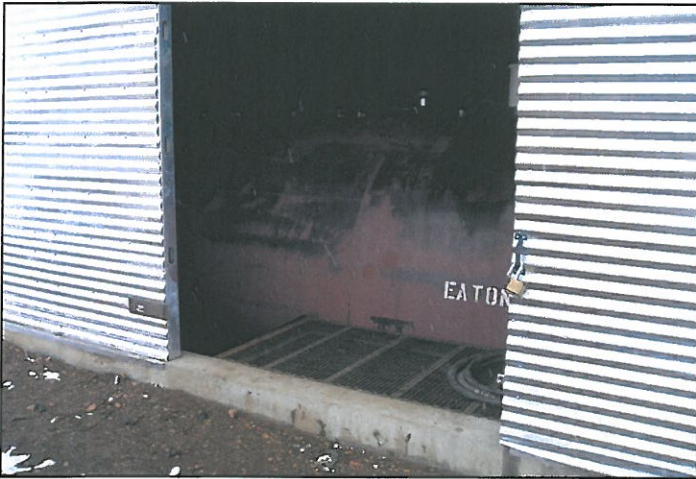
All chemicals will be listed in the EPP, including the maximum quantity stored, whether it is dry or liquid, type of packaging, type of secondary containment, where it is stored and used on the site, and MSDS. This should include all hydrocarbons such as fuel, hydraulic fluid, lube, oil and used oil. Chemical storage (dry and liquid) is secure and within secondary containment in the mill currently. Diesel is stored in a new 10,000-gallon steel tank, mounted in a concrete containment sump, inside a locked steel building. It supplies the diesel generator/compressor, housed within a steel building with concrete floor.

Diesel tank in fuel storage bldg

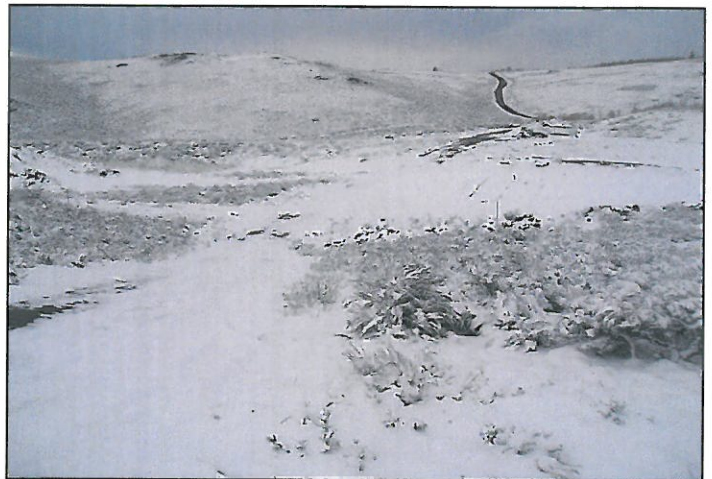
There is a sediment pond within the larger tailings impoundment, created recently by bulldozing some of the

old surface tails. Neither of the ponds is lined, and neither was observed to be impounding water. No new tailings are in the tailings disposal area at this time, but the operator wishes to begin mining and milling at a date in the near future. Obviously it is important to know whether the milling operation and tailings disposal contribute to water quality degradation. An important aspect of a DMO permit, detailed in the EPP requirements, is a water quality (WQ) monitoring program. This was discussed onsite, and will be one of the initial activities to be performed, in order to characterize and define the water quality baseline and trends. A minimum of five consecutive quarterly samples is required for a baseline. Since the operator wishes to commence mining and milling soon, the operator should commence WQ sampling as soon as possible.

Tailings dam on left, sediment pond on right

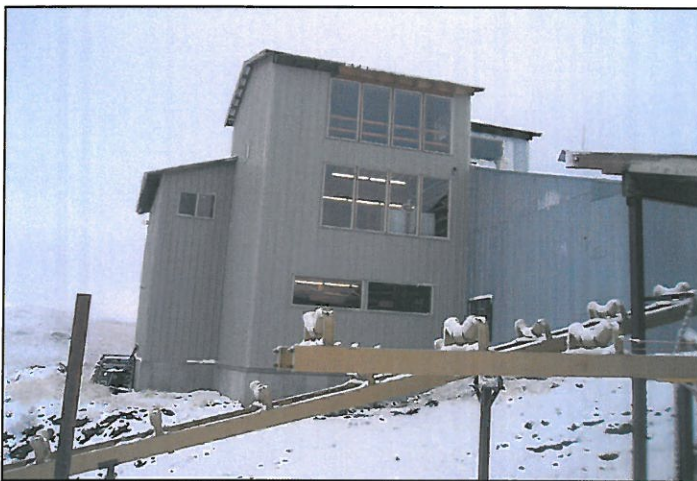
Looking north at new part of mill bldg

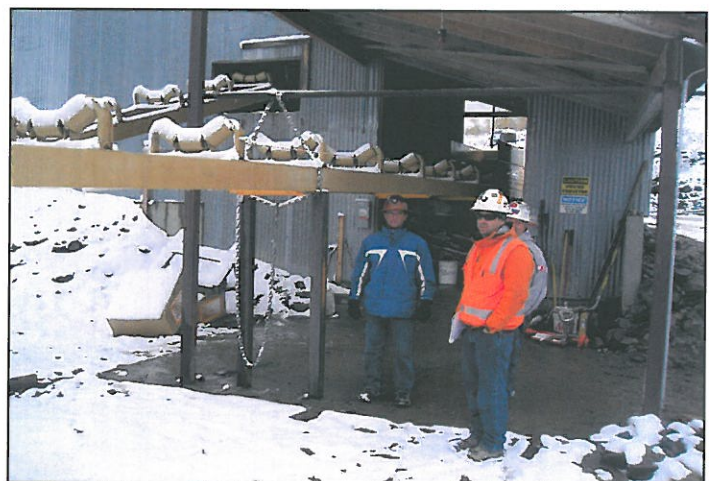
New ore conveyors being installed

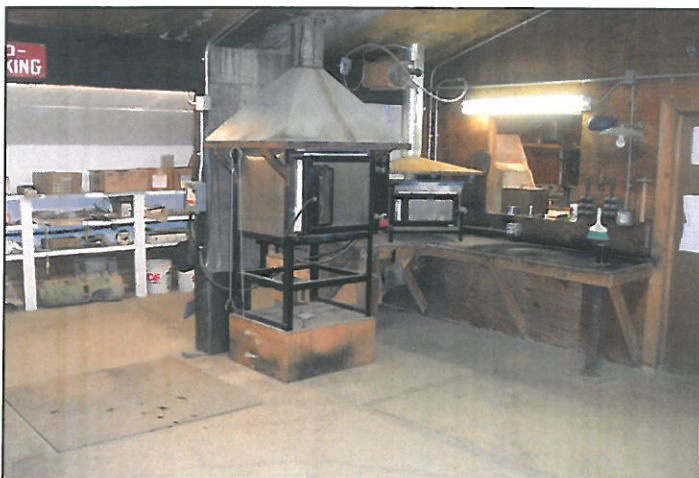
Assay area with furnace, in mill bldg

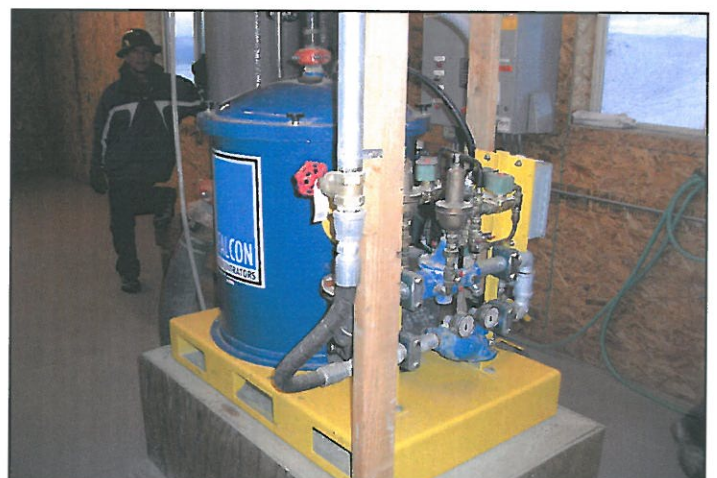
Falcon concentrator in mill bldg
