**COLORADO DIVISION OF RECLAMATION, MINING AND SAFETY**  
**MINERALS PROGRAM INSPECTION REPORT**  
**PHONE: (303) 866-3567**

<b>MINE NAME:</b> Stonewall #1	<b>MINE/PROSPECTING ID#:</b> M-2013-053	<b>MINERAL:</b> Borrow material for and aggregate	<b>COUNTY:</b> Las Animas
<b>INSPECTION TYPE:</b> Preoperation Inspection	<b>INSPECTOR(S):</b> Tyler V. O'Donnell	<b>INSP. DATE:</b> October 17, 2013	<b>INSP. TIME:</b> 15:45
<b>OPERATOR:</b> ALL-RITE PAVING & REDI-MIX, INC.	<b>OPERATOR REPRESENTATIVE:</b> Consultant: Angela Bellantoni	<b>TYPE OF OPERATION:</b> 112c - Construction Regular Operation

<b>REASON FOR INSPECTION:</b> Pre-operation Inspection	<b>BOND CALCULATION TYPE:</b> Complete Bond	<b>BOND AMOUNT:</b> None
<b>DATE OF COMPLAINT:</b> NA	<b>POST INSP. CONTACTS:</b> None	<b>JOINT INSP. AGENCY:</b> None
<b>WEATHER:</b> Clear	<b>INSPECTOR'S SIGNATURE:</b> <i>Tyler O'Donnell</i>	<b>SIGNATURE DATE:</b> October 24, 2013

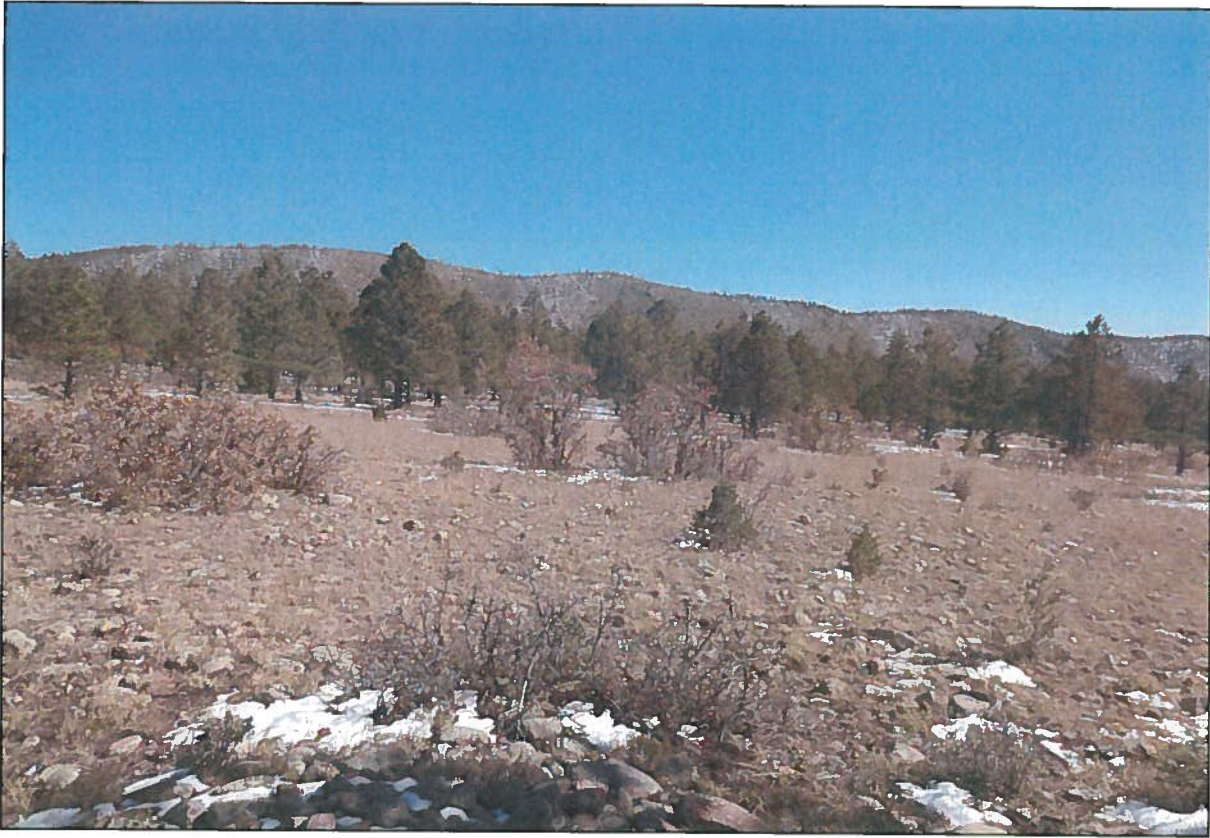
**Photo 1:** View looking southeast from the northwestern corner of the proposed permit boundary.

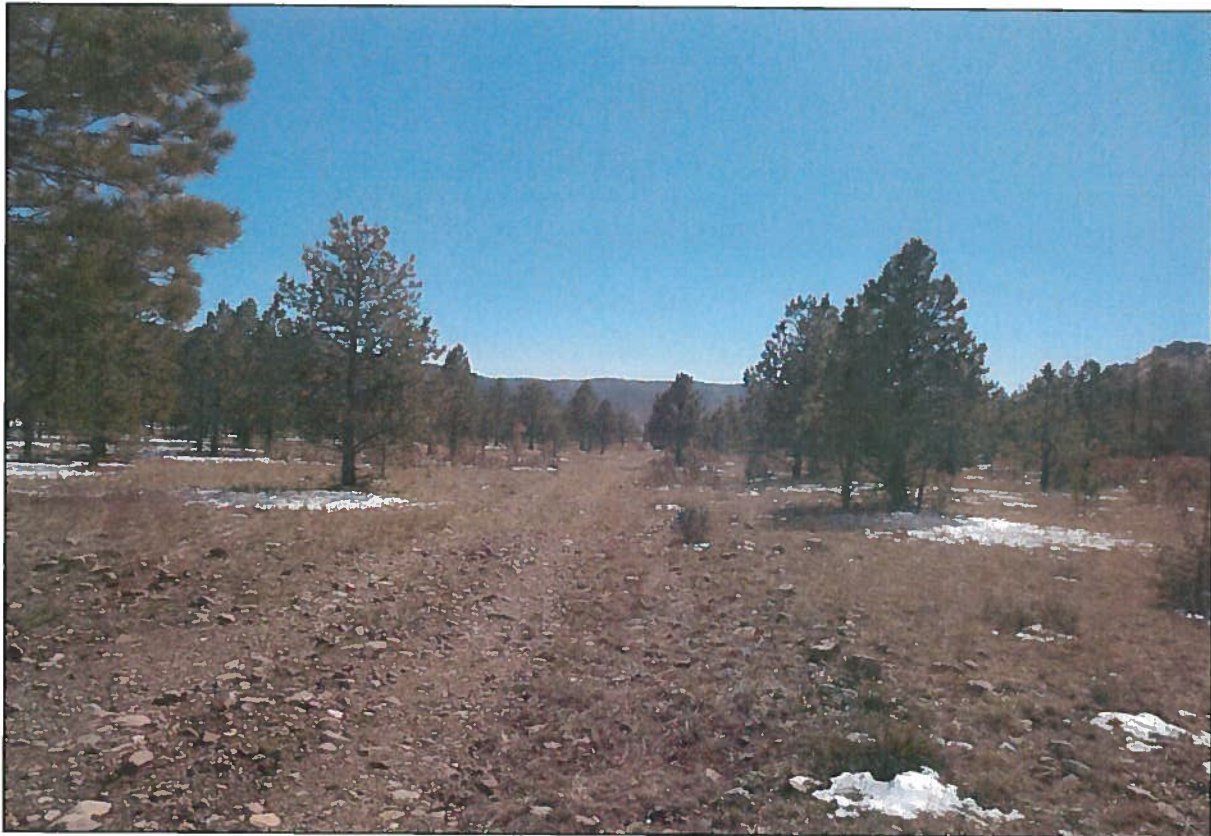
**Photo 2:** View looking south from the center of the old airstrip.

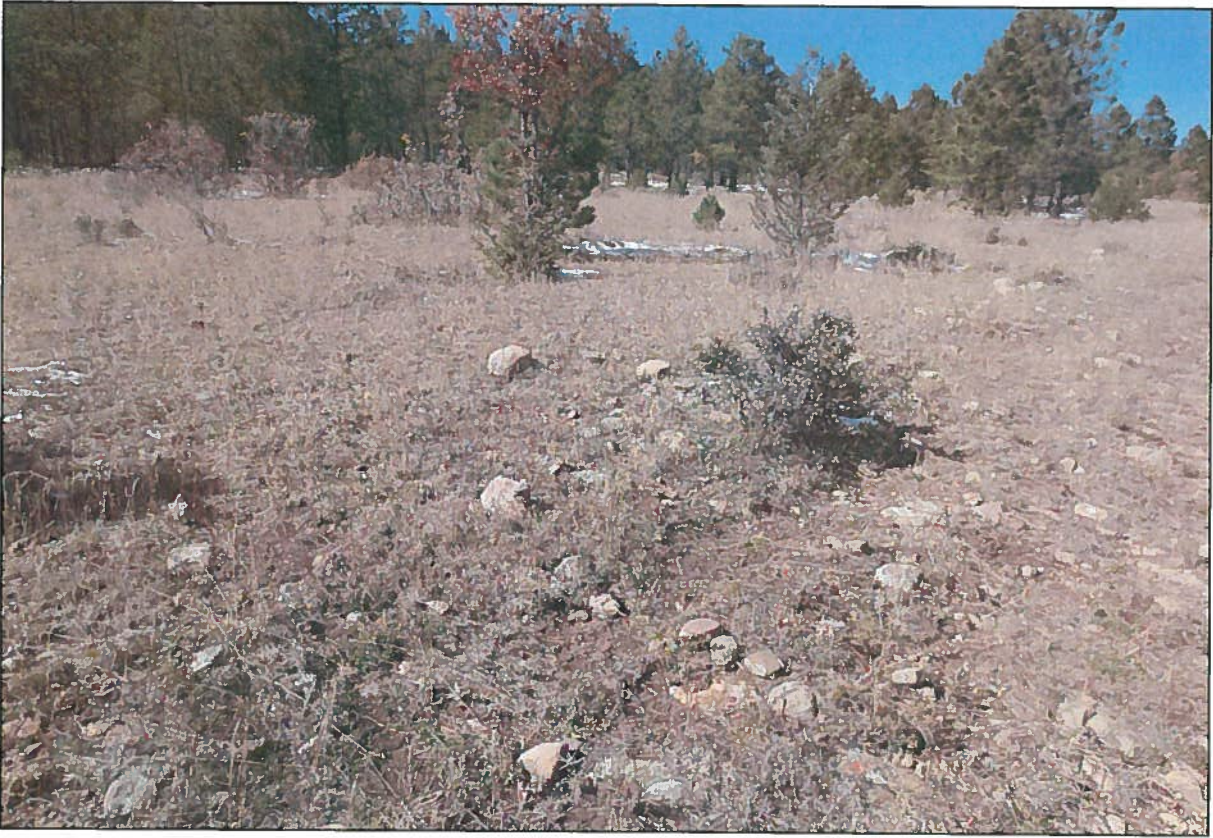
**Photo 3:** Photo of the current site vegetation.

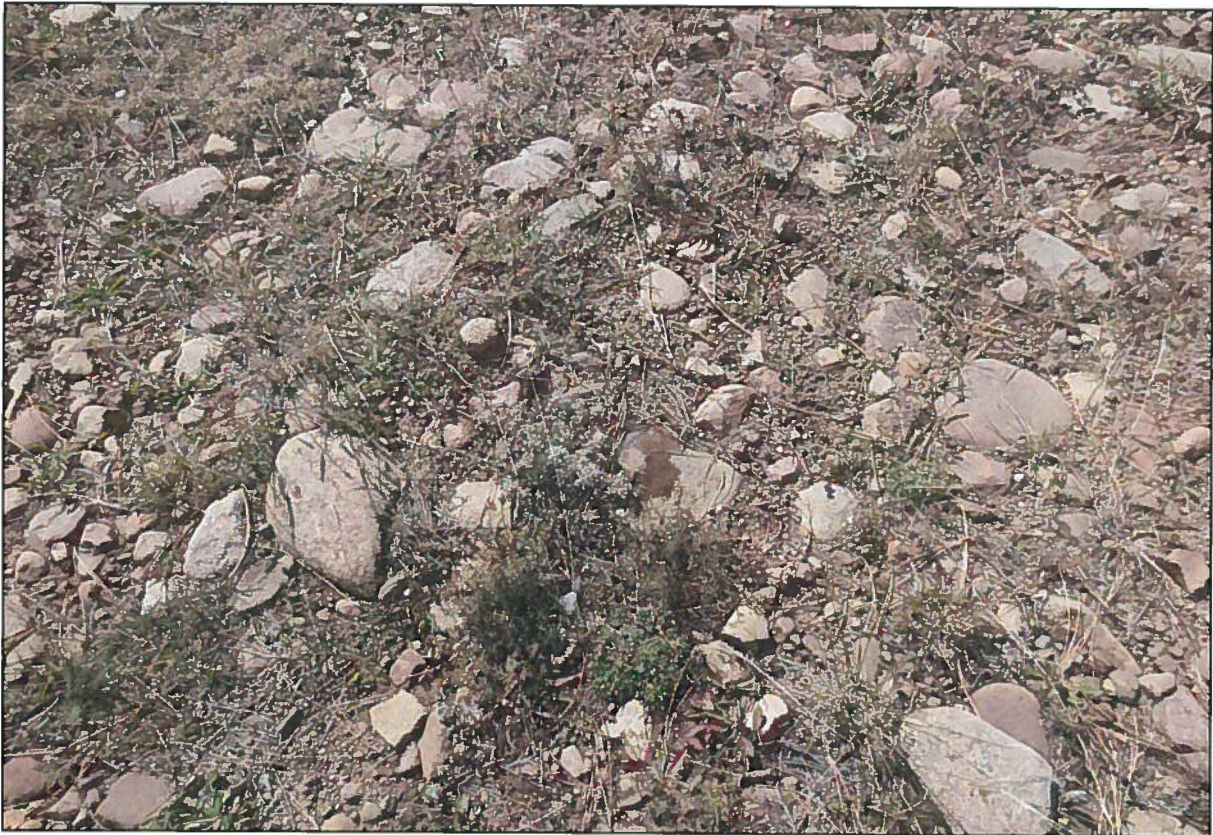
**Photo 4:** detailed photo of the soil and vegetation.
