**COLORADO DIVISION OF RECLAMATION, MINING AND SAFETY
COAL PROGRAM INSPECTION REPORT**

Permit Number: C-1980-005 Mine Name: Seneca II Mine Operator: Seneca Coal Company, LLC Operator Address: Mr Roy Karo P.O. Box 670 Hayden, CO 81639	County: Routt Operation Type: Surface Permit Status: Inactive Ownership: Private
	Operator Representative Present: Scott Cowman
Operator Representative Signature: (Field Issuance Only)

Inspection Start Date: October 22, 2013 Inspection Start Time: 07:00 Inspection End Date: October 22, 2013 Inspection End Time: 13:00	Inspection Type: Coal Complete Inspection Inspection Reason: Normal I&E Program Weather: Clear
Joint Inspection Agency: None	Joint Inspection Contacts:
Post Inspection Agency: None	Post Inspection Contacts:
Inspector(s): Jason D. Musick	Inspector's Signature:

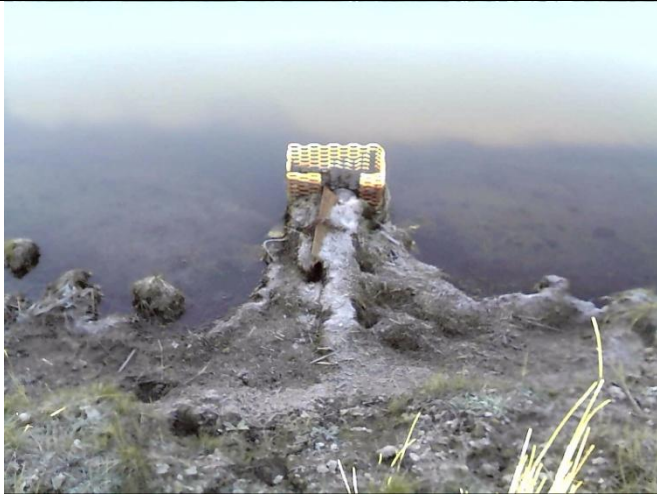
Pond 008 Primary Spillway Inlet

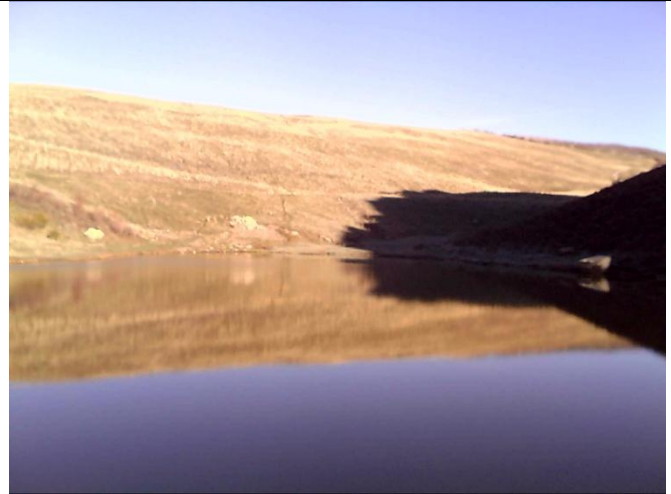
- A heavy amount of cattle were observed on the crest of the Pond 008 embankment and along the southern end of the embankment during the July 2013 inspection. As suspected, the cattle presence has reduced the vegetation on the crest of the embankment to near bare ground condition and had caused “trails” to be created down the side of the embankment to the water’s edge and along the discharge ditch to the flume. The embankment may require interseeding and the presence of cattle should be minimized.

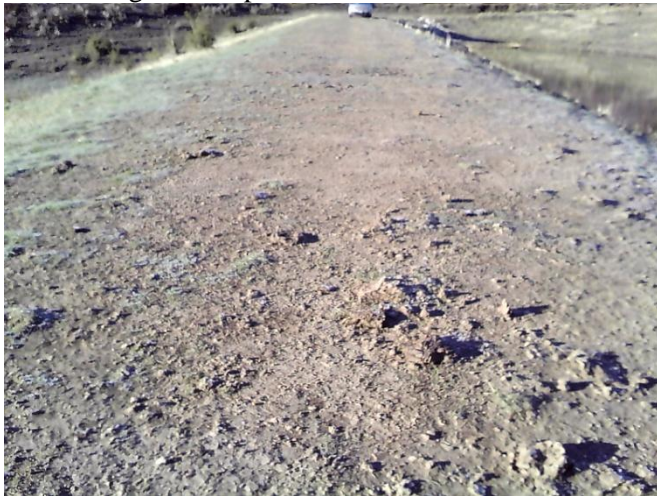
Pond 008 Embankment

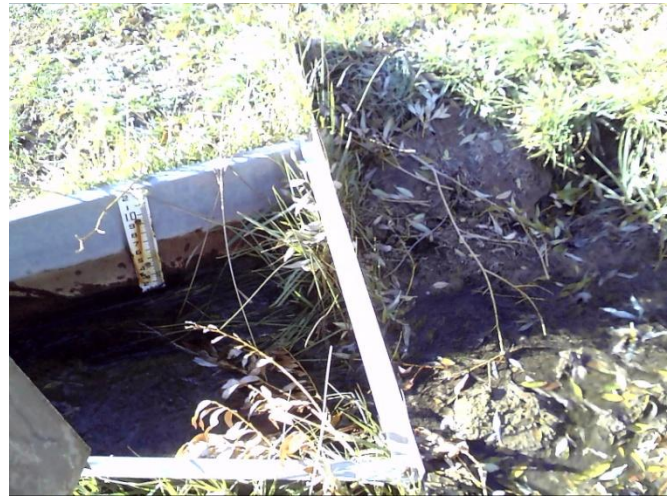
Pond 008 Flume

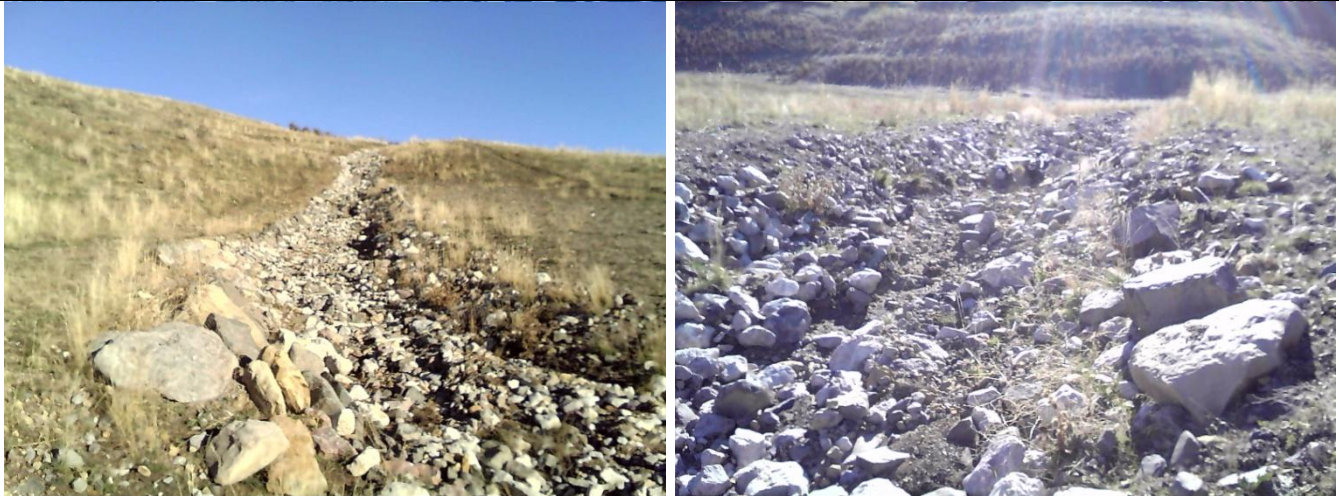
SIIPM 8 Drainage

- Due to precipitation events since the July 2013 inspection has caused some movement of rock and fabric within the drainage. Down cutting was observed and contained within the drainage. Maintenance will be required to address the movement of material and down cutting.
