## COLORADO DIVISION OF RECLAMATION, MINING AND SAFETY COAL PROGRAM INSPECTION REPORT

<b>Permit Number:</b> C-1981-019 <b>Mine Name:</b> Colowyo Coal Mine <b>Operator:</b> Colowyo Coal Company L.P. <b>Operator Address:</b> Mr. Tony Tennyson 5731 State Highway 13 Meeker, CO 81641	<b>County:</b> Moffat, Rio Blanco <b>Operation Type:</b> Surface <b>Permit Status:</b> Active <b>Ownership:</b> Federal
<b>Operator Representative Present:</b>	
<b>Operator Representative Signature: (Field Issuance Only)</b>

<b>Inspection Start Date:</b> October 22, 2013 <b>Inspection Start Time:</b> 13:30 <b>Inspection End Date:</b> October 23, 2013 <b>Inspection End Time:</b> 16:30	<b>Inspection Type:</b> Coal Partial Inspection <b>Inspection Reason:</b> Normal I&E Program <b>Weather:</b> Clear
<b>Joint Inspection Agency:</b>  None	<b>Joint Inspection Contacts:</b>
<b>Post Inspection Agency:</b>  None	<b>Post Inspection Contacts:</b>
<b>Inspector(s):</b>  Robert D. Zuber, P.E.	<b>Inspector's Signature:</b>  <i>Robert D. Zuber</i>  <b>Signature Date:</b>  10/28/2013

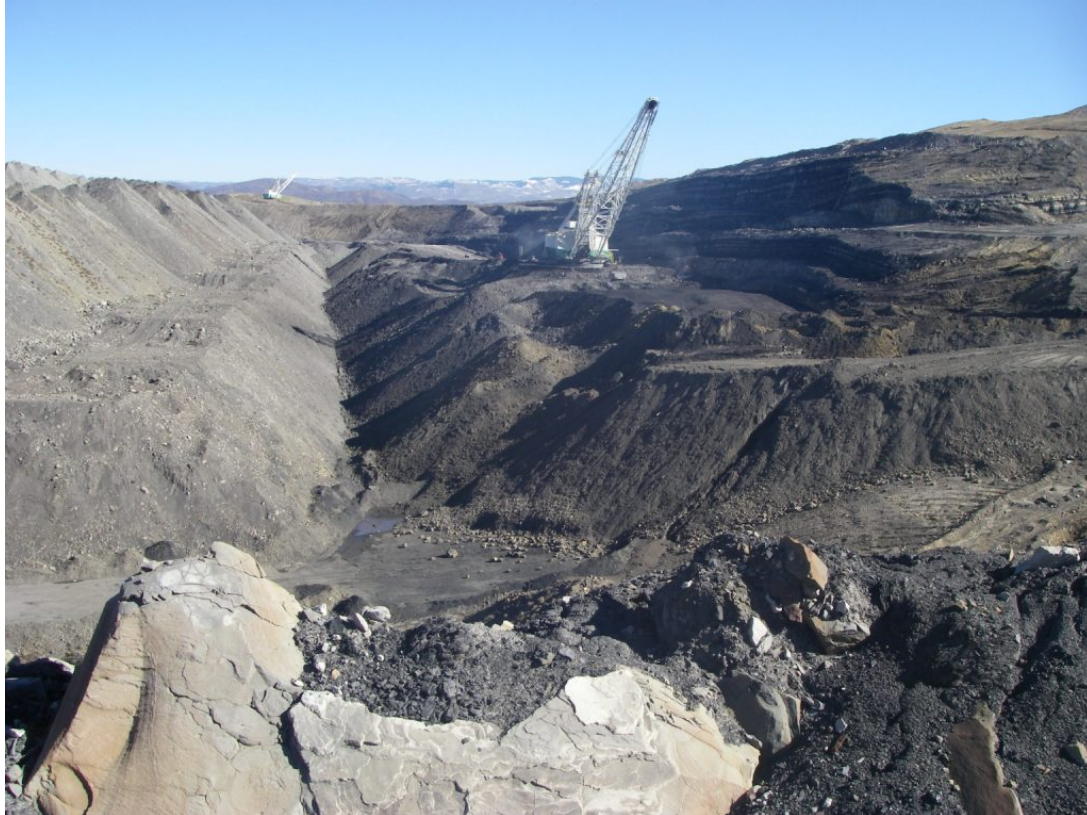
- In the West Pit, the final advance (south end) is underway. Two drill rigs were on site; one was actively drilling in D seam overburden. The 103 dragline was moving spoil in the West Pit during part of the inspection.
- In the southwest corner of South Taylor Pit a truck/loader operation was removing F1 overburden. The floor of the pit (G8 seam) has been leveled for the highwall mining operation. The 114 shovel was idle during the inspection but has been removing overburden to enable the pit to extend to the west.
- Scrapers continue to work on the West Pit spoil pile – reclamation is nearly done in this area (“Hink’s Peak”).
- Blasting – see below.

**West Pit, final advance**

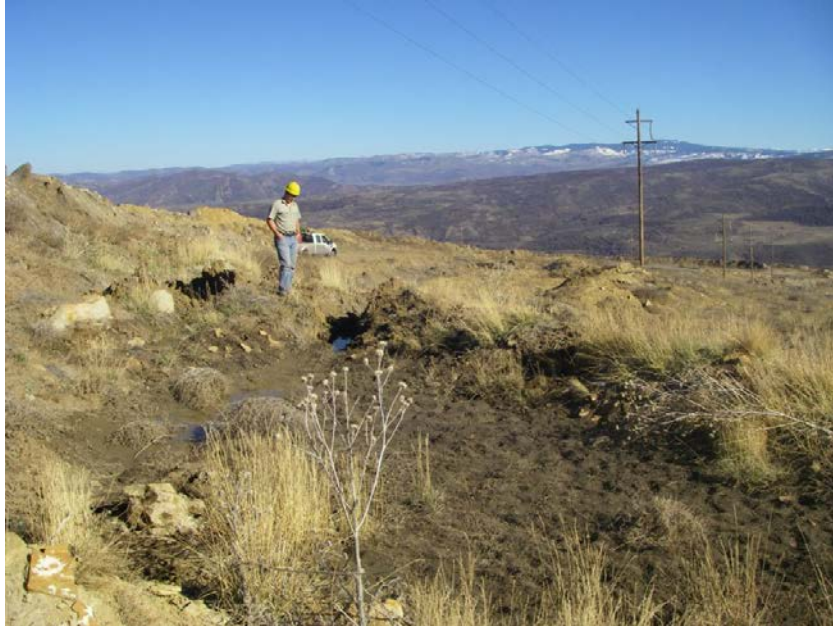
- In the Section 29 Ditch, repairs have been made to provide positive drainage.
- The western-most segment of Section 28 Ditch was inspected, and no problems were identified. Regarding the liner at the lower end, rocks have been placed to keep the liner in place. This area must continue to be monitored, and, if the problem gets worse, additional measures may be needed.
- Taylor Tributary Ditch and Taylor Ditch were found to be stable.
- In the lower portion of Prospect Ditch where repairs were performed, wattles have been re-staked. There is no erosion in the channel. Contour ditches in this area are in good shape.

**Section 29 Ditch – completed repair**

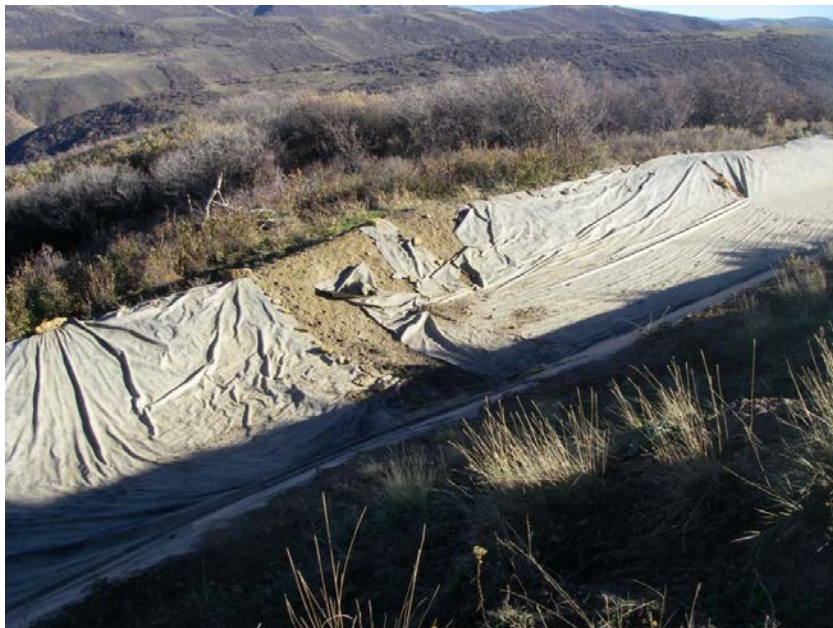
**Section 28 Ditch – damaged liner**

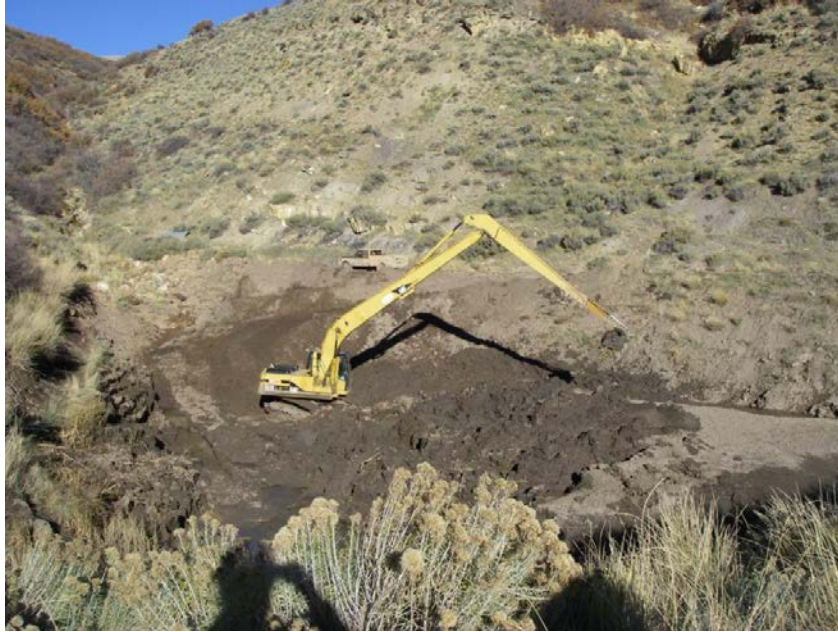
Prospect Pond was being cleaned during the inspection with a long-reach excavator. Per Kurt Blunt, the material was being hauled to an area near Wilson Reservoir. Mr. Blunt also said that a water quality sample was taken when de-watering operations began and that this is in compliance with Water Quality Control Division requirements.

**Prospect Pond cleaning operations**

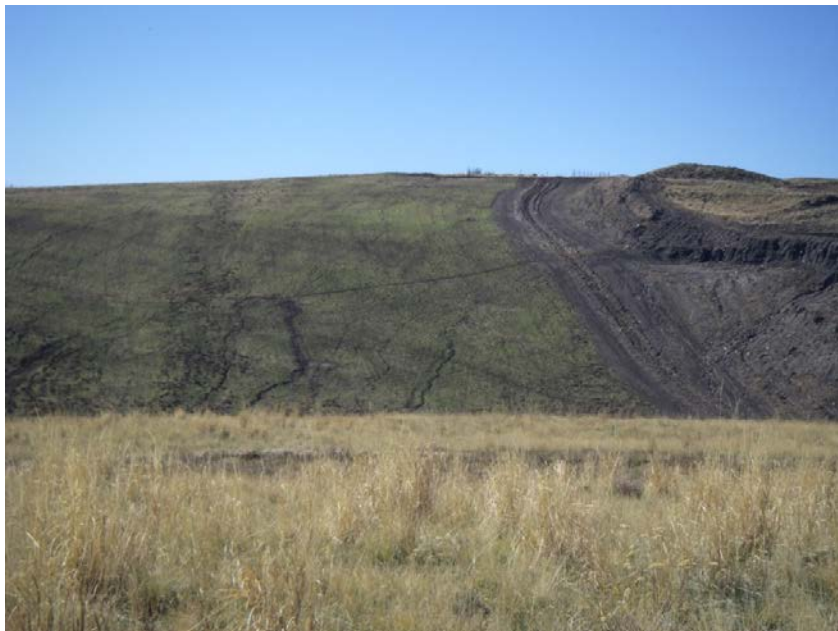
In the East Pit, the rill on the south side of Final East Pit Ditch, which has been noted in past inspections, still requires repair; wet weather has prevented the ability for Colowyo to put equipment in this area without causing problems. The rill near Gulch A (also noted before) has been repaired.

**Rills near Final East Pit Ditch**

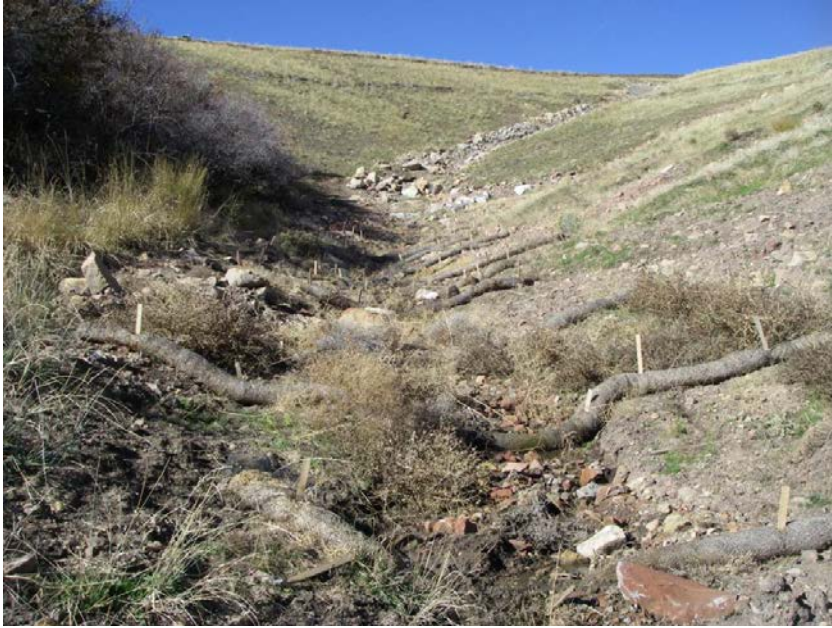
**Prospect Ditch wattles**

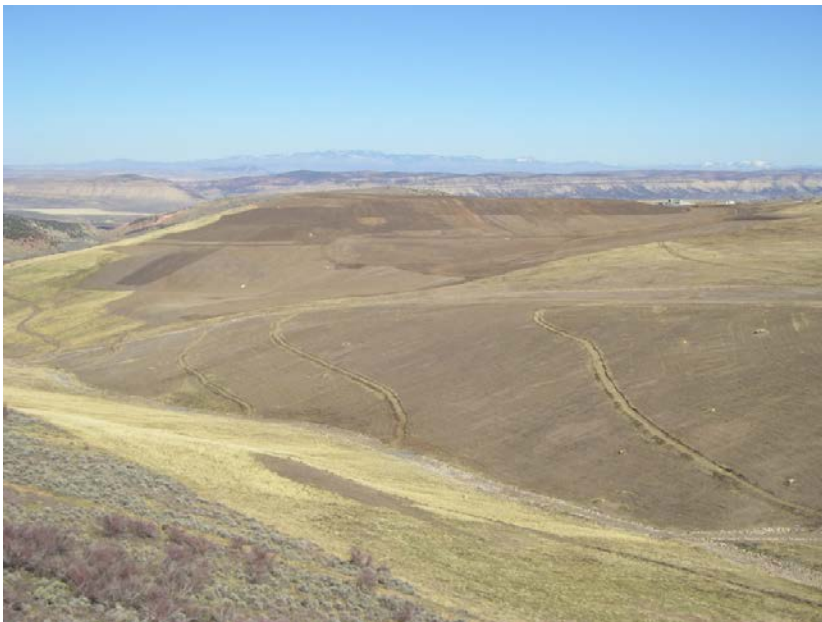
The West Pit reclamation, including the large spoil pile that is near the end of grading operations, was observed from the large runaway truck ramp at the south end. No erosion or other problems were observed.

**West Pit reclamation (from runaway truck ramp)**

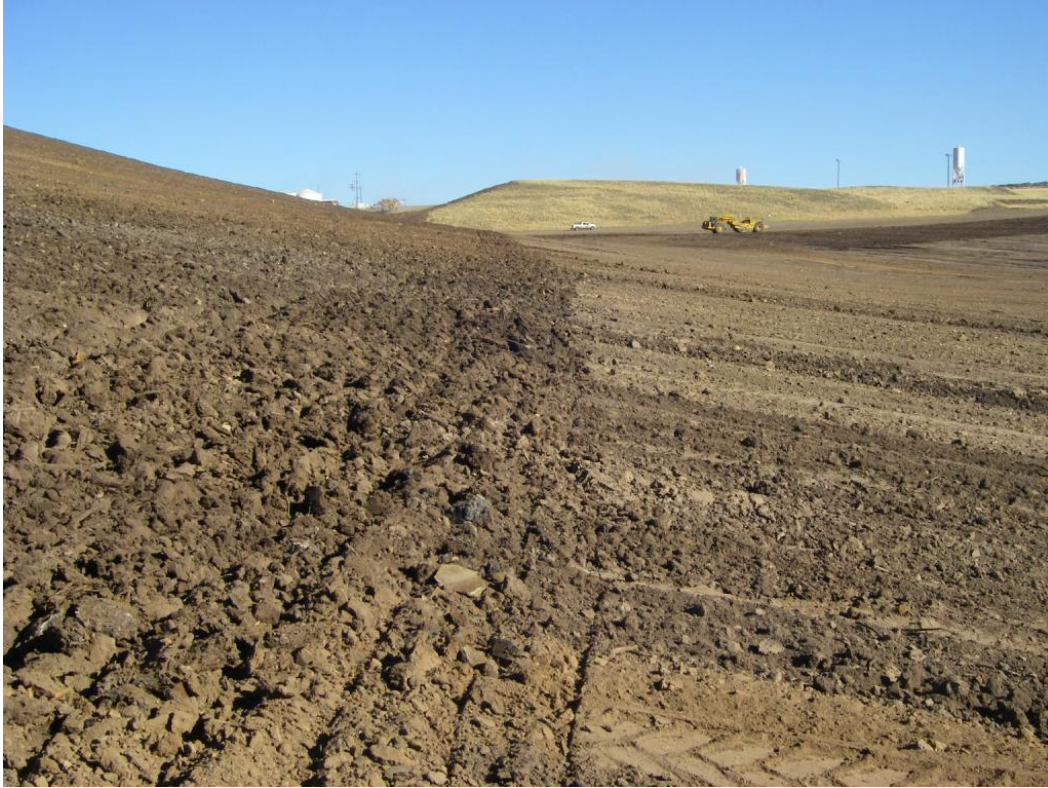
On the West Pit spoil pile (“Hink’s Peak”) the surface had been roughened well to prepare for seeding.

**West Pit reclamation – left side has been disked**
