# COLORADO DIVISION OF RECLAMATION, MINING AND SAFETY COAL PROGRAM INSPECTION REPORT

<b>Permit Number:</b> C-1992-081 <b>Mine Name:</b> Hayden Gulch Loadout <b>Operator:</b> Hayden Gulch Terminal, LLC <b>Operator Address:</b> Mr Roy Karo 37796 Routt County Road 53 P.O. Box 670 Hayden, CO 81639	<b>County:</b> Routt <b>Operation Type:</b> Loadout <b>Permit Status:</b> Permanent Cessation <b>Ownership:</b> Private
	<b>Operator Representative Present:</b>  Roy Karo
<b>Operator Representative Signature:</b> (Field Issuance Only)

<b>Inspection Start Date:</b> October 21, 2013 <b>Inspection Start Time:</b> 13:15 <b>Inspection End Date:</b> October 22, 2013 <b>Inspection End Time:</b> 09:30	<b>Inspection Type:</b> Coal Complete Inspection <b>Inspection Reason:</b> Normal I&E Program <b>Weather:</b> Cloudy
<b>Joint Inspection Agency:</b>  None	<b>Joint Inspection Contacts:</b>
<b>Post Inspection Agency:</b>  None	<b>Post Inspection Contacts:</b>
<b>Inspector(s):</b>  Janet H. Binns	<b>Inspector's Signature:</b>

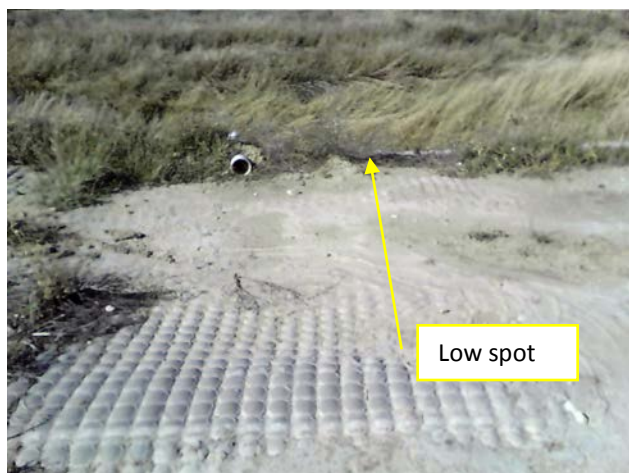
Photo 1: Rail Loop Pond spillway

The Rail Loop pond was dry and had a good grass cover in the bottom of the pond. No problems were identified

on the embankment or with the spillway of the Rail Loop pond. HGT has placed a PVC pipe on top of the combination spillway that will direct any primary discharge to a point that can be sampled. A small section of the earthen material directing the flow is slightly low.

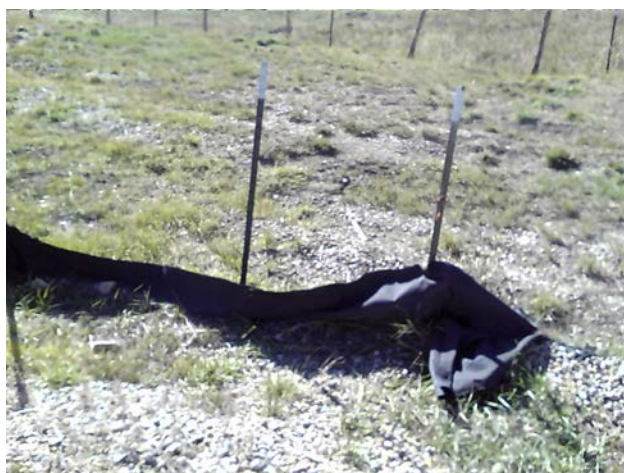
Photo 2: Silt fence at substation SAE

Substation SAE west of the office trailers: silt fence has come down and is need of repair.
