**COLORADO DIVISION OF RECLAMATION, MINING AND SAFETY
COAL PROGRAM INSPECTION REPORT**

Permit Number: C-1982-056 Mine Name: Foidel Creek Mine Operator: Twentymile Coal, LLC Operator Address: Mr Jerry Nettleton 29515 Routt County Road No. 27 Oak Creek, CO 80467	County: Routt Operation Type: Underground Permit Status: Active Ownership: Federal
	Operator Representative Present: Brian Watterson
Operator Representative Signature: (Field Issuance Only)

Inspection Start Date: October 22, 2013 Inspection Start Time: 13:00 Inspection End Date: October 23, 2013 Inspection End Time: 12:00	Inspection Type: Coal Complete Inspection Inspection Reason: Normal I&E Program Weather: Clear
Joint Inspection Agency: None	Joint Inspection Contacts:
Post Inspection Agency: None	Post Inspection Contacts:
Inspector(s): Jason D. Musick	Inspector's Signature:

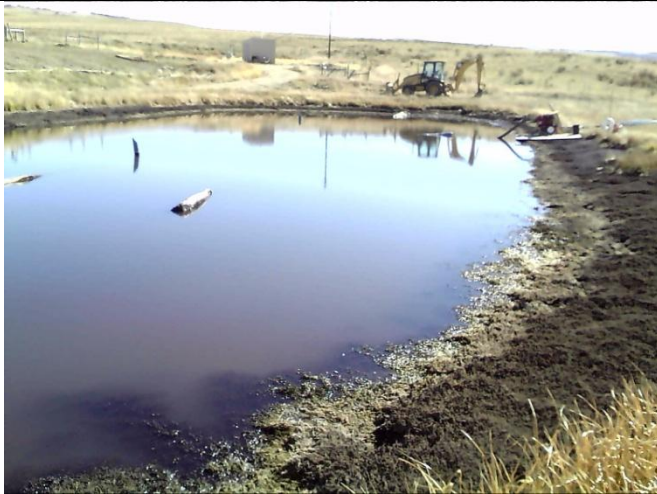
Drainage Control 4.05.1, 4.05.2, 4.05.3; Siltation Structures 4.05.5, 4.05.6; Discharge Structures 4.05.7, 4.05.10; Diversions 4.05.4; Effluent Limits 4.05.2; Ground Water Monitoring 4.05.13; Surface Water Monitoring 4.05.13; Drainage – Acid and Toxic Materials 4.05.8; Impoundments 4.05.6, 4.05.9; Stream Buffer Zones 4.05.18: Ponds B, C, D, E, F, G, 6NM, 18LT, 6NM sediment pond, the Fish Creek borehole ponds, the Fish Creek Tipple pond and the Pit Pond were observed during the inspection. Discharge was noted at Ponds D, Pond B, and the Fish Creek Tipple pond. The Fish Creek Borehole Pond #1 was in the process of being pumped in order to dredge the pond. New baffles will be installed in all three of the ponds.

Fish Creek Borehole Ponds Cell#1 Pumping

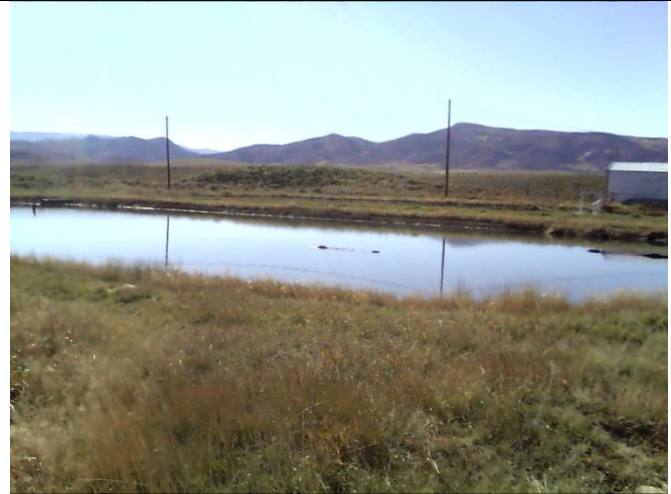
Fish Creek Borehole Ponds Cell#2

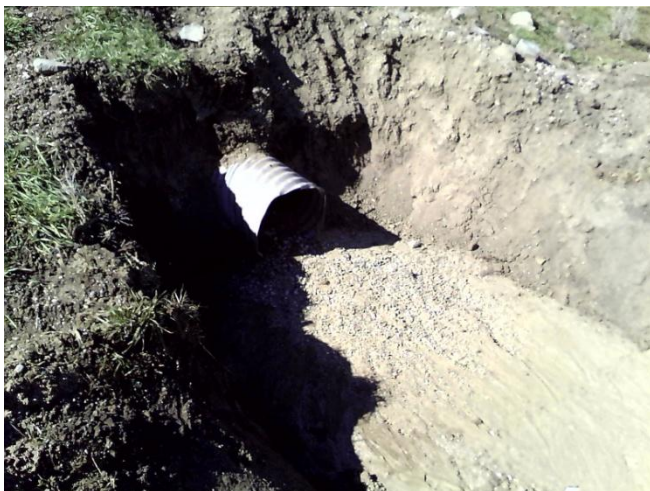
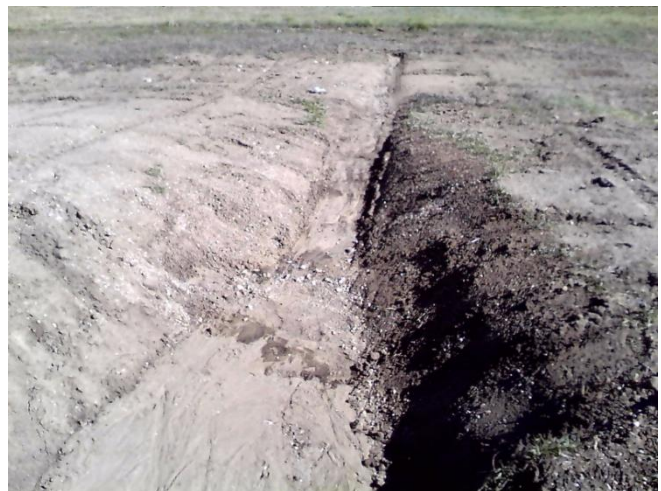
18RT Access Road Culvert Maintenance Work

- The outlet of third culvert from the northern most end of the 18RT access road was blocked and has been re-established.
- The 18RT access roadside ditch continued to cut into the road. The ditch has been cleaned and rock check dams have been repaired and re-established.
- Material had been spilled or dumped in the 6MN diversion ditch at the Rock dust tank at 6MN pad. This material has been pulled back and the ditch re-established.

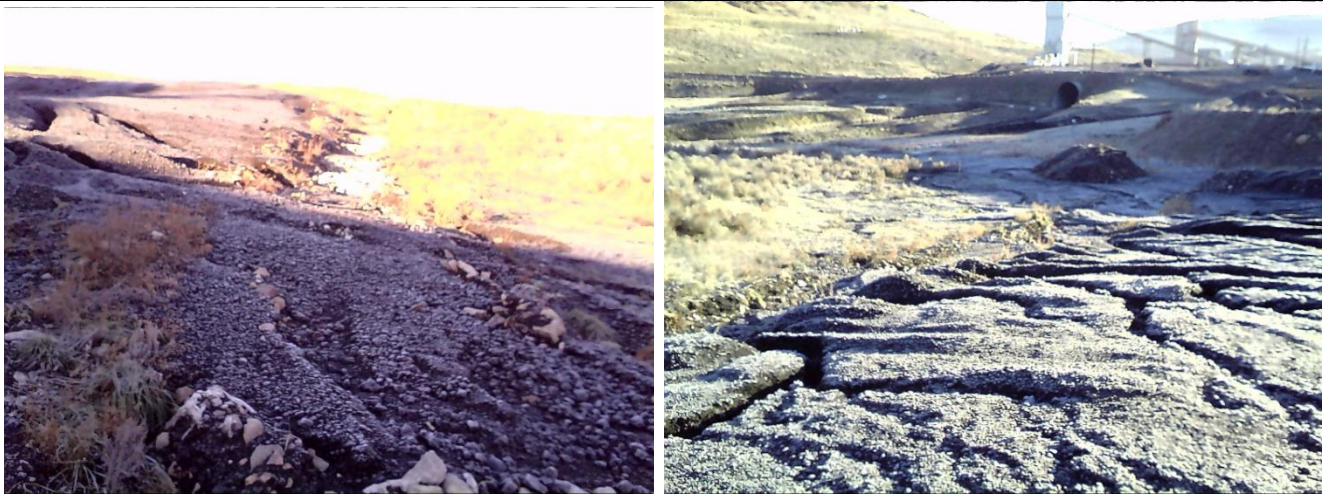
- The lower end of the ditch and associated rock check dams (B-1) west of the BOB Pile has failed. The coal fines were contained in the area by the Southeast sediment basin and the ditch along the railway; however this area will require maintenance to clear coal fines that have built up and to re-establish the ditch. Evidence of maintenance was identified; however additional material has breached the ditch and continues towards the north west. **All repairs and clean-up to be conducted before November 30, 2013.**

Ditch B-1 Breach from BOB Pile

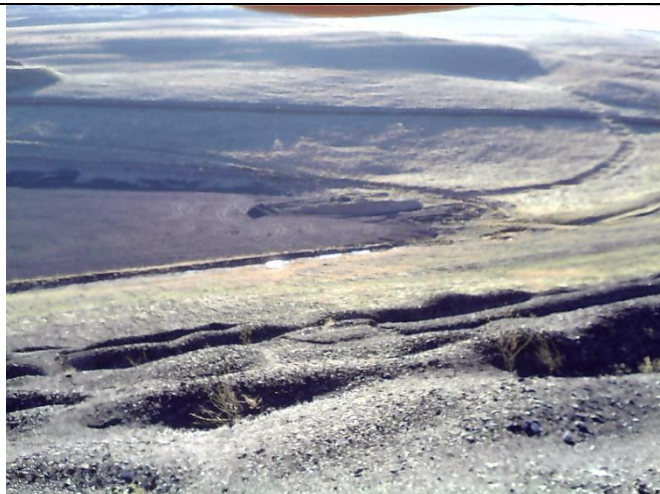
The underdrain outlet was draining into the Pit Area Pond as designed. Evidence of weed management along the west side of the RDA was observed.

Toe Drain at RDA Expansion

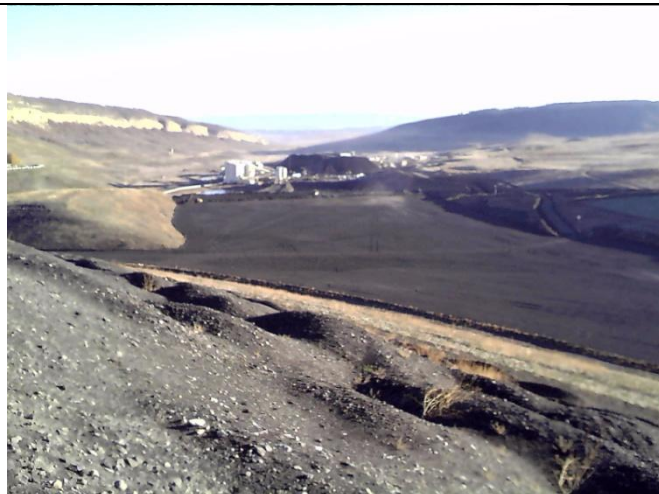
RDA Expansion

Refuse material continues to be placed in the RDA expansion area. Material was in the process of placement and grading at the time of the inspection. The RDA was well compacted and stable at the time of the inspection. The refuse material had not yet reached the head of the under-drain of the RDA. The exposed under-drain was stable and constructed as designed. Phase 1 of the RDA expansion is nearing completion. TR67 was approved with a stipulation that future bonding for each phase of construction will be required prior to the initiation of the next Phase.

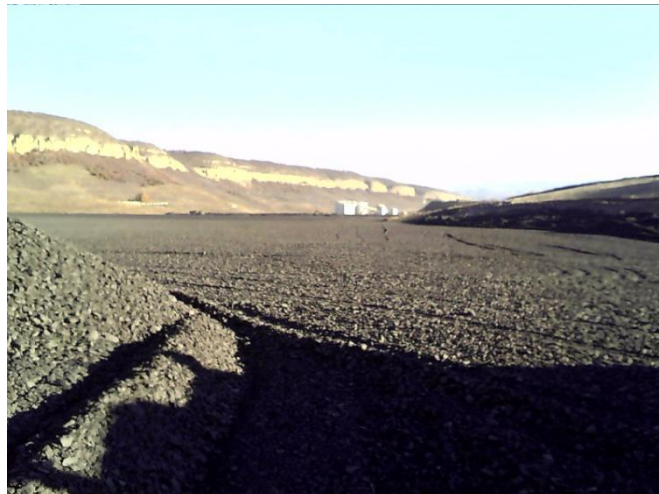
The first bench has been completed and the second bench is near elevation. The out slope of the first bench is stable and the outslope of the second bench is stable. The construction of the east perimeter ditch is on-going with topsoil being direct hauled to the face of the RDA Expansion slope. Piezometers have yet to be installed.

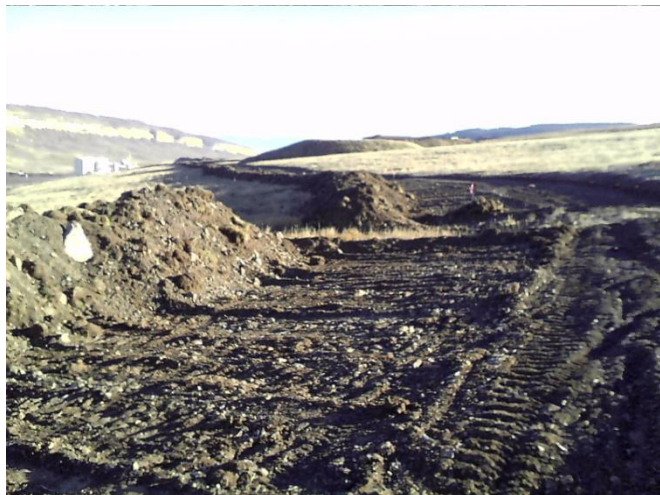
Perimeter Ditch Construction

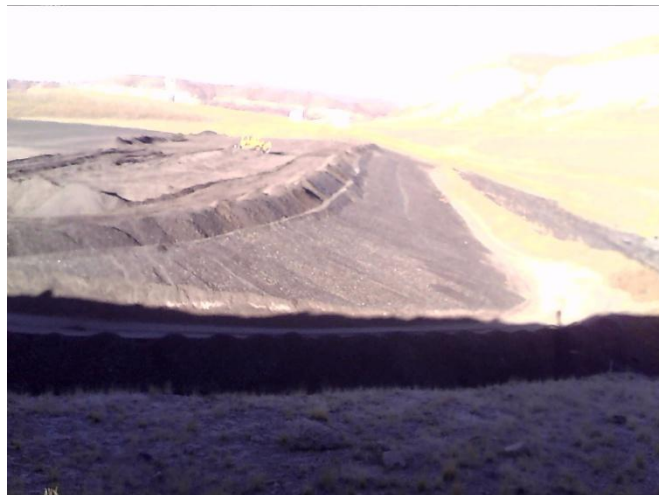
Topsoil Placement

As noted above, topsoil is being replaced on the out slopes of the RDA Expansion area via direct haul and from the RDA Topsoil pile. No topsoil depths were confirmed during this inspection.

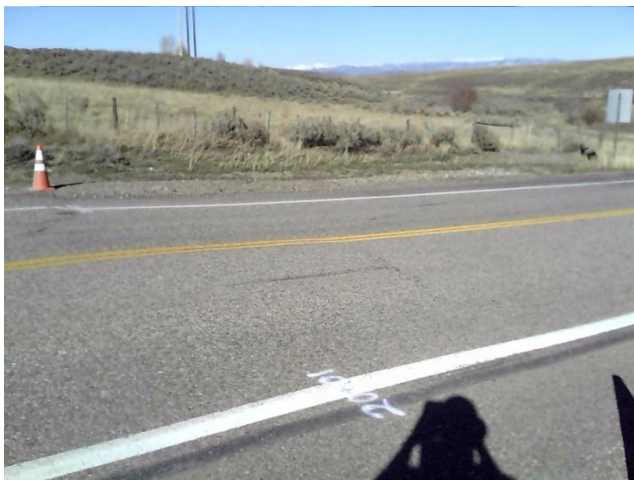
During the inspection, the Division identified two damaged areas of Routt County Road 27. These areas were ~100ft apart in the asphalt on the North side of the road. The damage was well outside of the current mining limits and the predicted angle of draw due to subsidence. The Division recognized the RCR27 culvert below the damage. At this time the Division does not believe that the damage is due to subsidence; however TC has installed survey points to monitor the area and the Division will continue to research current mining limits and effects of the subsidence.

RCR 27 Damage
