COLORADO DIVISION OF RECLAMATION, MINING AND SAFETY COAL PROGRAM INSPECTION REPORT

Permit Number: C-1981-019 Mine Name: Colowyo Coal Mine Operator: Colowyo Coal Company L.P. Operator Address: Mr. Tony Tennyson 5731 State Highway 13 Meeker, CO 81641	County: Moffat, Rio Blanco Operation Type: Surface Permit Status: Active Ownership: Federal
	Operator Representative Present: None
Operator Representative Signature: (Field Issuance Only)

Inspection Start Date: October 24, 2013 Inspection Start Time: 10:30 Inspection End Date: Inspection End Time:	Inspection Type: Aerial Inspection Inspection Reason: Normal I&E Program Weather: Clear
Joint Inspection Agency: None	Joint Inspection Contacts:
Post Inspection Agency: None	Post Inspection Contacts:
Inspector(s): Robert D. Zuber, P.E.	Inspector's Signature: <i>Robert D. Zuber</i> Signature Date: 10/29/2013

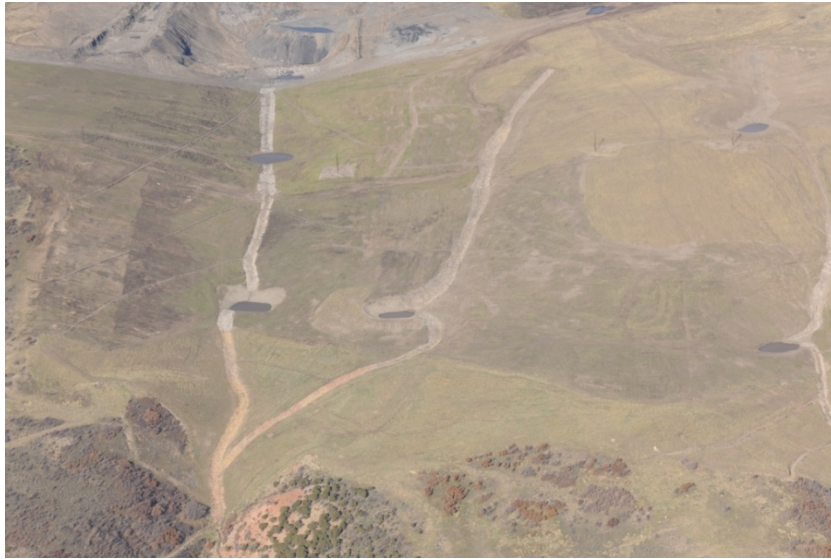
East Pit and West Pit reclamation were found to be in good shape.

East Pit reclamation with ditches and stock tanks

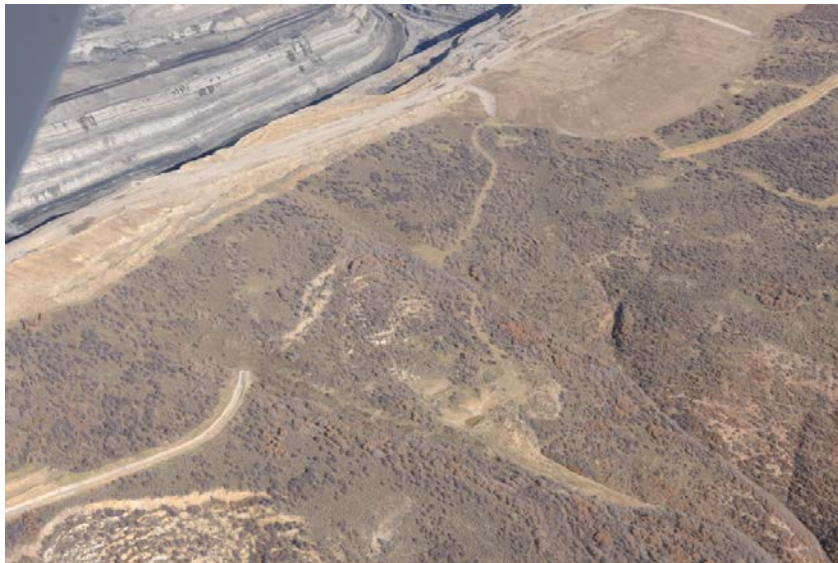
**Section 28 Ditch and eastern edge of South Taylor Pit
(ditch and slump in lower left portion of photo)**

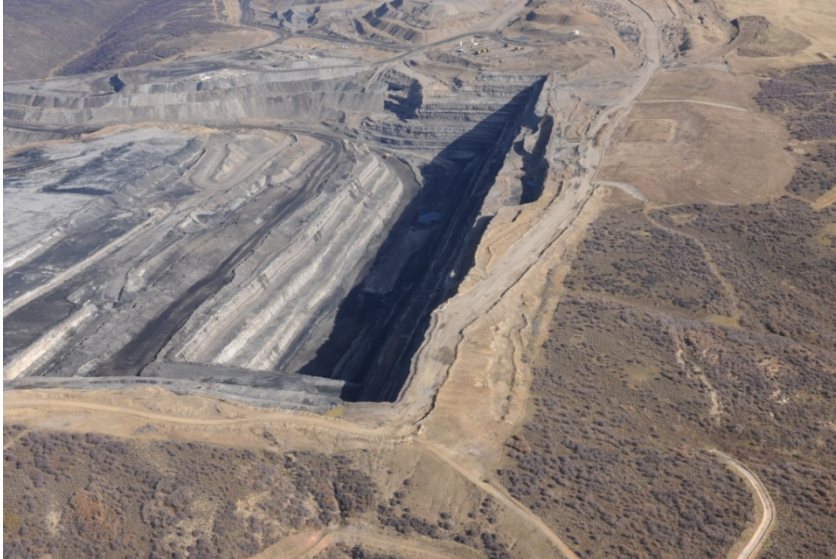
Operations in the pits were minimal at the time of the inspection. Highwall mining is planned to begin in South Taylor Pit in the near future.

South Taylor Pit, looking north

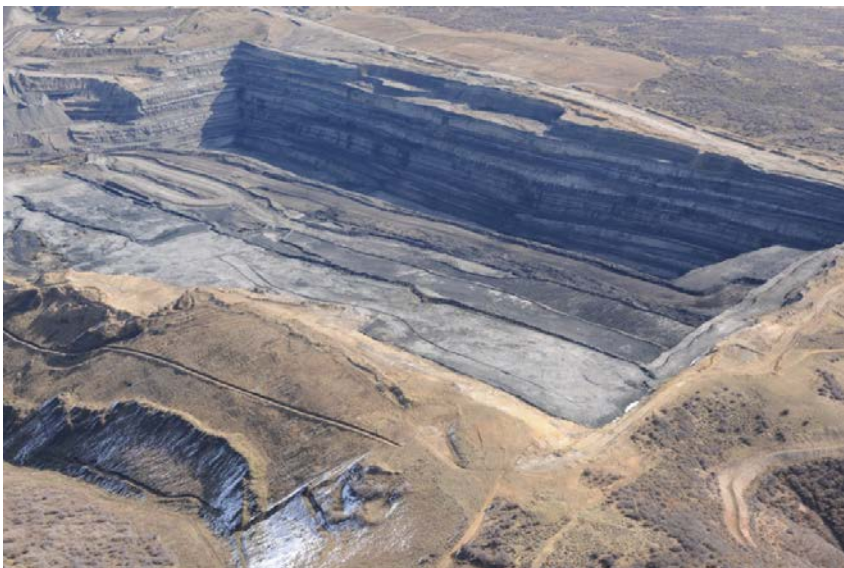
South Taylor Pit, looking east

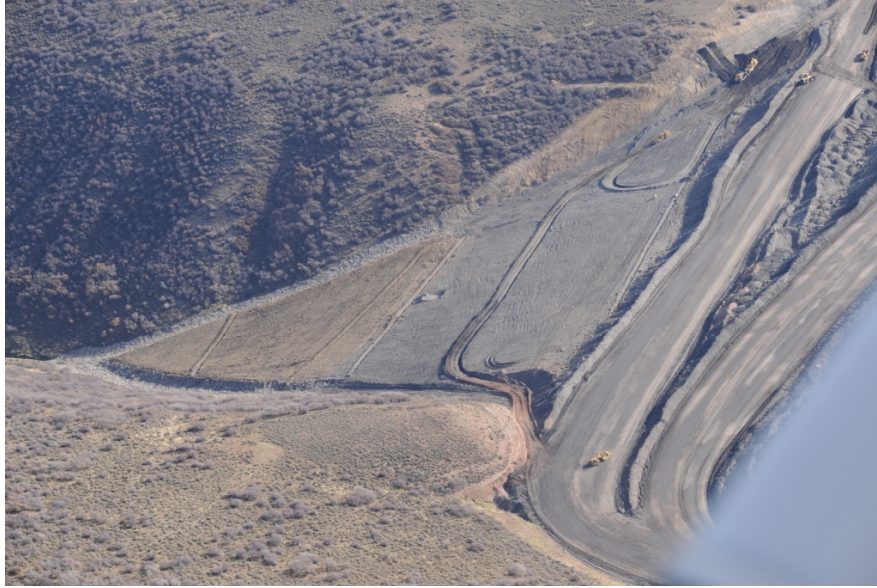
West Taylor Fill and West Pit Fill were observed, and no gullies or other significant problems were seen.

West Taylor Fill

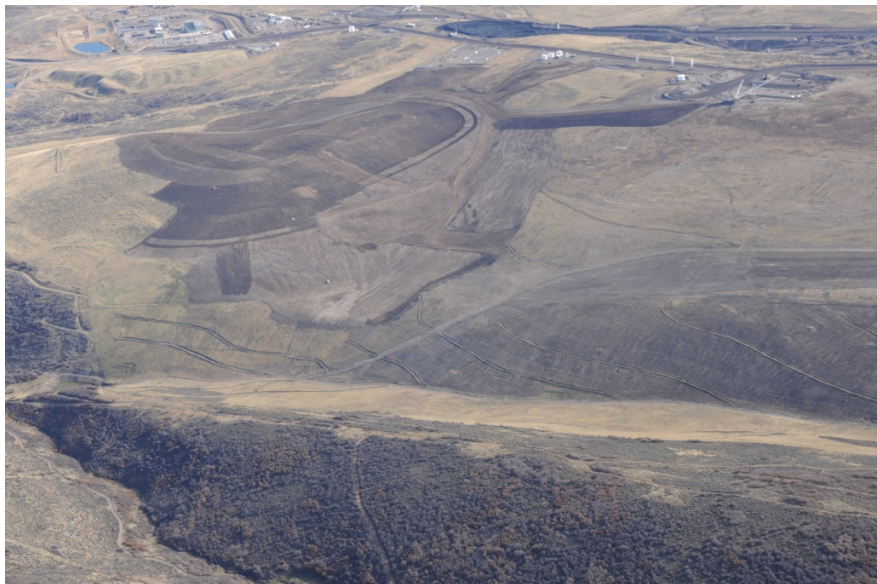
In the West Pit reclamation, a great deal of grading work has been completed on the large spoil pile (“Hink’s Peak”). No erosion or other problems were seen in the aerial photographs.

Spoil grading in West Pit

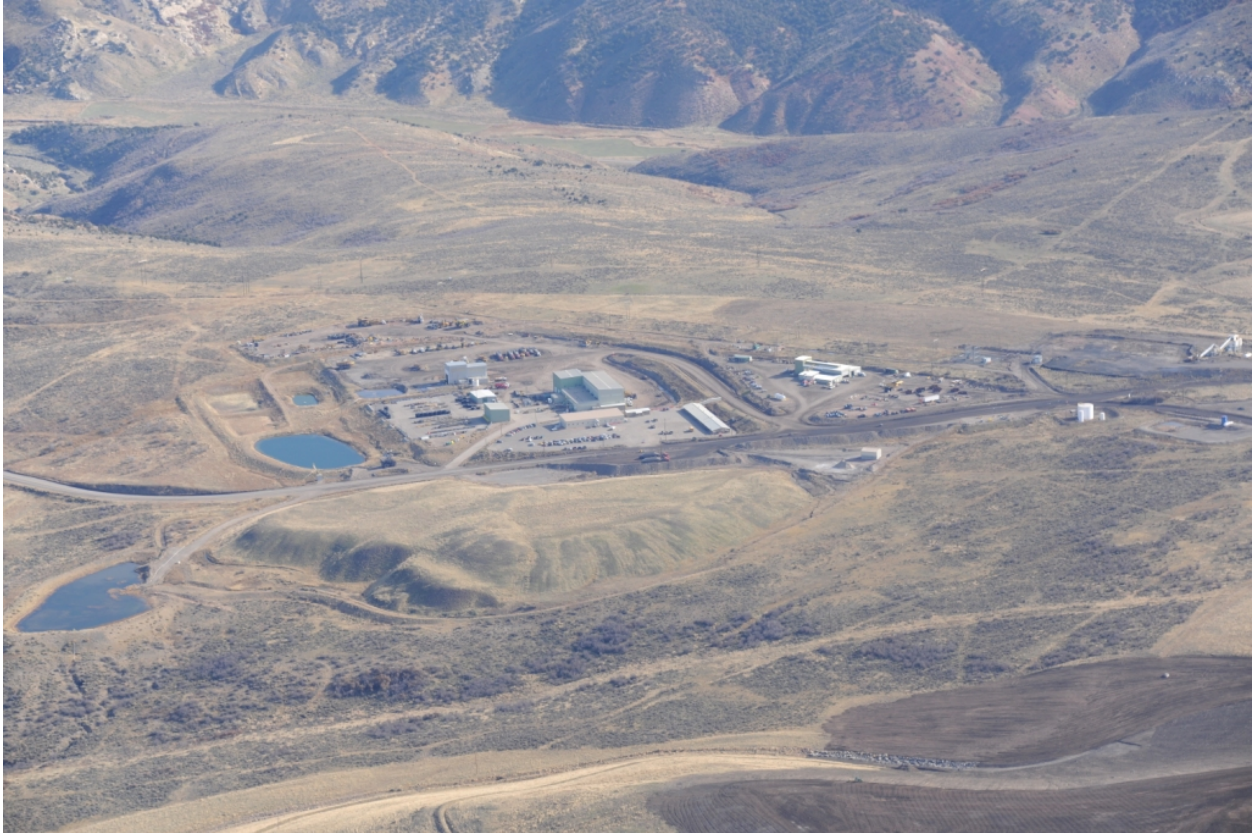
In general, the main facilities area (including the Wash Bay Pond and other ponds), the South Taylor Ready Line, and the Gossard Loadout were found to be in good condition. Detailed photographs of these areas were not taken.

Main facilities area, looking east
