# COLORADO DIVISION OF RECLAMATION, MINING AND SAFETY COAL PROGRAM INSPECTION REPORT

<b>Permit Number:</b> C-1982-057 <b>Mine Name:</b> Seneca II-W Mine <b>Operator:</b> Seneca Coal Company, LLC <b>Operator Address:</b> Mr Roy Karo 37796 Routt County Road 53 P.O. Box 670 Hayden, CO 81639	<b>County:</b> Routt <b>Operation Type:</b> Surface <b>Permit Status:</b> Permanent Cessation <b>Ownership:</b> Federal
	<b>Operator Representative Present:</b>  None
<b>Operator Representative Signature:</b> (Field Issuance Only)

<b>Inspection Start Date:</b> October 22, 2013 <b>Inspection Start Time:</b> 09:30 <b>Inspection End Date:</b> October 24, 2013 <b>Inspection End Time:</b> 10:00		<b>Inspection Type:</b> Coal Complete Inspection <b>Inspection Reason:</b> Normal I&E Program <b>Weather:</b> Clear	
<b>Joint Inspection Agency:</b>  None		<b>Joint Inspection Contacts:</b>	
<b>Post Inspection Agency:</b>  None		<b>Post Inspection Contacts:</b>	
<b>Inspector(s):</b>  Janet H. Binns  Jared L. Ebert	<b>Inspector's Signature:</b>

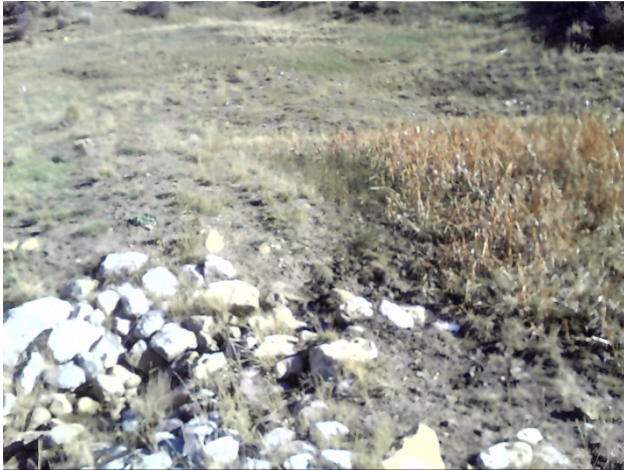
Stock Pond T-22 had filled with sediment and vegetation, cattails (Photo 1). A small trickle of water was flowing through this stock tank. Jared noted that no permanent impoundment demonstration had been found for this stock tank yet.

Photo 1: Embankment and spillway T-22

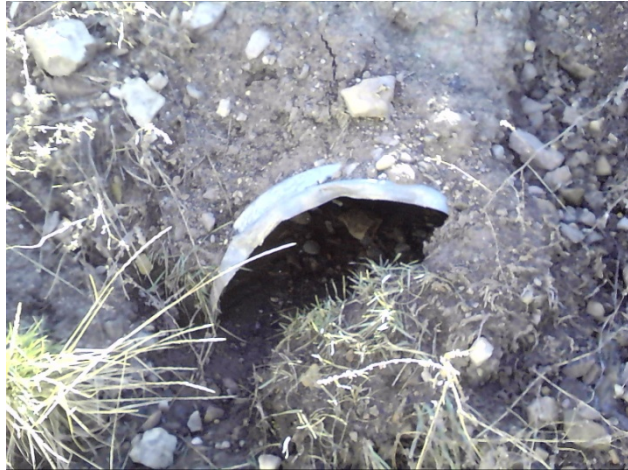
PM-3 outfall is blocked and requires clean out. (Photo 2)

Photo 2: Culvert PM-3 outlet needs clean out

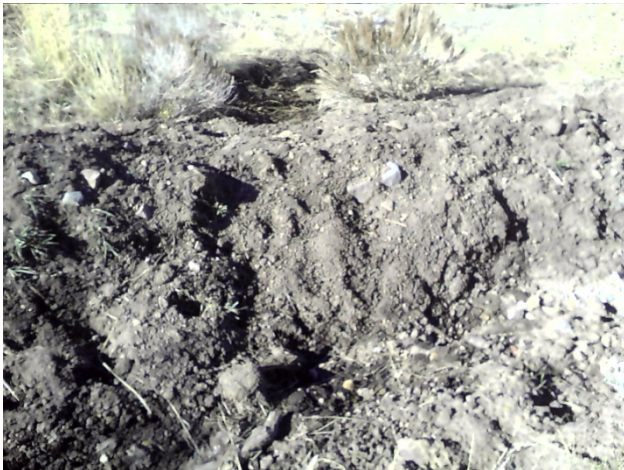
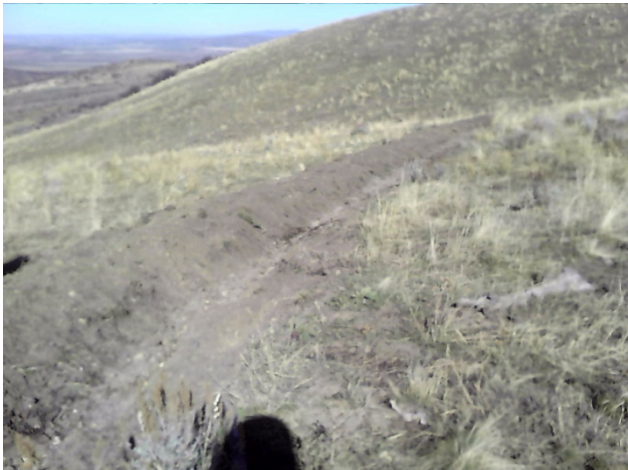
SCC has cut a new contour furrow from the Ridge Line Access road over to drainage 005-E1. (Photos 3 & 4) Although this is an effective method to reduce gully formation on the slope, this feature is not shown on a map. SCC needs to permit this feature and depict it on an appropriate map. Repaired gully should be seeded if not completed already.

Photo 3: Recent Contour furrow east of T-20

Photo 4: Recent contour furrow east of T-20

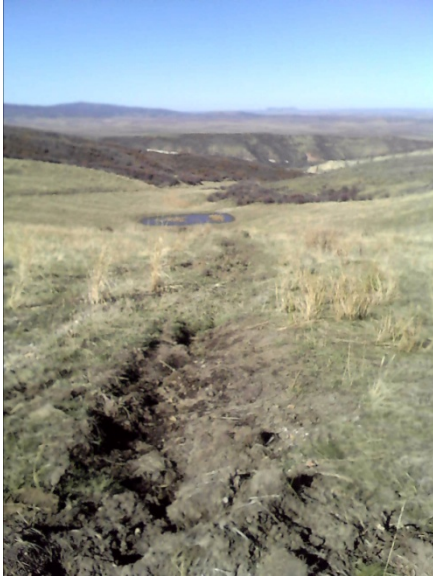
Photo 5: Gully repair downslope from Recent contour furrow construction

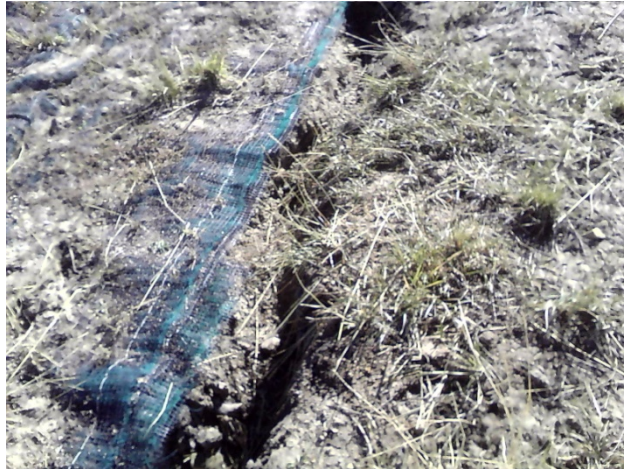
Gully repair upslope from Culvert PM3 furrow is undercutting on the west side of the TRM. SCC needs to maintain this fabric to keep the runoff from undercutting the repair. (Photo 6)

Photo 6: side cutting along TRM in gully repair upslope from PM-3 culvert

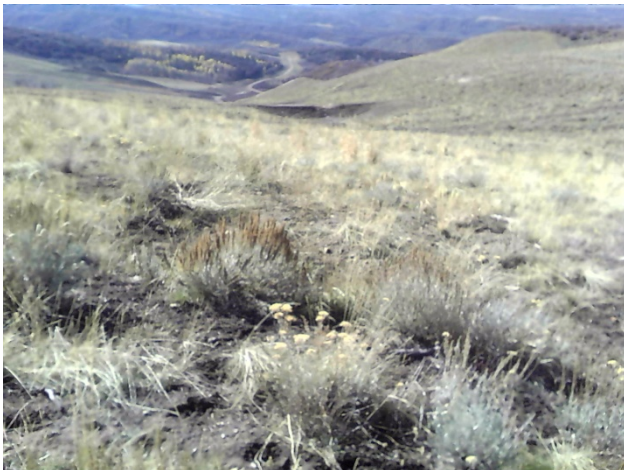
Photo 7: Reclamation PM-3 drainage

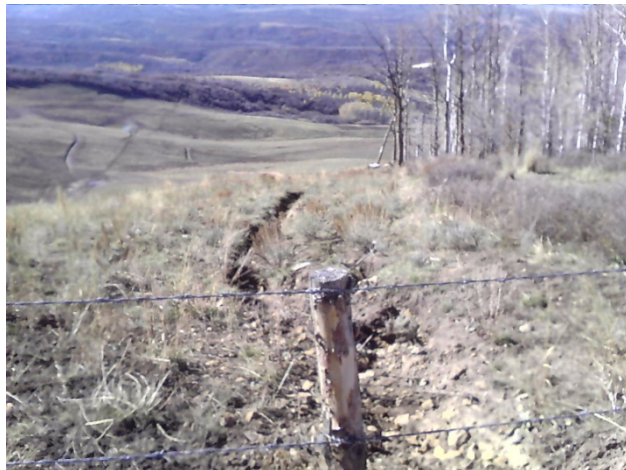
In the South Extension area a gully is forming along PM2-C drainage. This gully measured 8 to 12 inches deep. It initiates near the top of the slope by LU-5 road by the interface of the reclaimed slope and the undisturbed area (Photo 8)

Photo 8: Gully formation north of PM-3 drainage

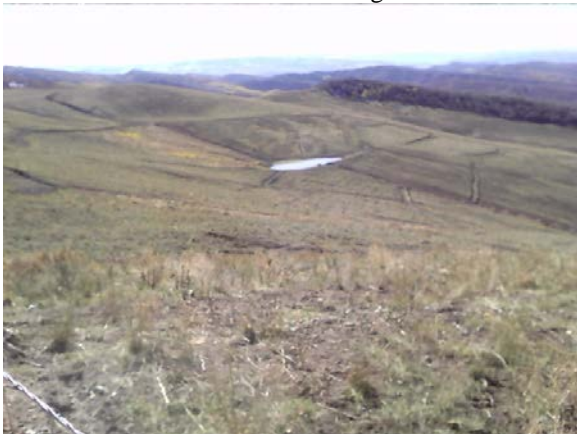
Photo 9: Looking south across South expansion area.
