COLORADO DIVISION OF RECLAMATION, MINING AND SAFETY
MINERALS PROGRAM INSPECTION REPORT
PHONE: (303) 866-3567

MINE NAME: 32 Road Pit	MINE/PROSPECTING ID#: M-1985-219	MINERAL: Sand and gravel	COUNTY: Mesa
INSPECTION TYPE: Monitoring	INSPECTOR(S): Travis H. Marshall	INSP. DATE: October 8, 2013	INSP. TIME: 13:30
OPERATOR: Parkerson Construction, Inc.	OPERATOR REPRESENTATIVE: Royce Clements	TYPE OF OPERATION: 112c - Construction Regular Operation

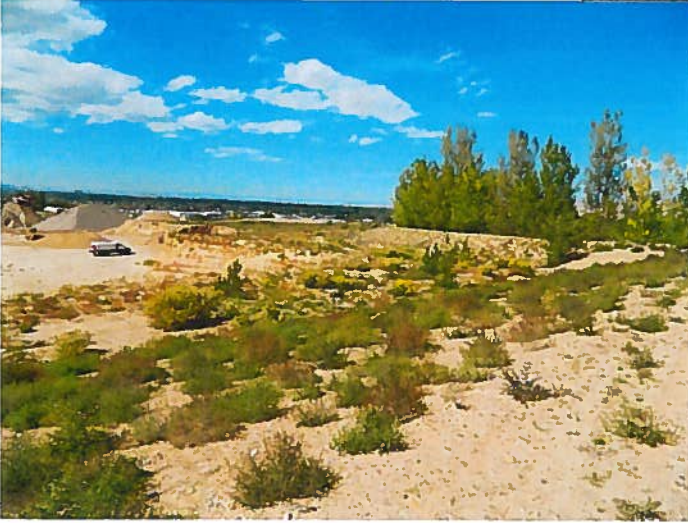
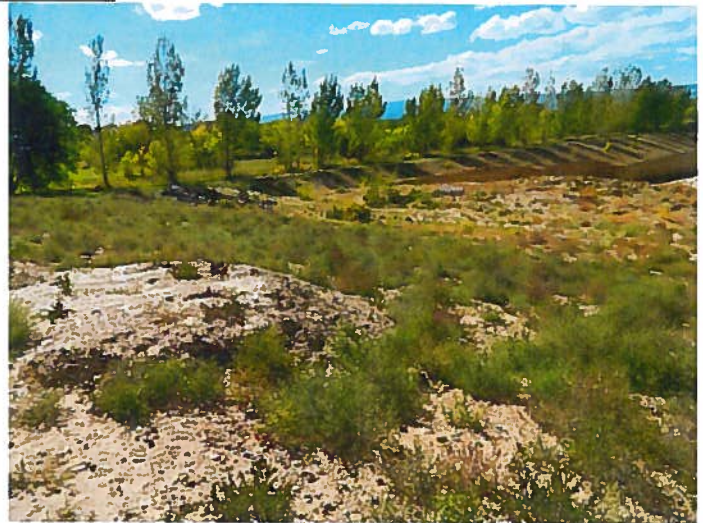
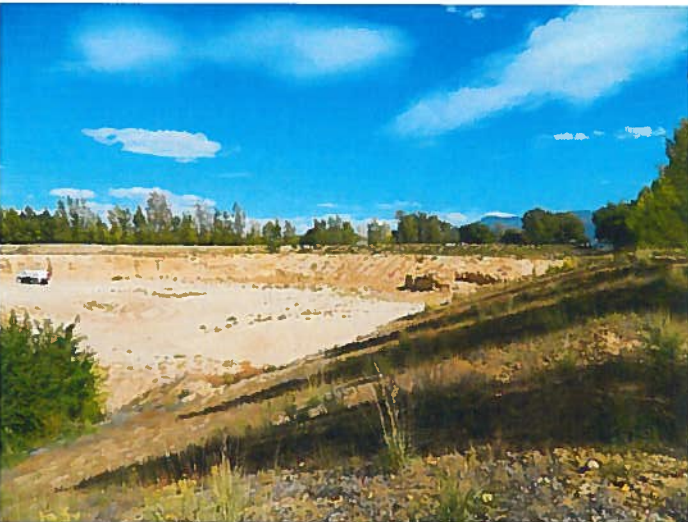
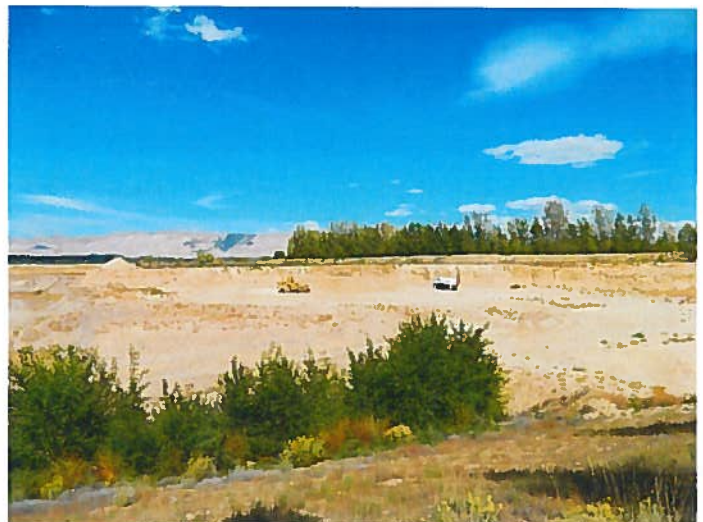
The inspection was to observe the amount of vegetation established on the topsoil stock piles and determine if the previously ordered corrective action of vegetating the topsoil stockpiles was necessary. The vegetation on topsoil stockpiles located along the eastern border of the permit consisted primarily of annual weeds that were abundant due to the higher than average amount of precipitation. The topsoil stockpiles located along the southern border of the permit area had perennial grasses along with shrubs. The operator was instructed to seed the areas that were bare or covered with annual weeds.
