COLORADO DIVISION OF RECLAMATION, MINING AND SAFETY COAL PROGRAM INSPECTION REPORT

Permit Number: C-1994-082 Mine Name: Yoast Mine Operator: Seneca Coal Company, LLC Operator Address: Mr Roy Karo 37796 Routt County Road 53 P.O. Box 670 Hayden, CO 81639	County: Routt Operation Type: Surface Permit Status: Permanent Cessation Ownership: Federal
	Operator Representative Present: None
Operator Representative Signature: (Field Issuance Only)

Inspection Start Date: October 23, 2013 Inspection Start Time: 09:45 Inspection End Date: October 24, 2013 Inspection End Time: 11:45	Inspection Type: Coal Complete Inspection Inspection Reason: Normal I&E Program Weather: Clear
Joint Inspection Agency: None	Joint Inspection Contacts:
Post Inspection Agency: None	Post Inspection Contacts:
Inspector(s): Janet H. Binns Jared L. Ebert	Inspector's Signature:

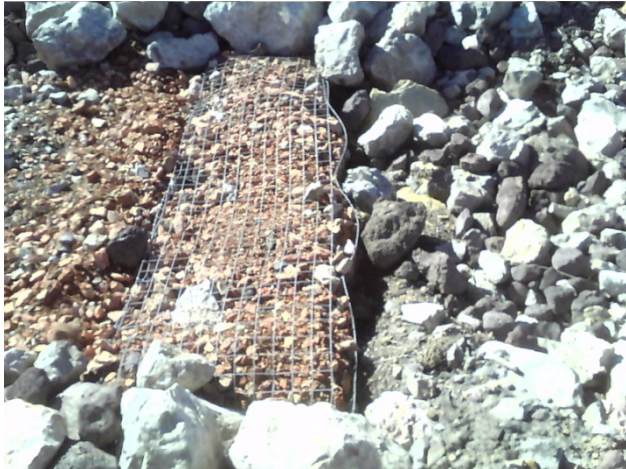
Photo 1: lowest gabion in YPM-14.

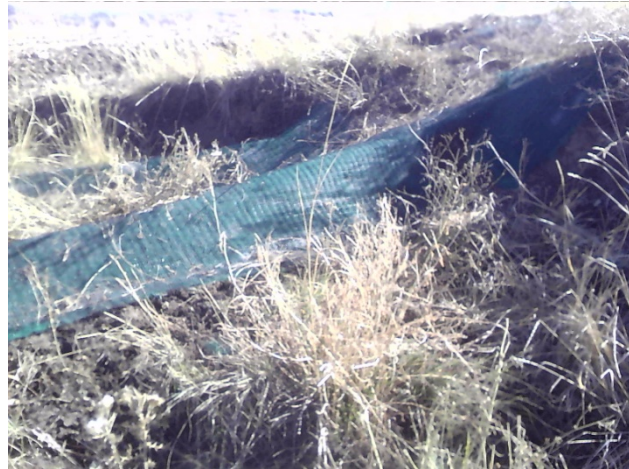
Repairs at the base of the neck pit slide, alongside road LU3A, and immediately upslope of SP07-1, needs additional repair. TRM matting has been undercut. (Photos 2 & 3).

The piezometer in this location has been broken off as well.

Photo 2: TRM unsupported and ripping at base of neck pit slide.

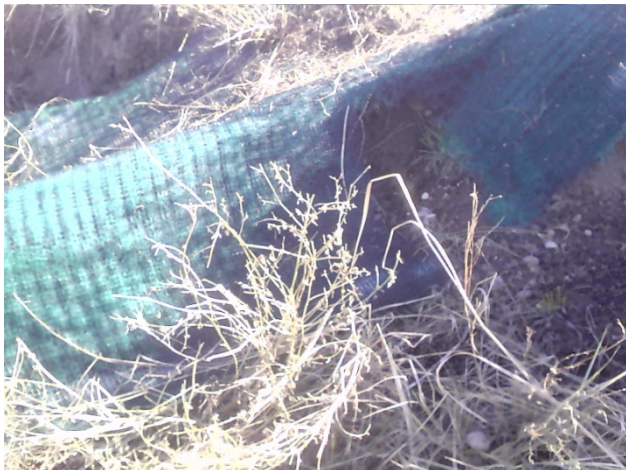
Photo 3: Tearing of TRM at base of neck pit slide

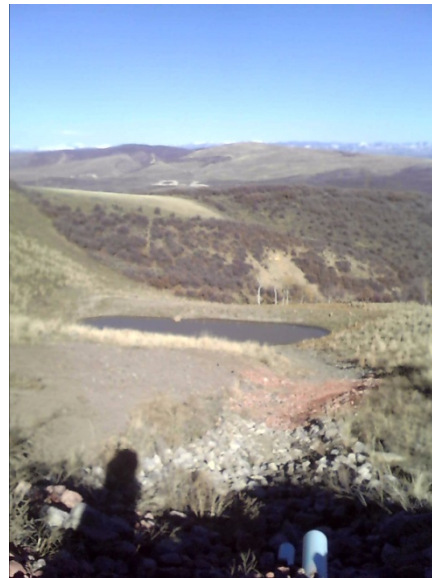
Photo 4: Pond 11A

The surge tanks located upslope of Pond 11A has been repaired and the risers stabilized.

Pond 11A was holding water.

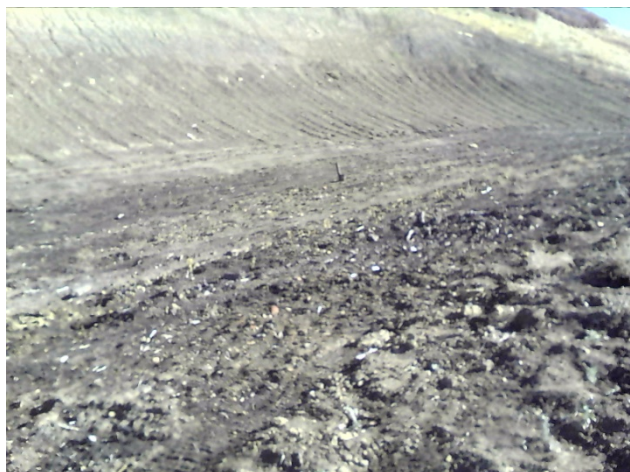
Shrub plantings along YPM 6-2 have lost their leaves. Plantings do not appear to have been browsed by wildlife or livestock. Weed barriers are in place. Canada thistles are becoming established within the shrub plantings.

Photo 5: Shrub plantings at Pond 12 slide area

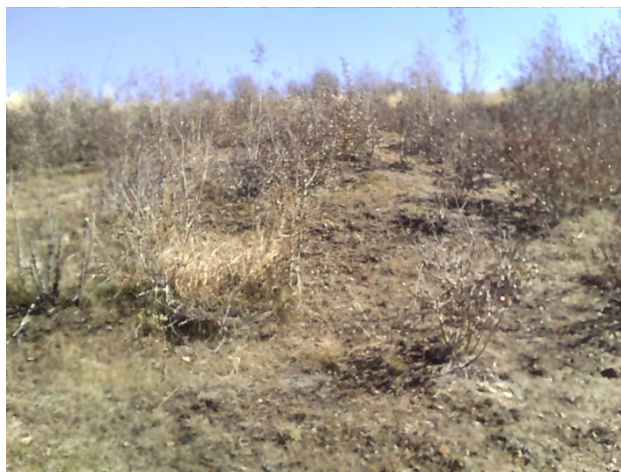
The Aspen plot in the southern end of the reclaimed area remains in good condition. The leaves have turned color and are beginning to drop. The aspen appear healthy and viable and not excessively browsed by wildlife. Noxious weed species within the Aspen plot are rare.

Photo 6: Aspen farm

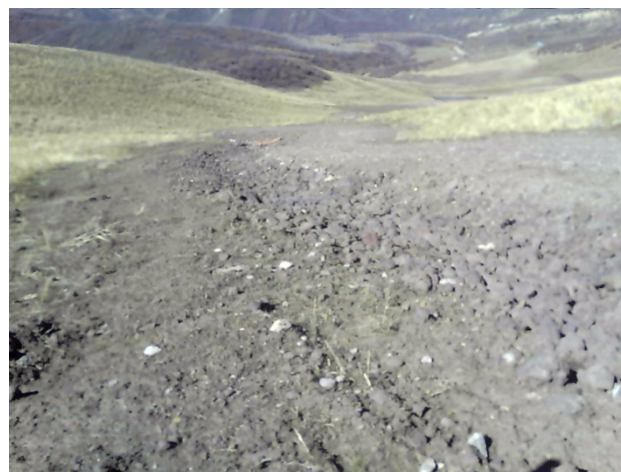
YPM-6-1 has been reconstructed.

Photo 8: Regraded drainage repairs YPM 1-3, YPM 6-1
