COLORADO DIVISION OF RECLAMATION, MINING AND SAFETY
MINERALS PROGRAM INSPECTION REPORT
PHONE: (303) 866-3567

MINE NAME: Eureka Gravel Pit	MINE/PROSPECTING ID#: M-1990-070	MINERAL: Gravel	COUNTY: San Juan
INSPECTION TYPE: Monitoring	INSPECTOR(S): Wallace H. Erickson	INSP. DATE: Sept 13, 2013	INSP. TIME: 16:30
OPERATOR: San Juan County	OPERATOR REPRESENTATIVE: None present	TYPE OF OPERATION: 110c - Construction Limited Impact	
REASON FOR INSPECTION: Normal I&E Program	BOND CALCULATION TYPE: None	BOND AMOUNT: \$0.00	
DATE OF COMPLAINT: NA	POST INSP. CONTACTS: None	JOINT INSP. AGENCY: None	
WEATHER: Clear	INSPECTOR'S SIGNATURE: <i>Wallace H. Erickson</i>	SIGNATURE DATE: November 5, 2013

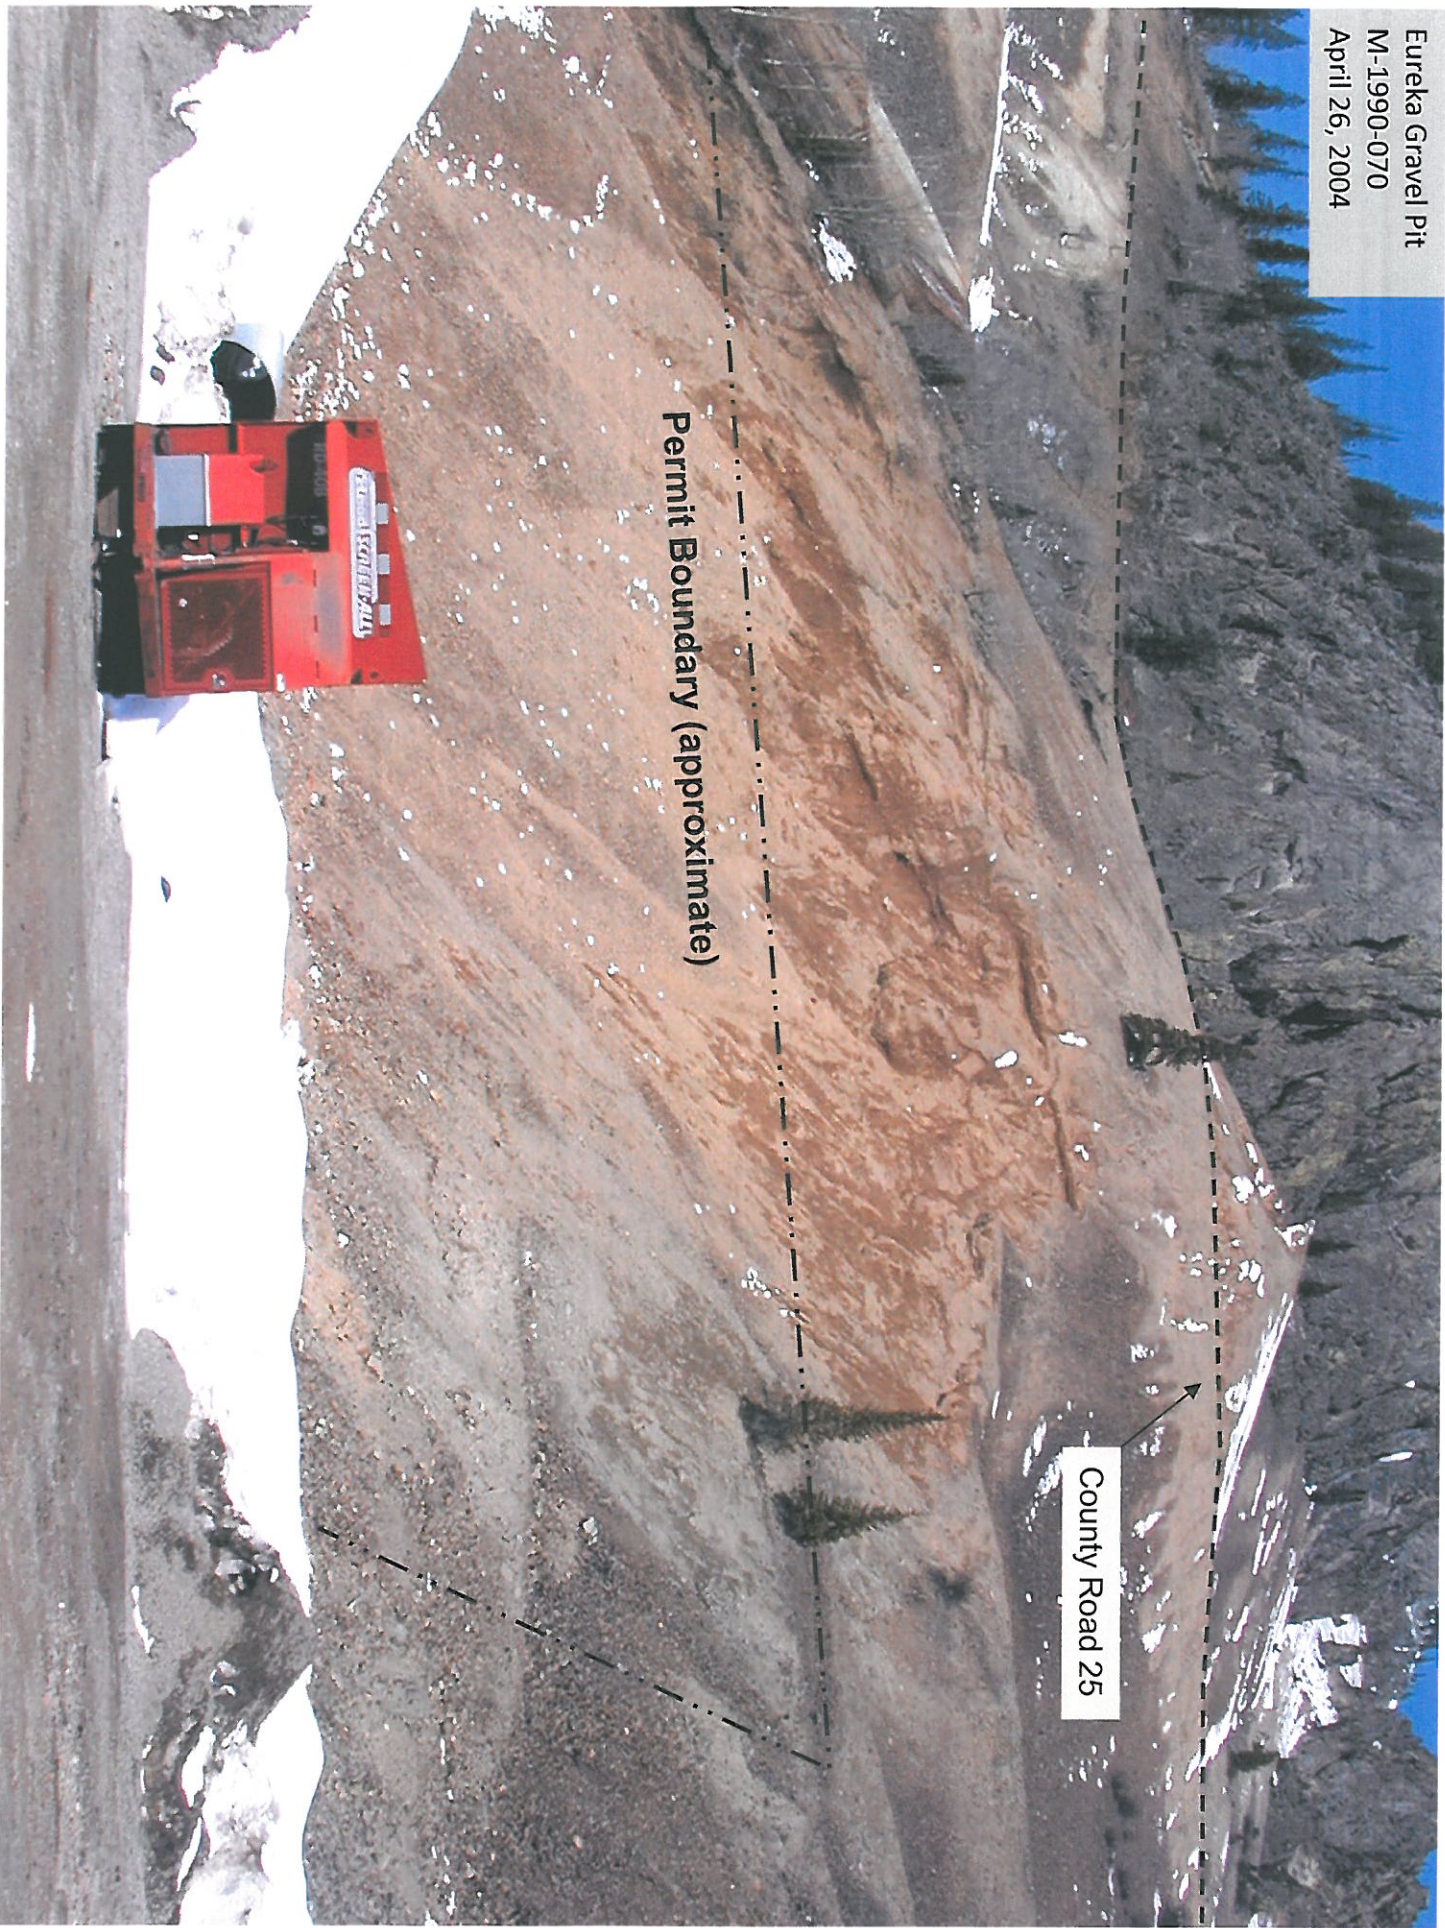
The original permit was approved to excavate materials from the toe of a talus slope. County Road 25 crosses the talus slope approximately 350 feet above the excavation area. The excavation activity ultimately over-steepened the talus slope, resulting in head-ward erosion advancing up slope and terminating at a scarp approximately 200 feet above the toe of slope and approximately 150 feet below County Road 25. The advancing head-ward erosion appeared to threaten the stability of County Road 25. The Operator was issued Violation MV-2004-051 on April 26, 2004, which was abated on November 22, 2004.

The three enclosed photographs show the results of the Operator's efforts. The well defined scarp, evident in 2004, has been partially backfilled and no longer spans the entire circumference above the previous excavation activity. Head-ward erosion continues to advance but at a reduced rate and as isolated gullies and not as an advancing front. In time the head-ward erosion will breach the edge of County Road 25, but the road has been widened, effectively relocating the driving surface more distant from the eroding slope.

In response to the violation the Operator ceased the excavation activity and commenced backfilling the toe of slope. Later, the Operator commenced end-dumping talus materials which had been excavation from above County Road 25. The excavation activity above County Road 25 resulted in widening and/or realignment of County Road 25 deeper into the cut side of the talus slope and further from the downhill edge.

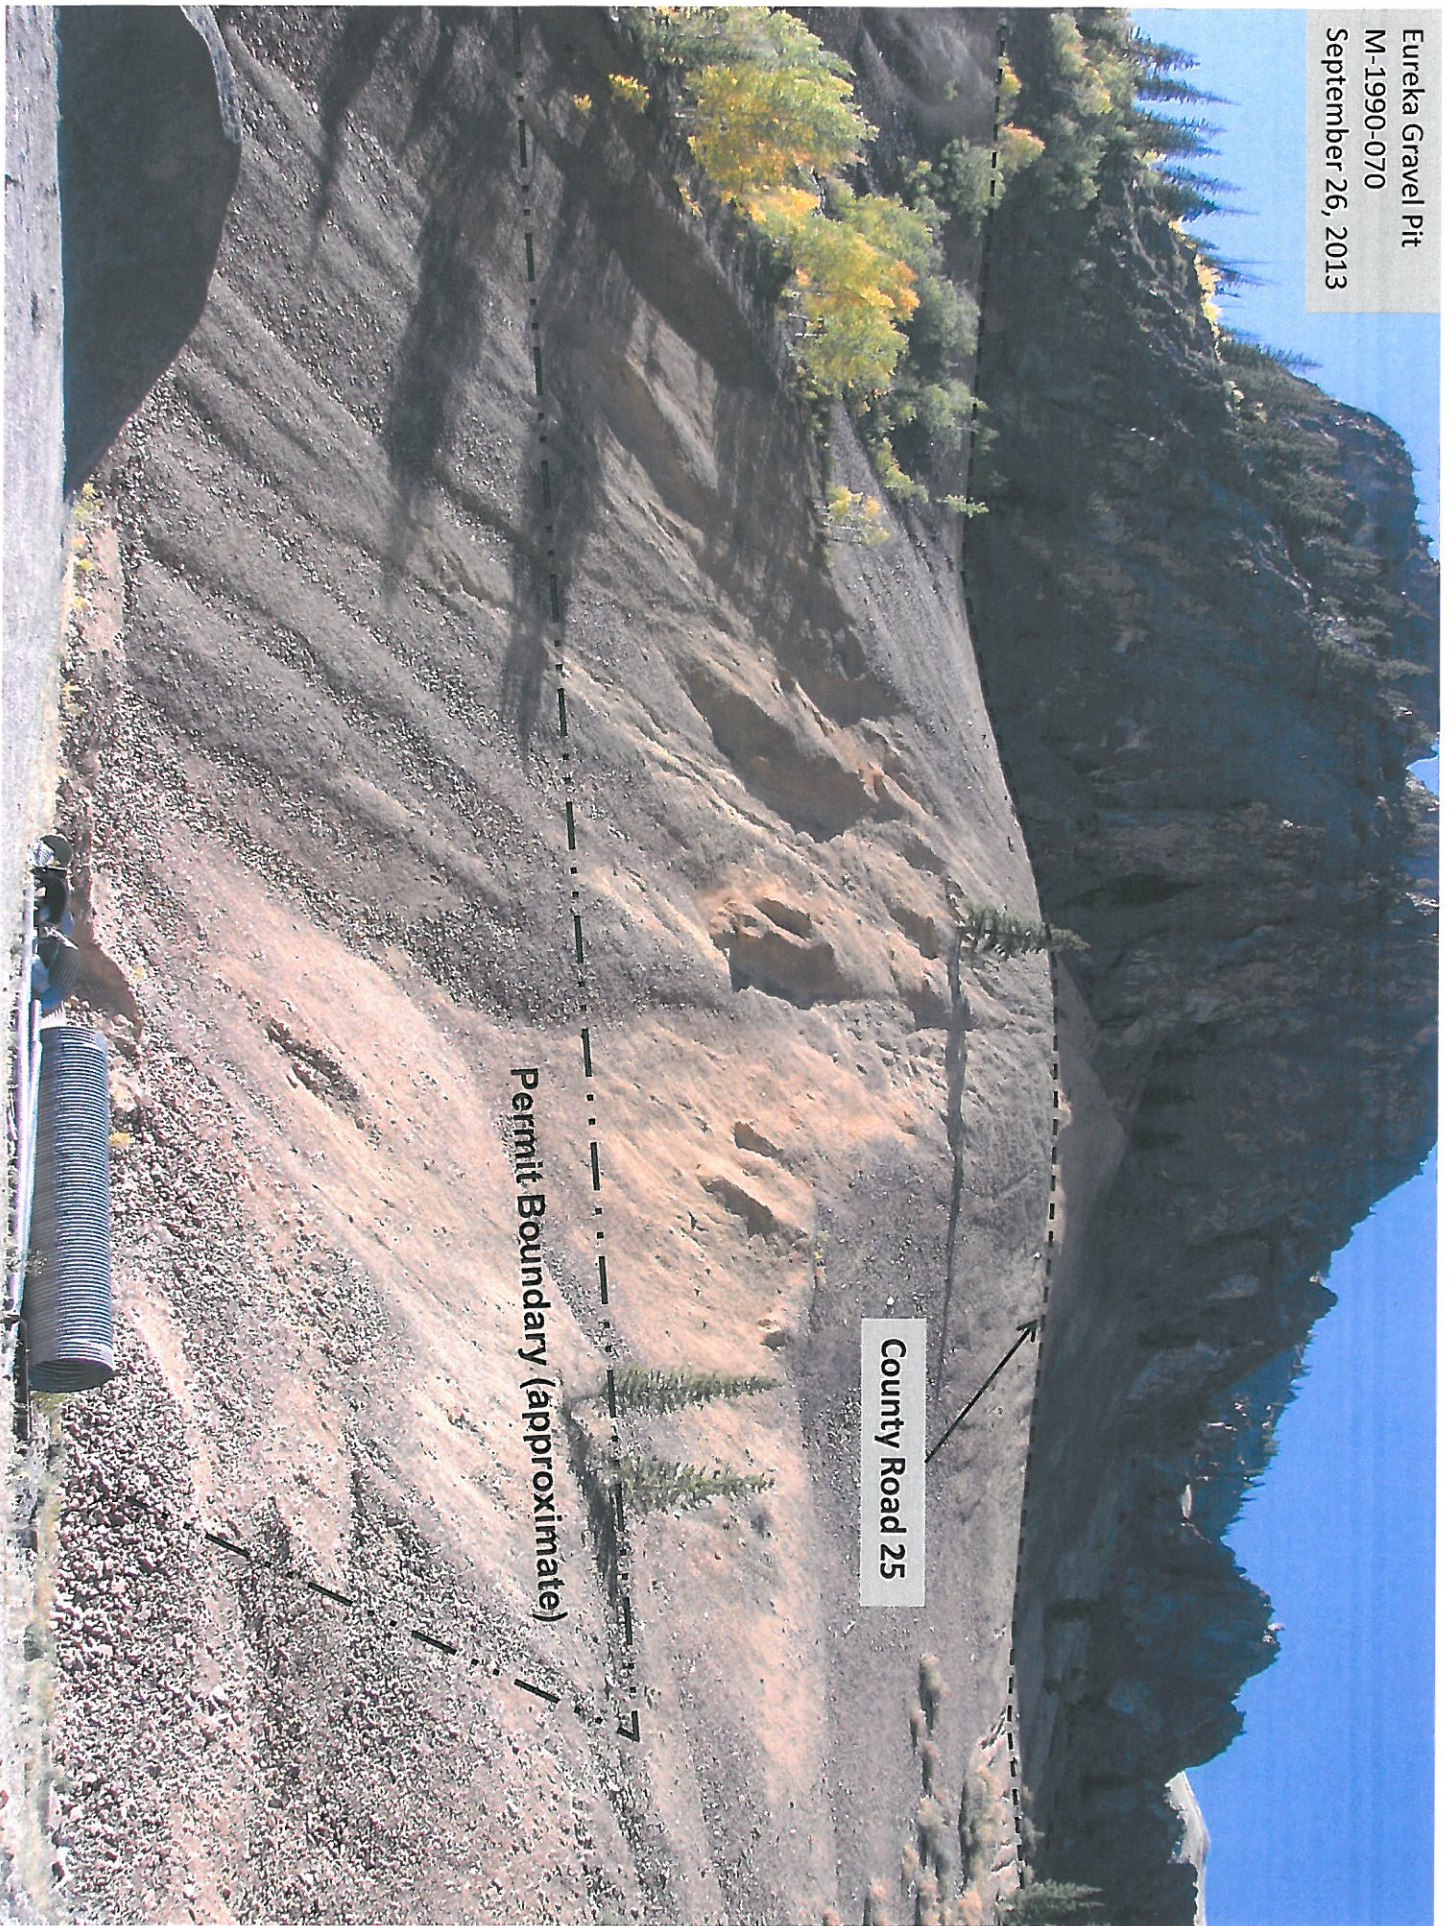
The Operator has permanently ceased excavation activity at the site but continues to utilize the permit area to stockpile and process road maintenance materials. As shown in the 2013 photo, a stockpile of imported gravel and various culverts were present.
