COLORADO DIVISION OF RECLAMATION, MINING AND SAFETY COAL PROGRAM INSPECTION REPORT

Permit Number: C-1996-083 Mine Name: Bowie No. 2 Mine Operator: Bowie Resources, LLC Operator Address: Mr William A Bear P.O. Box 483 Paonia, CO 81428	County: Delta Operation Type: Underground Permit Status: Active Ownership: Federal and Forest
Operator Representative Present: Bill Bear and Chris Hansen	
Operator Representative Signature: (Field Issuance Only)

Inspection Start Date: November 7, 2013 Inspection Start Time: 08:10 Inspection End Date: November 7, 2013 Inspection End Time: 11:20	Inspection Type: Coal Partial Inspection Inspection Reason: Normal I&E Program Weather: Clear
Joint Inspection Agency: None	Joint Inspection Contacts:
Post Inspection Agency: None	Post Inspection Contacts:
Inspector(s): Susan L. Burgmaier Marcia L. Talvitie, P.E.	Inspector's Signature:

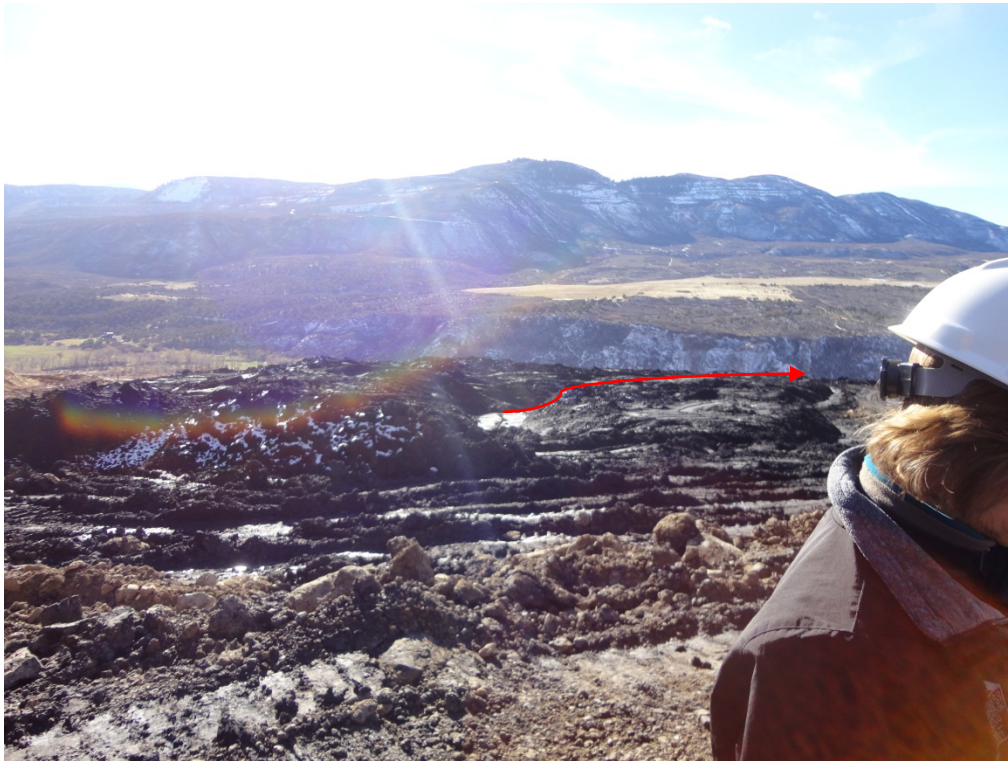
Gob material had been end dumped on the upper bench of the northeastern area of the pile. The operator had cut trenches through the material to ensure positive drainage, and had also placed 4" flexible pipe on the outslope edge of the material to ensure that water would flow directly to the approved ditches. The operator has submitted a minor revision to the permit application that describes the function of these drain pipes.

End dumped material on Gob Pile #2; drainage directed to ditch

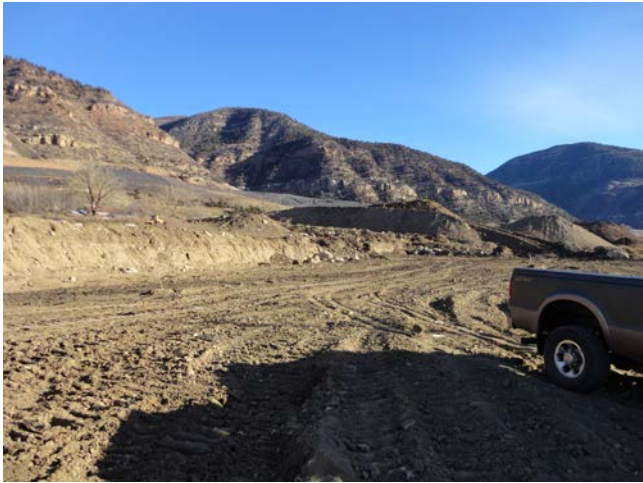
Cover material was being excavated from the northeastern area of Gob Pile #3, and hauled to the approved cover fill stockpiles. The operator indicated that construction of the approved underdrain would begin the week following the inspection, weather permitting.

Cover material excavation at Gob Pile #3

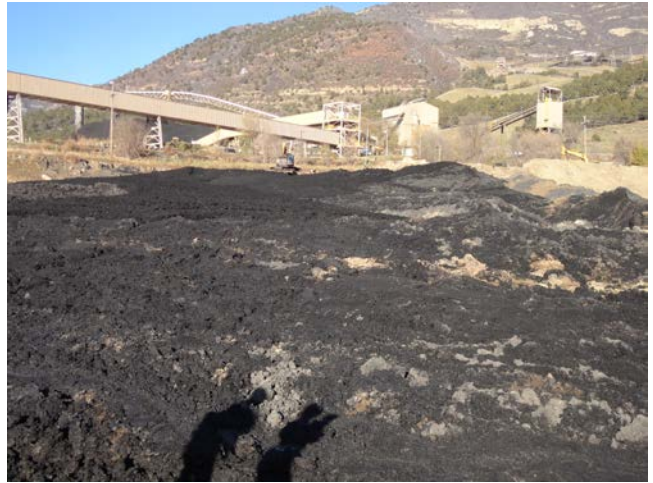
Gob material was being hauled to the designated drying area on the southwestern portion of Gob Pile #3. Material from the drying area was being spread and compacted in an adjacent area just east/northeast of the drying area. The operator indicated that the first compaction testing on Gob Pile #3 was done the week prior to the inspection.

Gob Drying area at Gob Pile #3

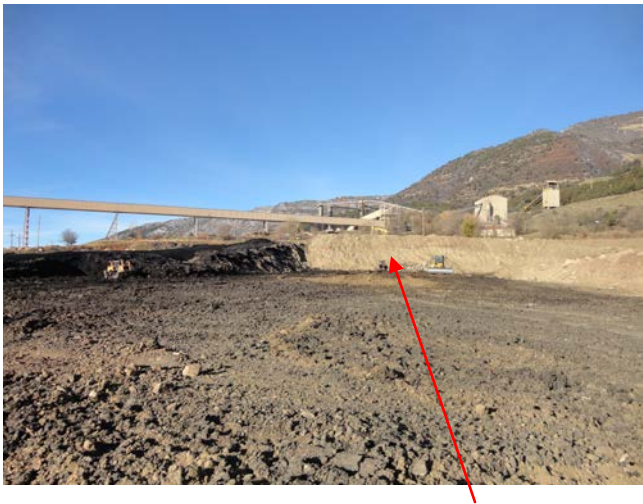
On the northwestern edge of the compacted gob, there is a steep slope of unexcavated material against which the gob is being compacted. As each lift of gob is added and compacted, material from the slope should be scraped off to ensure that the material does not slough or settle and become a conduit for water to enter the back side of the pile and saturate the gob material.

Compacted gob at Gob Pile #3; vertical wall

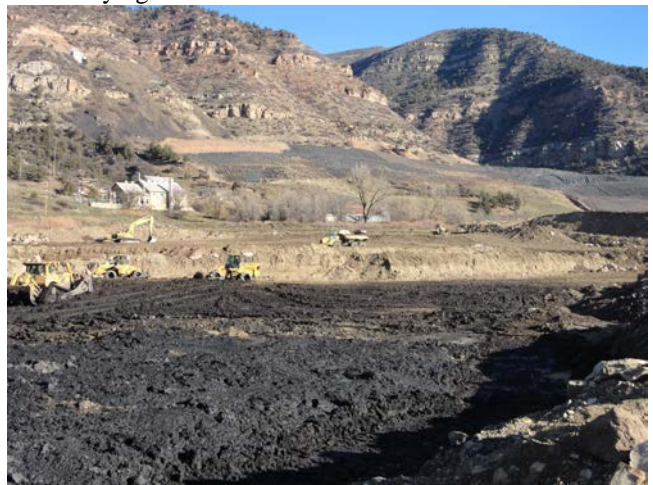
Gob compaction underway at Gob Pile #3

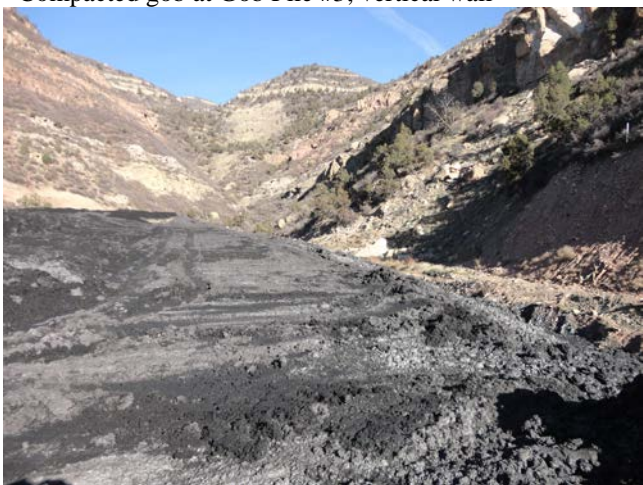
Upper bench of Gob Pile #2

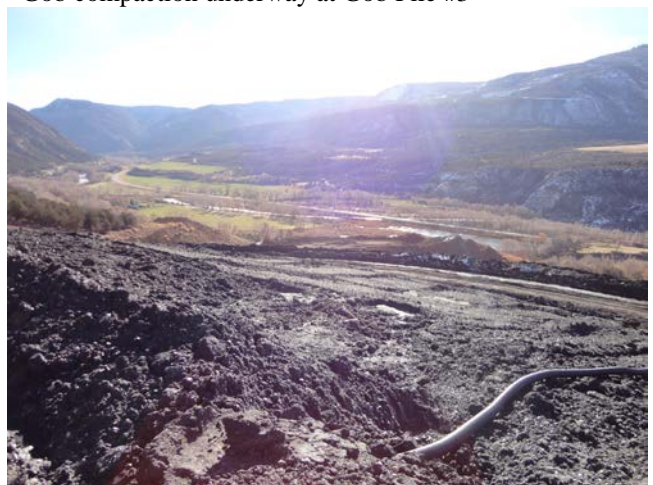
Drain pipe off of upper Gob Pile #2 bench

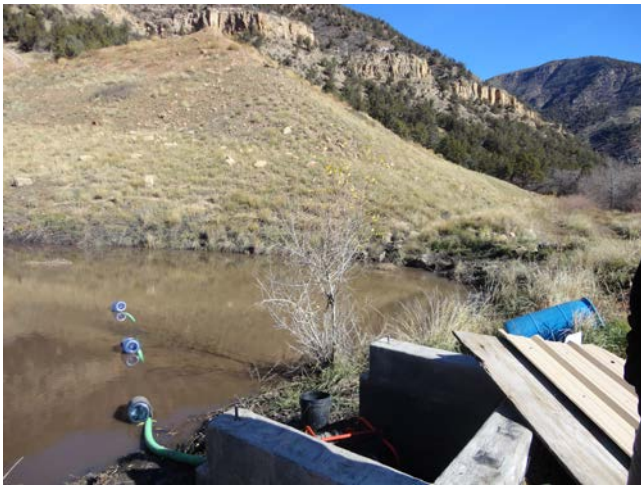
Ponds B, C, F, and J all held water; none were being discharged during the inspection. Pond F should be dewatered as soon as possible to ensure that there is adequate capacity for the design event.

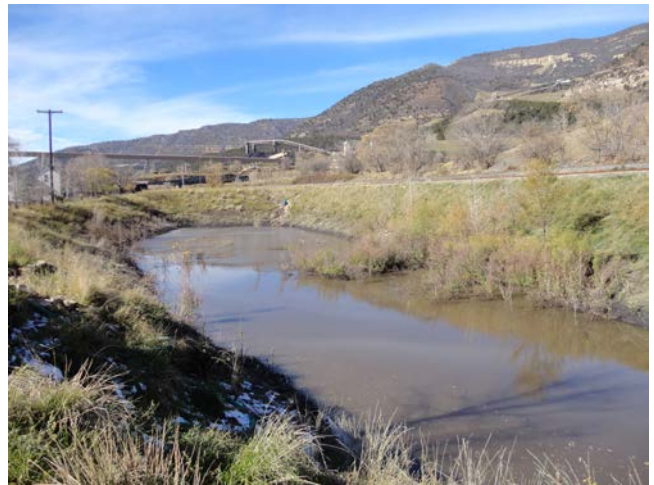
The operator also mentioned that Pond J may be enlarged to allow for additional settling time. We also discussed

the options of adding a second pond or including a baffle/two cell configuration if the pond is enlarged. These options might increase settling time and also allow greater flexibility with dewatering.
