COLORADO DIVISION OF RECLAMATION, MINING AND SAFETY COAL PROGRAM INSPECTION REPORT

Permit Number: C-1981-022 Mine Name: Elk Creek Mine Operator: Oxbow Mining, LLC Operator Address: Mr. Jim Kiger P.O. Box 535 3737 Highway 133 Somerset, CO 81434	County: Delta, Gunnison Operation Type: Underground Permit Status: Active Ownership: Federal
	Operator Representative Present: Jim Kiger
Operator Representative Signature: (Field Issuance Only)

Inspection Start Date: November 6, 2013 Inspection Start Time: 09:00 Inspection End Date: November 6, 2013 Inspection End Time: 14:30		Inspection Type: OSM Complete Inspection Inspection Reason: OSM Oversight Inspection Weather: Clear	
Joint Inspection Agency: OSM		Joint Inspection Contacts: Christine Belka	
Post Inspection Agency: None		Post Inspection Contacts:	
Inspector(s): Brock F. Bowles	Inspector's Signature:

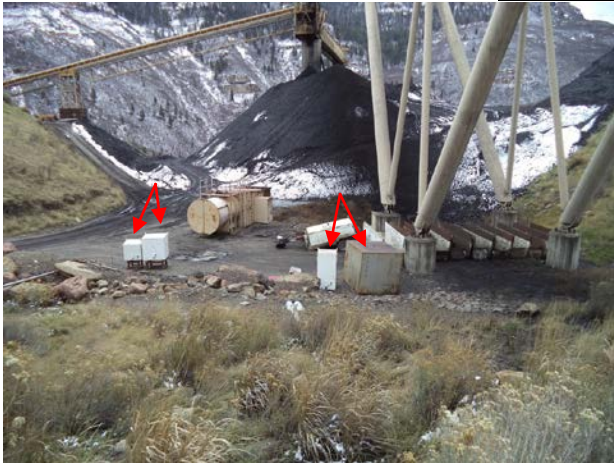
Photo 1 – Explosive Lockers

The area around the detonation cap and explosive lockers was free and clear of debris and vegetation (photo 1).

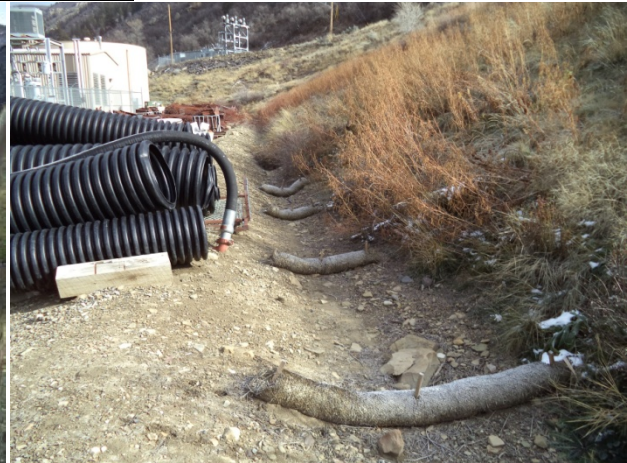
Photo 2 – Ditch D9

Ditch D9 at the base of the Elk Creek topsoil stock pile was free of debris and had straw waddles staked in place (photo 2). Ditch D6 was free and clear of debris. Ditch D1 and D5 were free of debris and the berm between the two ditches was also in good condition (photo 3). Culvert DD and DG at the ends of ditches D1 and D5 respectively, were free and clear of debris. The culvert under the Bear Creek fan was free and clear of debris.

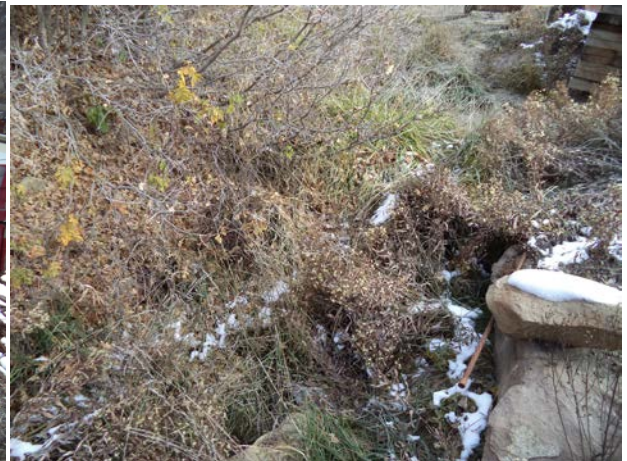
Photo 4 – Culverts DD and DG

Where ditch D2 goes into culvert DB, there was an excessive amount of vegetation and the sediment traps were not evident (photo 4). Ditch D2 through this area needs to be cleaned out and have sediment traps installed.

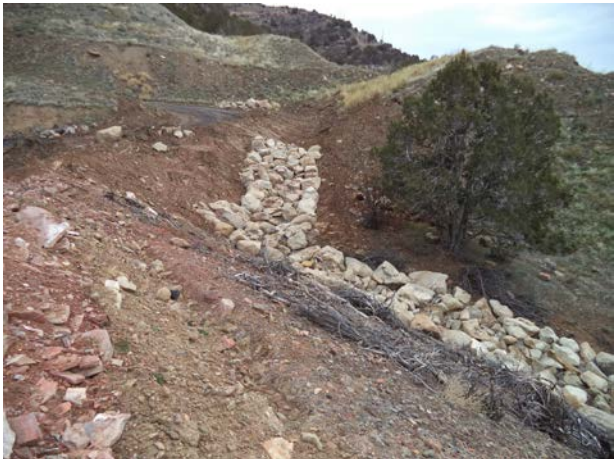
Photo 5 – Ditch 2 into Culvert DB

The perimeter ditch on the east side of the II West Refuse pile is being constructed. It is currently lined with rock up to the top of the pile (photo 5). The west side perimeter ditch that needed cleaning (Aug 6, 2013 inspection report) was repaired.

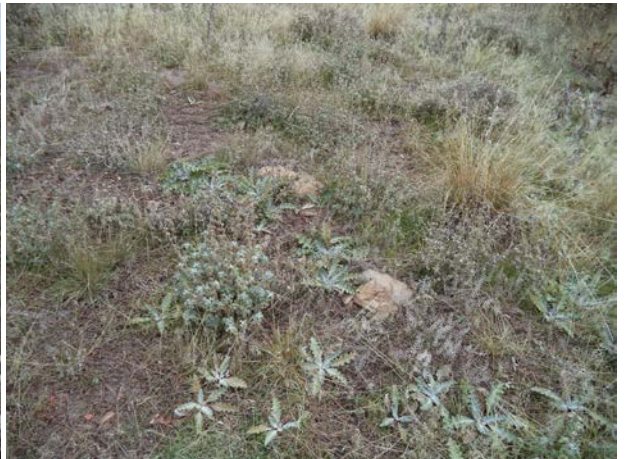
Photo 6 – II West Refuse Pile East Ditch

Pond E was dry but there were many thistle rosettes in the bottom of the pond (photo 6). These rosettes should be treated before the plant bolts and goes to seed next spring.
