COLORADO DIVISION OF RECLAMATION, MINING AND SAFETY COAL PROGRAM INSPECTION REPORT

Permit Number: C-1981-012 Mine Name: New Elk Mine Operator: New Elk Coal Company, LLC Operator Address: Mr Ron Thompson 12250 Highway 12 Weston, CO 81091	County: Las Animas Operation Type: Underground Permit Status: Temporary Cessation Ownership: Private
	Operator Representative Present: Greg Smith, Bobby Steele
Operator Representative Signature: (Field Issuance Only)

Inspection Start Date: November 5, 2013 Inspection Start Time: 12:15 Inspection End Date: November 5, 2013 Inspection End Time: 15:00	Inspection Type: Coal Partial Inspection Inspection Reason: Normal I&E Program Weather: Snowing
Joint Inspection Agency: None	Joint Inspection Contacts:
Post Inspection Agency: None	Post Inspection Contacts:
Inspector(s): Leigh D. Simmons	Inspector's Signature:

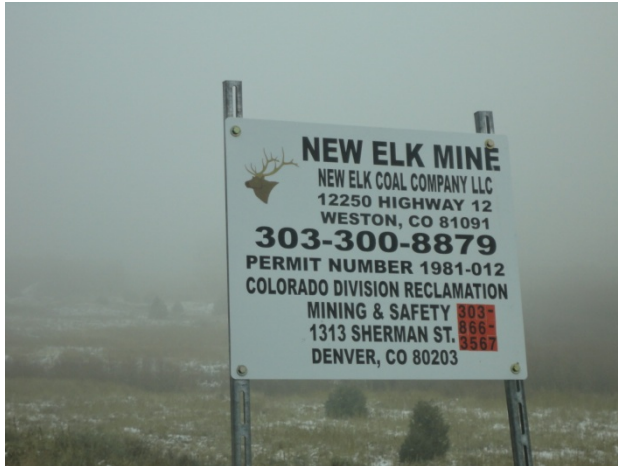
The mine ID signs at the east and west end of the site, on highway 12, had been updated to include the phone number for the Division. Other signs were not checked, but all should be altered in the same way.

Photo 1: Mine ID sign (west)

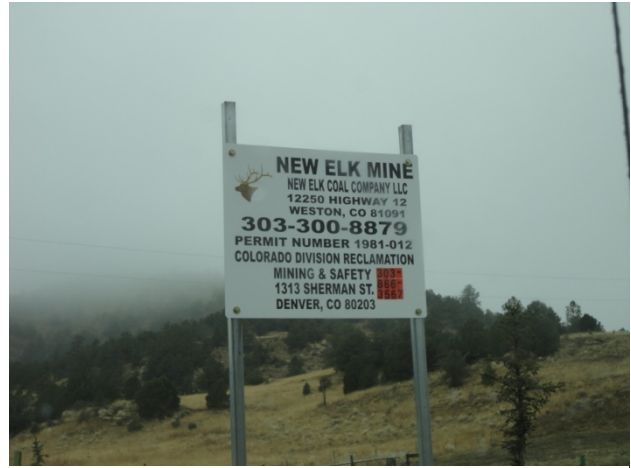
Photo 2: Mine ID sign (east)

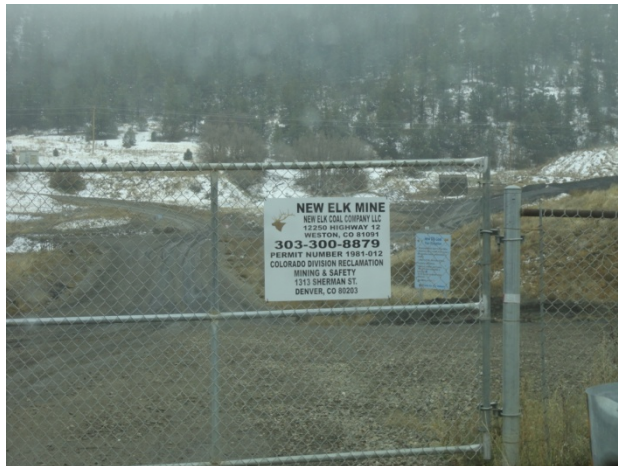
Photo 3: Mine ID sign (main gate, needs updating)

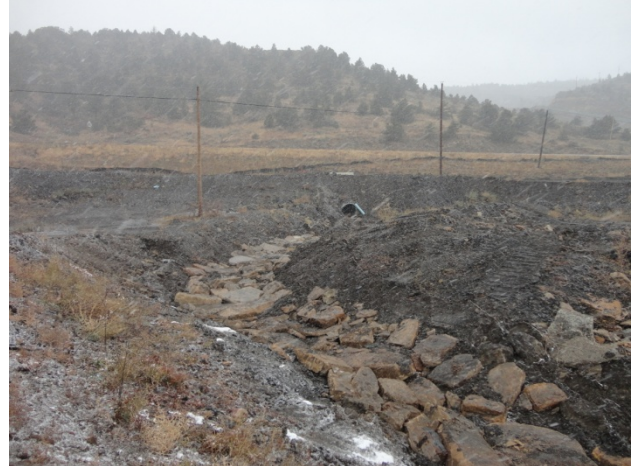
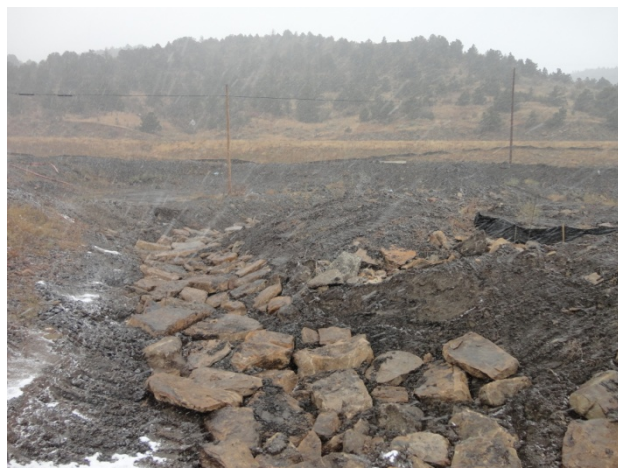
The clean-water ditch downstream of culvert C30, at the west end of the topsoil stockpile SAE, had been armored. This work has made the ditch much more effective.

Photo 4: Newly armored ditch below C30

Photo 5: Newly armored ditch below C30 (2)

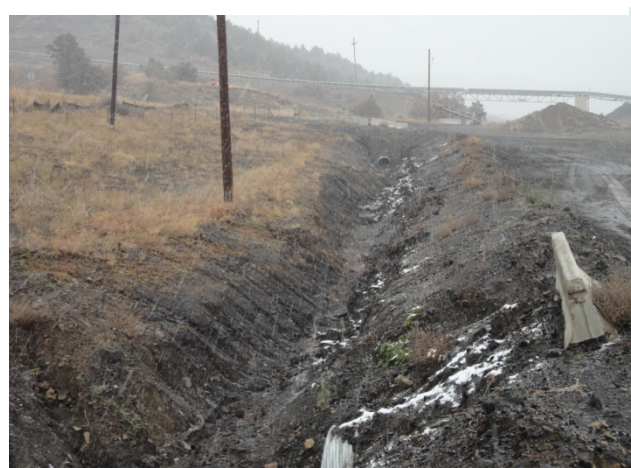
Culvert C14 had been cleaned.

Photo 6: C14, and ditch, cleaned

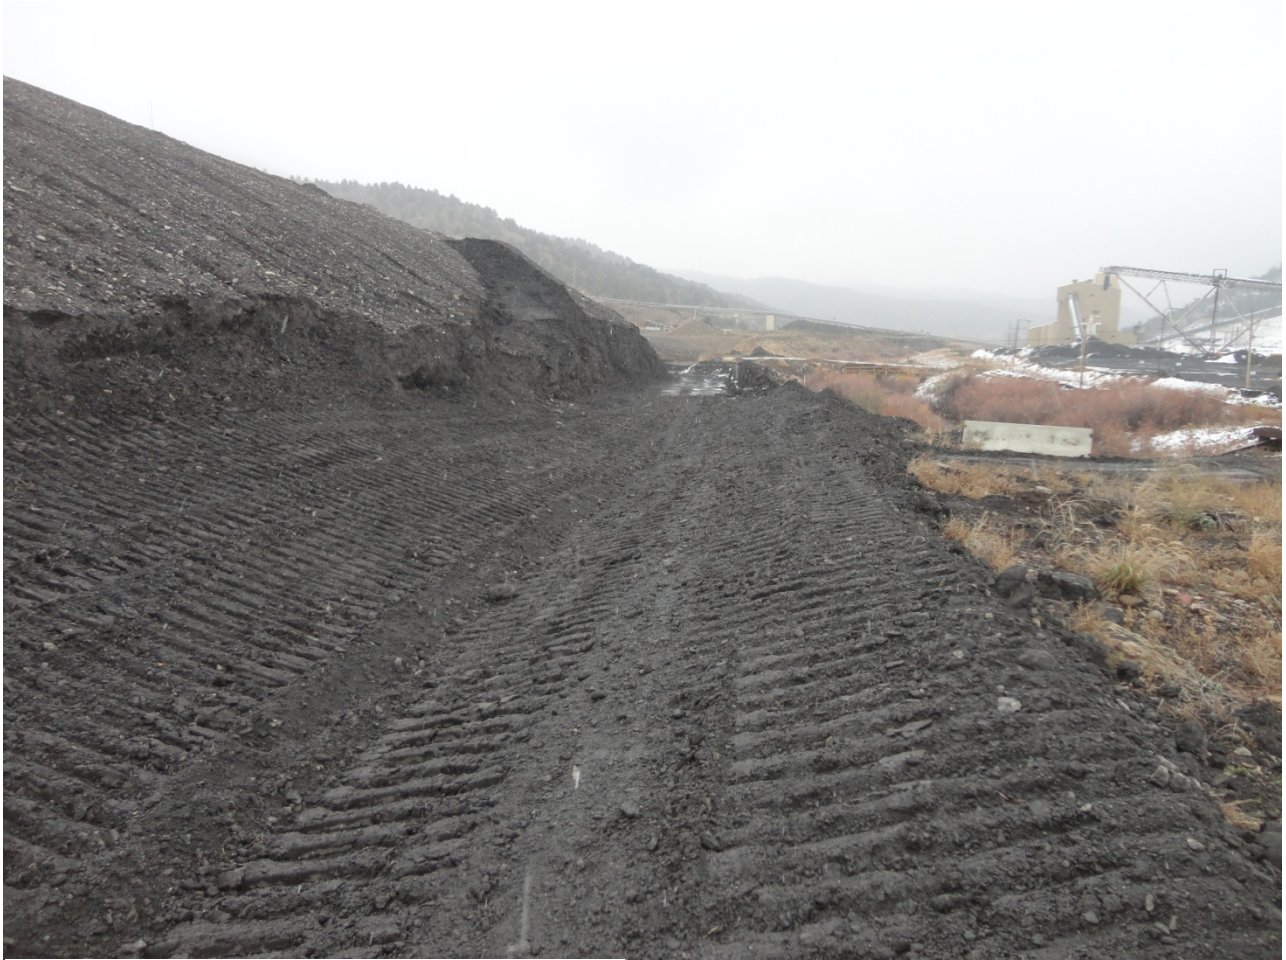
Ditch D14 had been restored, abating CV2013007.

Photo 7: Ditch D14, restored

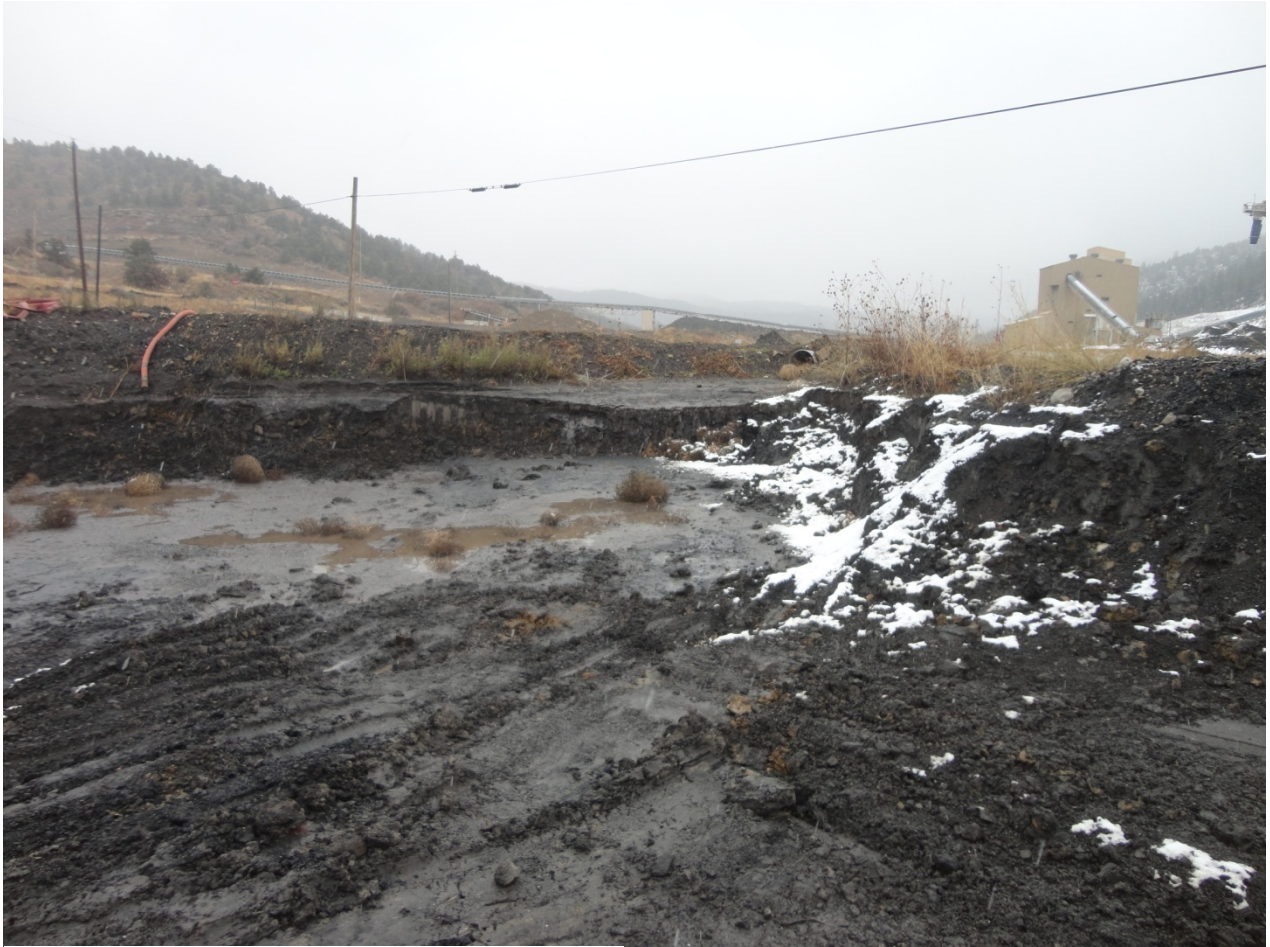
Photo 8: Ditch D14/Culvert C13 sump

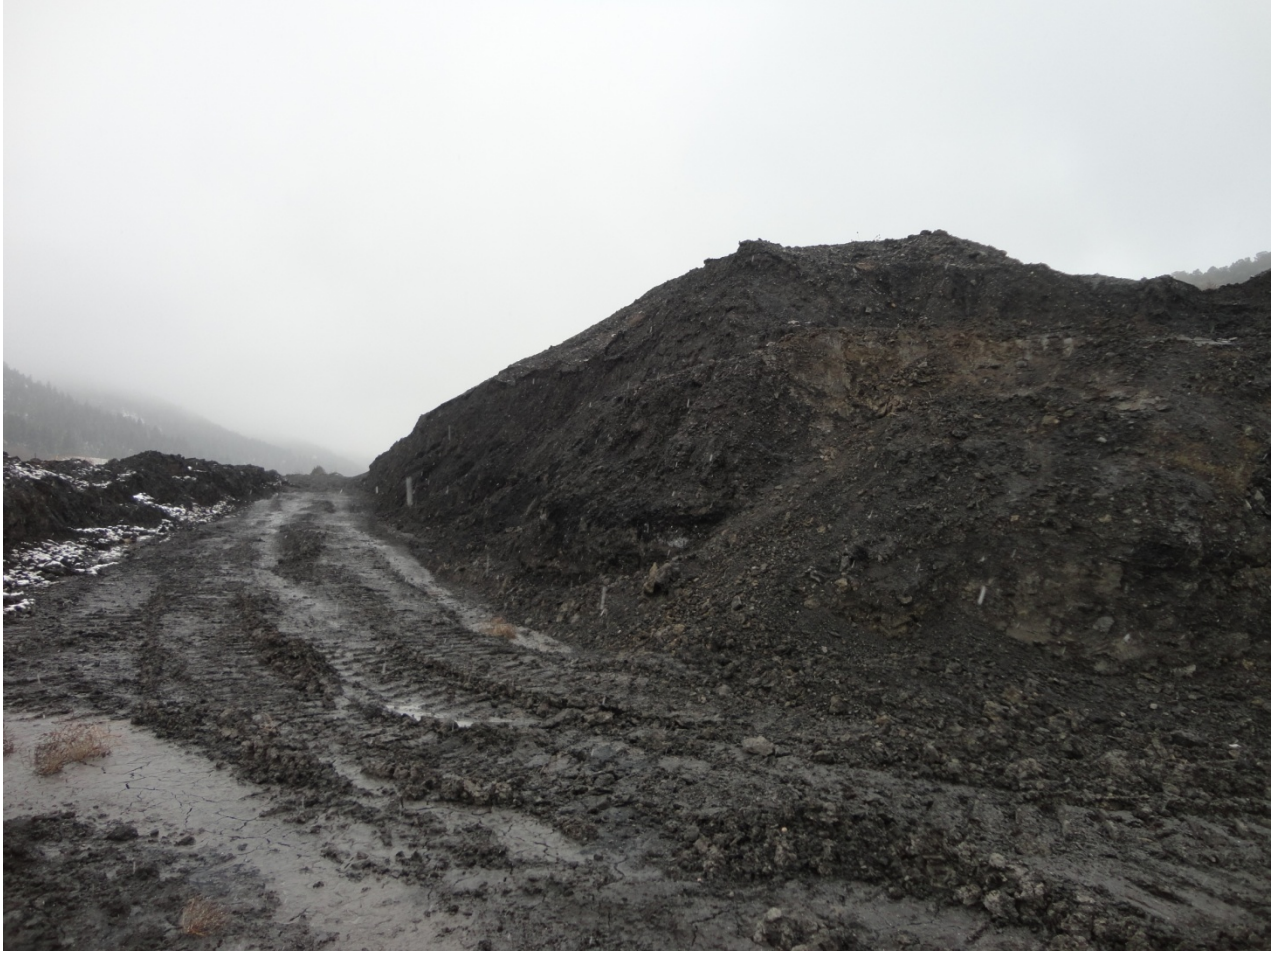
Photo 9: DWDA2, toe to be re-graded

Following the repairs made to Ditch D14, **the toe of DWDA2 needs to be re-shaped so that the slope is in accordance with the approved design.** Although there is a tentative plan to re-process the development waste, the feasible time-scale for this project, if it were to go ahead, means that the waste pile will need to be re-graded anyway.

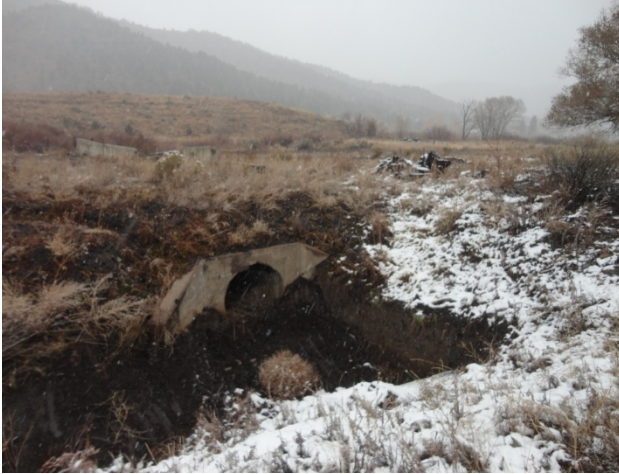
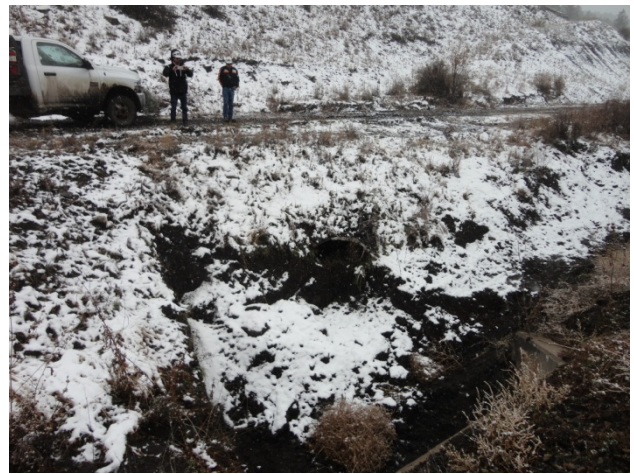
The two “railroad culverts” at the far east end of the site, C86 and C87, had been cleared at either side. A little shovel-work was needed to finish the job.

Photo 10: "Railroad culvert" C 87

Photo 11: "Railroad culvert" C86

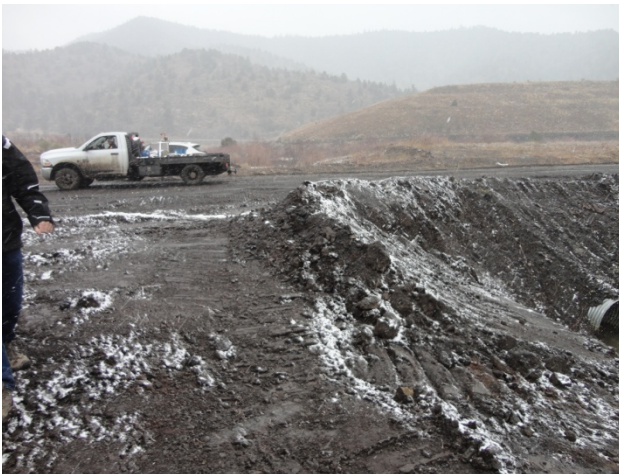
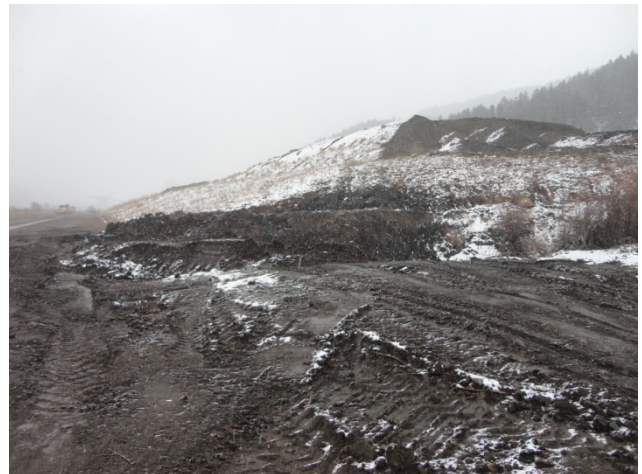
The material around culvert C3 had been cleaned up.

Photo 12: Clean up around C3

Photo 12: Clean up around C3 and soil storage pile
