**COLORADO DIVISION OF RECLAMATION, MINING AND SAFETY
COAL PROGRAM INSPECTION REPORT**

Permit Number: C-1981-046 Mine Name: Sunlight Mine Operator: Garfield Energy Corporation Operator Address:	County: Garfield Operation Type: Underground Permit Status: Revoked Ownership: Private
	Operator Representative Present: None
Operator Representative Signature: (Field Issuance Only)

Inspection Start Date: November 7, 2013 Inspection Start Time: 11:30 Inspection End Date: November 7, 2013 Inspection End Time: 12:00		Inspection Type: Coal Complete Inspection Inspection Reason: Normal I&E Program Weather: Clear	
Joint Inspection Agency: None		Joint Inspection Contacts:	
Post Inspection Agency: None		Post Inspection Contacts:	
Inspector(s): Brock F. Bowles	Inspector's Signature:

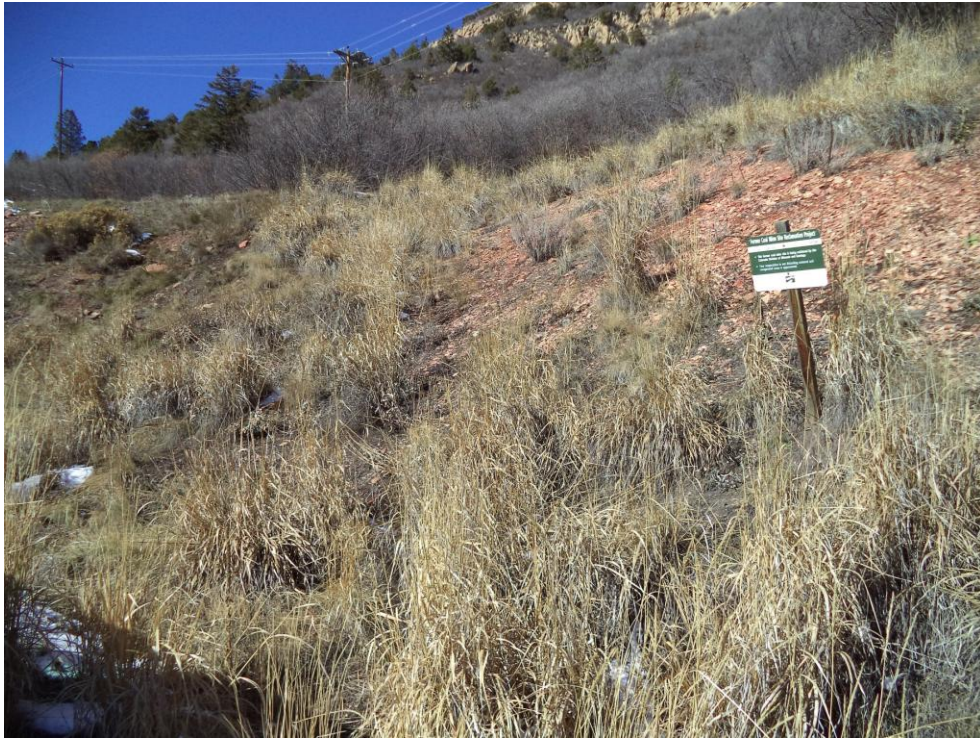
The upper portal area is stable. There were no signs of cracking or slumping (photo 1).

The sign on the upper portal area was in place.

Photo 1 – Upper Portal Area with Sign

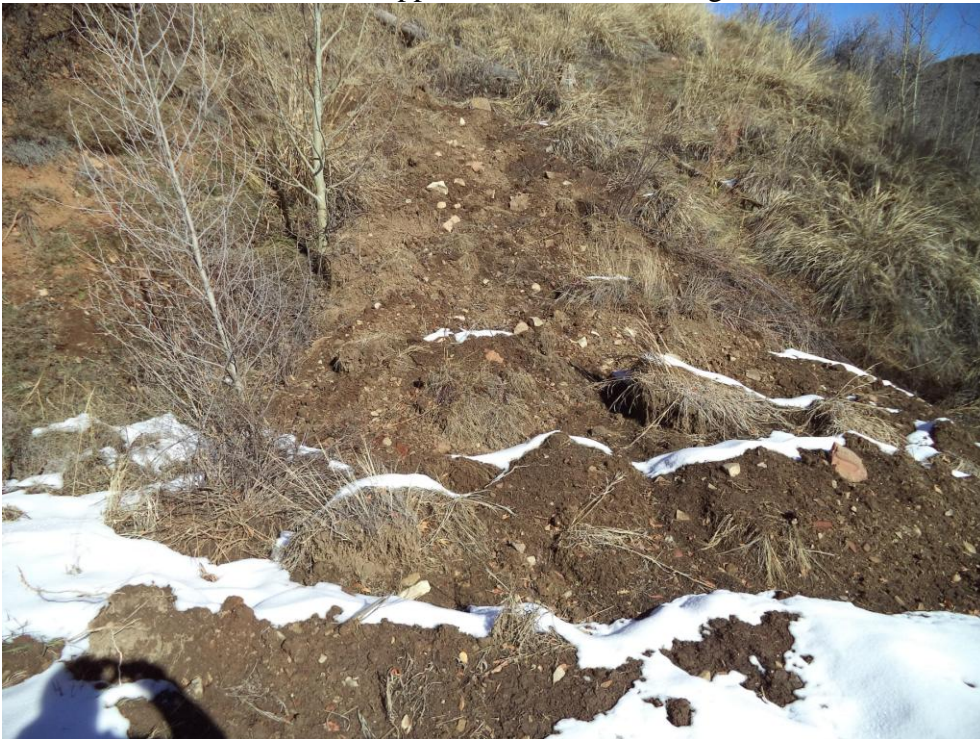
The newly backfilled lower portal (Sept 9, 2013) appeared to be stable (photo 2). There were no signs of slumping or cracking. The backfill was left in a rough condition with pockets and clumps of sod to catch moisture and seeds. The area remains rough with snow caught in the depressions and there were no signs of overland water flow.

Photo 2 – Lower Portal Area
