**COLORADO DIVISION OF RECLAMATION, MINING AND SAFETY  
COAL PROGRAM INSPECTION REPORT**

<b>Permit Number:</b> C-1981-028 <b>Mine Name:</b> Keenesburg Strip Mine <b>Operator:</b> Coors Energy Company <b>Operator Address:</b> Mr Benjamin Moline P.O. Box 4030 Suite 400 Golden, CO 80401	<b>County:</b> Weld <b>Operation Type:</b> Surface <b>Permit Status:</b> Active <b>Ownership:</b> Private
	<b>Operator Representative Present:</b>  Danny Kipp
<b>Operator Representative Signature:</b> (Field Issuance Only)

<b>Inspection Start Date:</b> November 14, 2013 <b>Inspection Start Time:</b> 08:40 <b>Inspection End Date:</b> November 14, 2013 <b>Inspection End Time:</b> 10:00		<b>Inspection Type:</b> Coal Partial Inspection <b>Inspection Reason:</b> Normal I&E Program <b>Weather:</b> Clear	
<b>Joint Inspection Agency:</b>  None		<b>Joint Inspection Contacts:</b>	
<b>Post Inspection Agency:</b>  None		<b>Post Inspection Contacts:</b>	
<b>Inspector(s):</b>  Jared L. Ebert	<b>Inspector's Signature:</b>

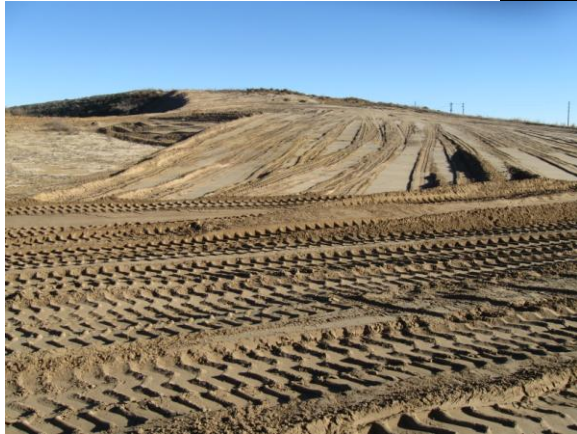
Topsand piles A-1 and B-1 were observed. The Operator had been recently excavating topsand material from the south face of topsand pile A-1 with a scrapper prior to the inspection. Both piles have adequate vegetation cover for stabilization. Pile B-1 has a significant number of perennial species established on the pile.

South face to Topsand Pile A-1.

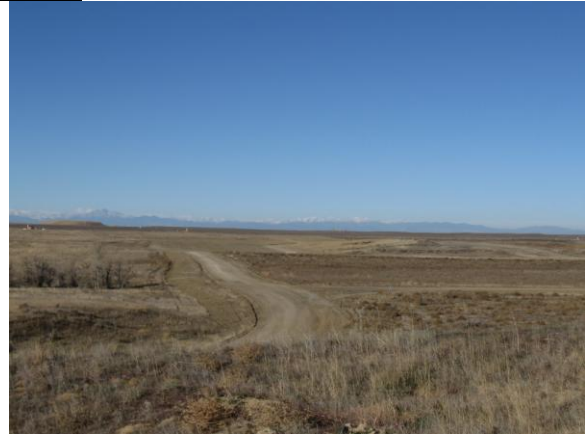
View from on top of Topsand Pile B-1 looking west.

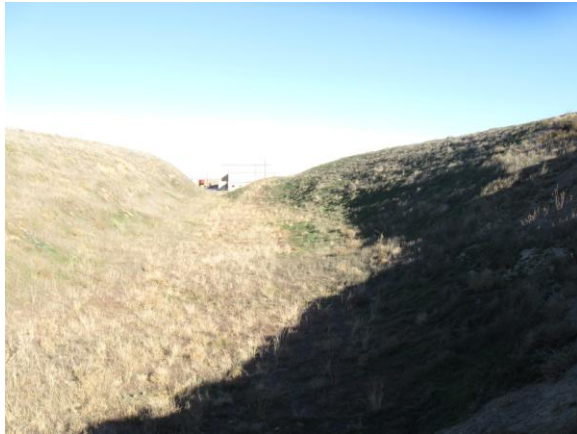
Topsand Pile A-1 and B-1, picture of the slope between the two piles.

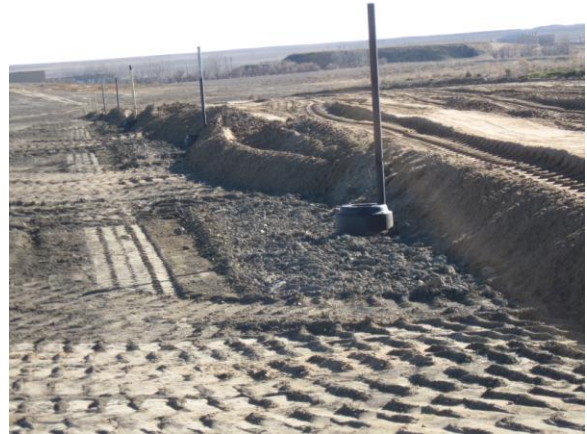
The Operator recently placed spoil material on the south side of B-Pit. Prior to the inspection, Mr. Kipp was spreading a lift of A Horizon topsand on top of the recently backfilled spoil material. Metal poles with a two foot depth marker have been placed adjacent to the lift to insure an adequate depth of material has been placed.

South of B-Pit excavation, A horizon topsand placed on top of spoil lift.

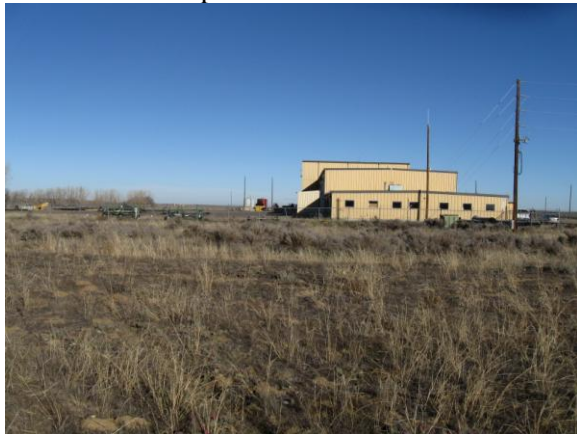
Shop facilities.

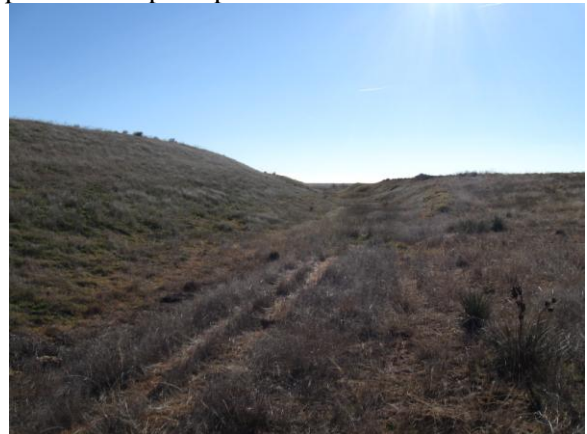
Topsand piles A-3 and the B stockpile northwest of A-3 was also inspected. These piles were well vegetated and stable.

B Horizon topsand pile adjacent to long term spoil pile.
